Requirement Detail

DENFELD HS

District: Duluth Public Schools
Facility: Denfeld High School
Category: Deferred Maintenance

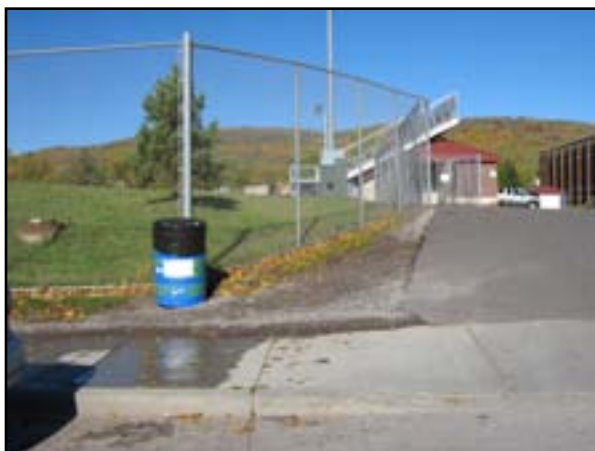
Parking Lot

Deteriorated parking lot.

Fill in bituminous pavement section at parking lot entrance along 4th street, southeast by stadium.

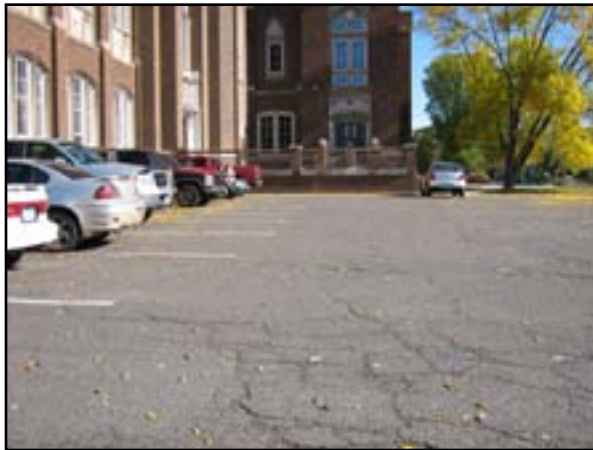
Main Parking Lot

Deteriorated parking lot.

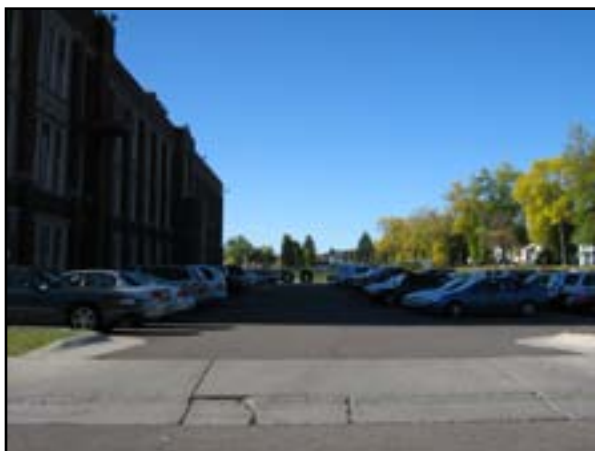
Parking Lot

Deteriorated parking lot.

Seal coat bituminous pavement and replace broken section of portland cement concrete.

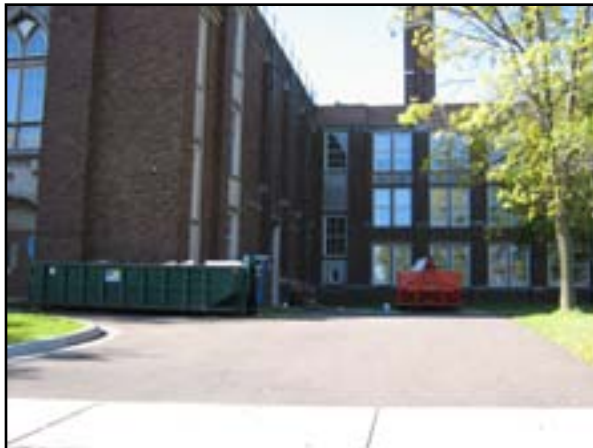
Parking Lot

Deteriorated parking lot.

Seal coat bituminous pavement. Existing pavement in good condition.

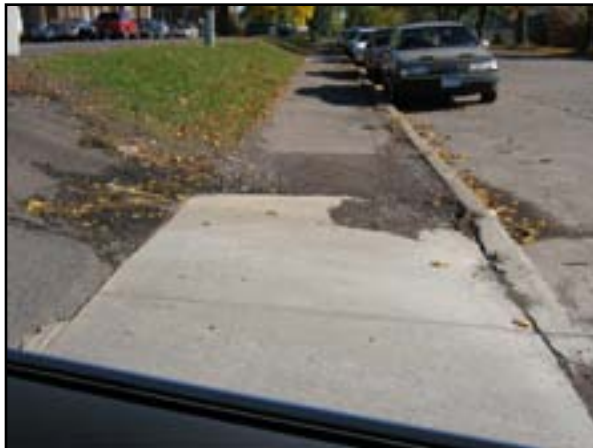
Sidewalk

Deteriorated sidewalk.

Replace missing/broken portland cement concrete sidewalk (city's ?).

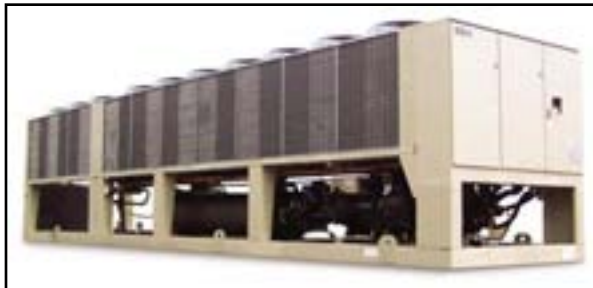
HVAC - Dehumidification Chiller and Piping Mains

Denfeld High School has no means of dehumidification, other than the office and boys club area. Without de-humidification capabilities, these spaces cannot meet ASHRAE 55-1992 space design conditions.

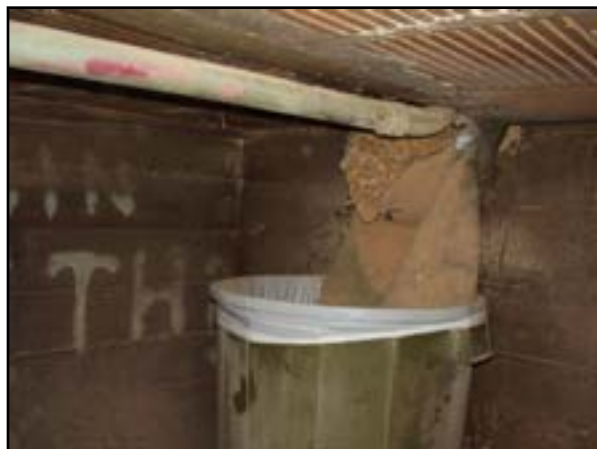
HVAC - Upgrade Ventilation and Replace Wood Shop Dust Collector and Upgrade Weld Hood Exhaust

The dust collector for the wood shop is 80 years old and is beyond it's recommended useful life. The exhaust duct is located above grade and does not serve all the required equipment. In addition, make up air is not being supplied to the wood shop as required by the 2000 International Mechanical Code.

The ventilation unit supplying these areas is not capable of providing 2000 International Mechanical Code required ventilation air. The return air is currently combining with the rest of the building supply air plenum and transferring wood dust to the common plenum.

Replace the wood shop dust exhaust system with a new re-circulating dust collector and pipe the exhaust duct overhead.

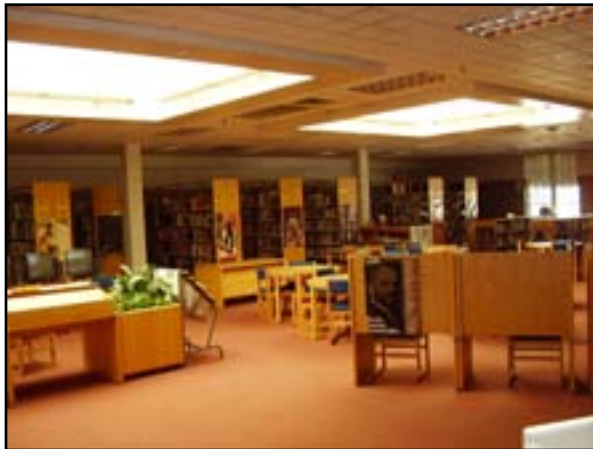
HVAC: Add Dehumidification in the Library and Computer Room Areas

The two (2) air handling systems serving the Library and Computer Room Area have no means of dehumidification. Without dehumidification capabilities, these spaces cannot meet ASHRAE 55-1992 space design conditions.

Addition of dehumidification coils to the two air handling units and installation of closed cell liner inside the air handling units. Installation of supply duct external insulation. Upgrade Controls System. Test and Balance and Commissioning of air handling units.

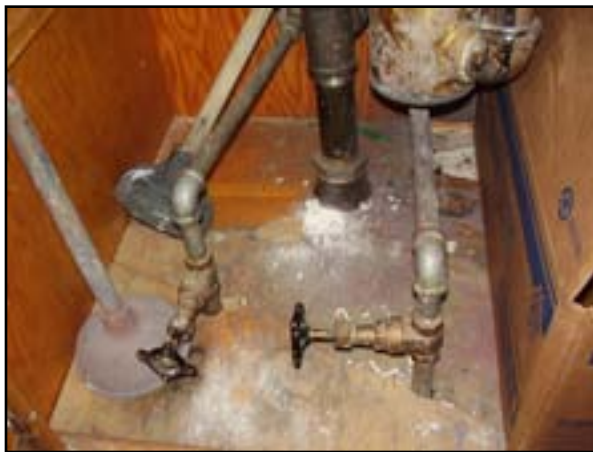
Plumbing: Replace Galvanized Domestic Water Piping

In addition many of the drinking fountains utilize indirect sumps for draining, some of which are located in supply air plenums. These need to be directly connected to the sanitary waste and vented per the plumbing code.

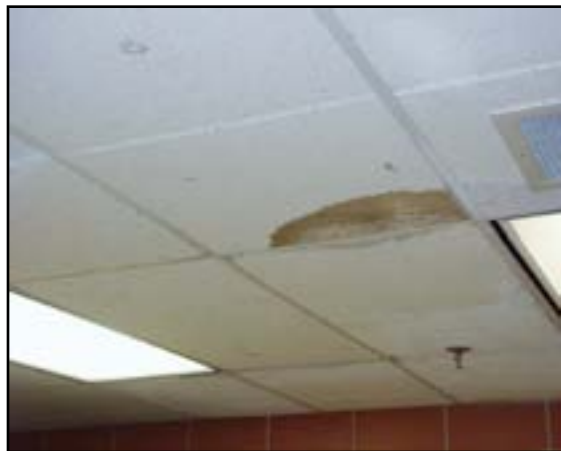
Ceiling Finishes: Replace Damaged Ceiling Tile

Existing suspended AC tile ceiling is very nicked water damaged or cracked. Replacement required.

Remove existing tiles and replace with new tile in existing grid. 23000 SQFT

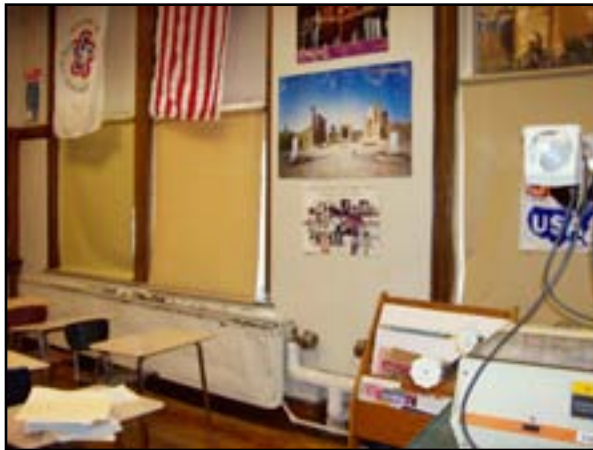
Exterior Windows: Replace All Blinds

Existing window blinds are yellowed and stained.

Remove existing blinds and replace with new.

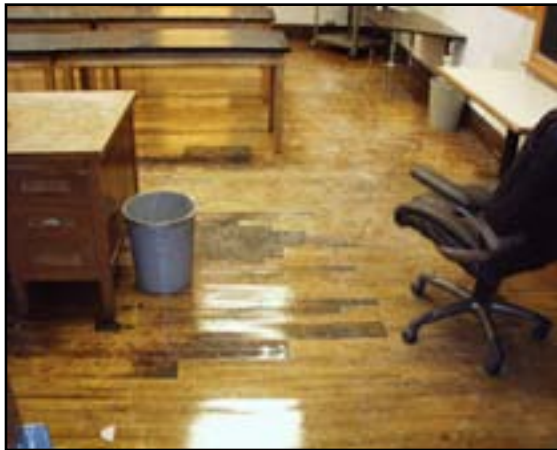
Floor Finishes: Refinish Wood Floors

Existing wood floors are in various degrees of condition, and show many years of wear.

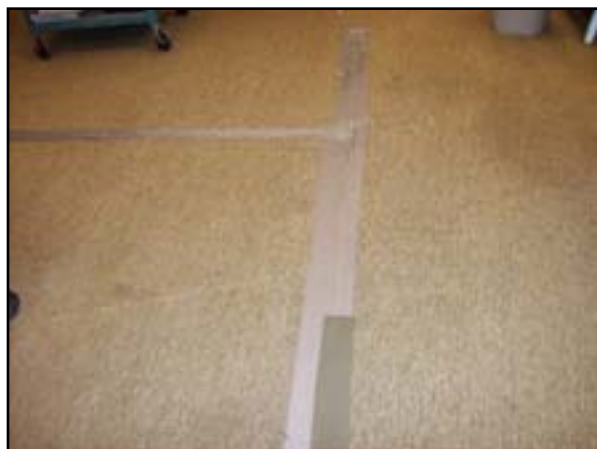
Floor Finishes: Replace Carpet

Existing carpet is worn and soiled, replacement required.

Remove existing carpet and replace. 21300 SQFT

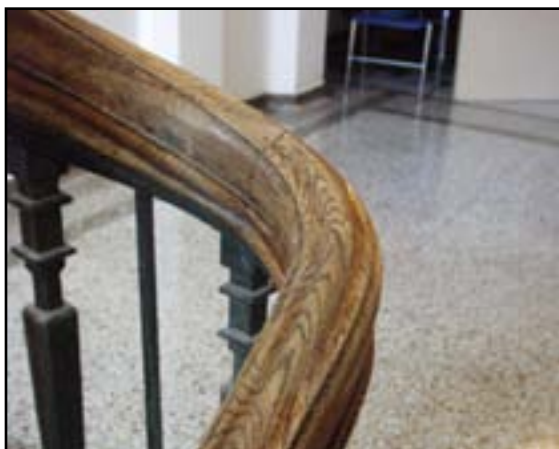
Wall Finishes: Refinish Stair Handrails

Existing handrail finish is worn and requires refinishing.

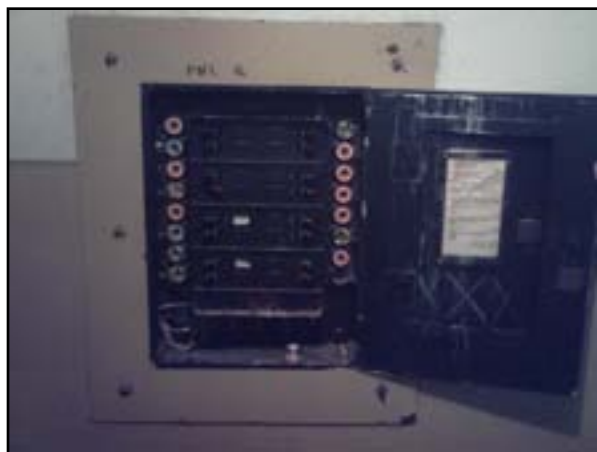
Electrical Distribution: Outdated Panels

Several electrical panels have become outdated which make it difficult to maintain and find the correct replacement parts.

New panels will replace outdated panels. The new panels will be easier to find parts for and to maintain.

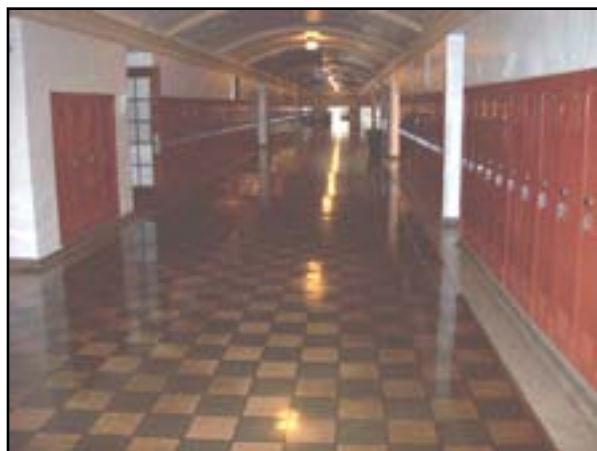
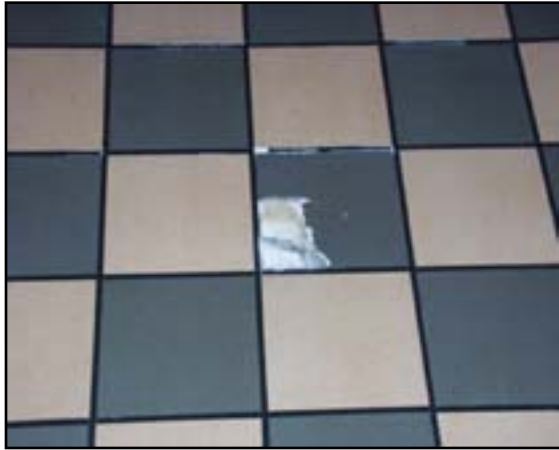
Floor Finishing: Replace Corridor Floor Tile

Existing tile floors are original and have locations where tile is chipped away and repaired with a concrete patch, recommended replacement.

Remove existing tile, prep floor, replace with new tile. 17000 SQFT

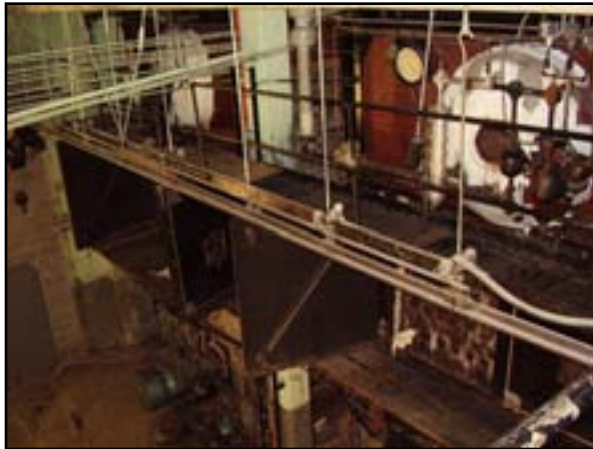
HVAC: Heating System Conversion - Steam to Hot Water

The steam system which is 80 years old has exceeded the recommended useful life. Most of the steam system is a one pipe system which is difficult to control/maintain/service. A steam system requires substantially more maintenance than a modern hot water heating system due to steam traps, condensate pumps, and chemical treatment.

Install new high efficiency hot water condensing boilers and hot water piping system. Replace all steam terminal heating devices and coils with hot water devices and coils.

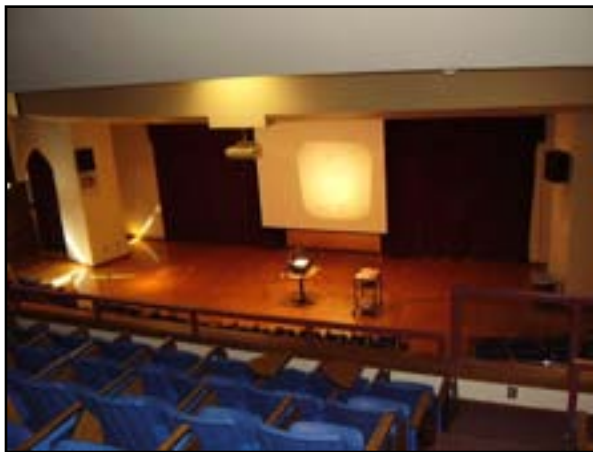
HVAC: Replace Ventilation All Floors 1926 Building Auditorium, Lecture Hall, and Music Areas

The 80 year old ventilation systems have exceeded the recommended useful life expectancy and currently poorly distributes ventilation air.

The auditorium utilizes a supply air plenum and should be ducted to new diffusers.

Replacement of the Existing Ventilation System with a Modern Ventilation System consisting of Air Handling Units with Energy Recovery, Duct Distribution System, and Variable Air Volume Boxes with Hot Water Reheat Coils and Hot Water Finned Tube Radiation.

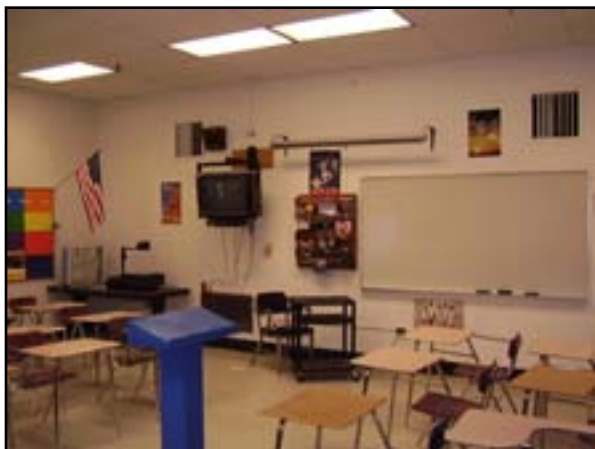
HVAC: Replace Ventilation All Floors 1926 Classroom Areas

The 80 year old ventilation systems have exceeded the recommended useful life expectancy and currently poorly distributes ventilation air.

There are four air handling units currently serving these areas (S-3,S-4,S-5, and S-6)

Replacement of the Existing Ventilation System with a Modern Ventilation System consisting of Air Handling Units with Energy Recovery, Duct Distribution System, and Variable Air Volume Boxes with Hot Water Reheat Coils and Hot Water Finned Tube Radiation.

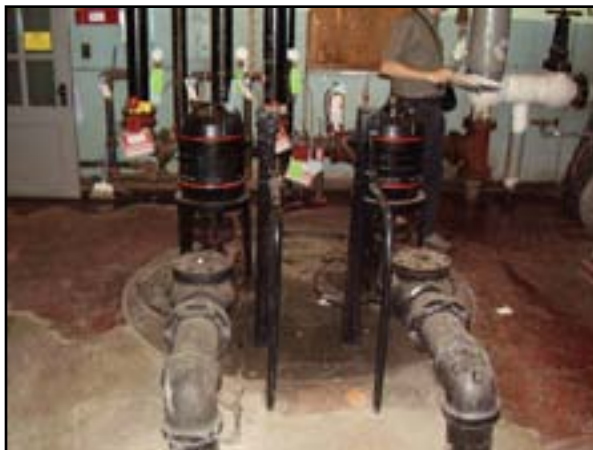
Plumbing - Sump Pump Replacement

The sump pump in the pump room is 80 years old and beyond it's recommended service life.

In addition, the sump pumps located in Fan Room #2 have been replaced with submersible pumps which are difficult to service.

Replace the existing vertical sump pumps with a new vertical duplex set of sump pumps with new duplex control panel.

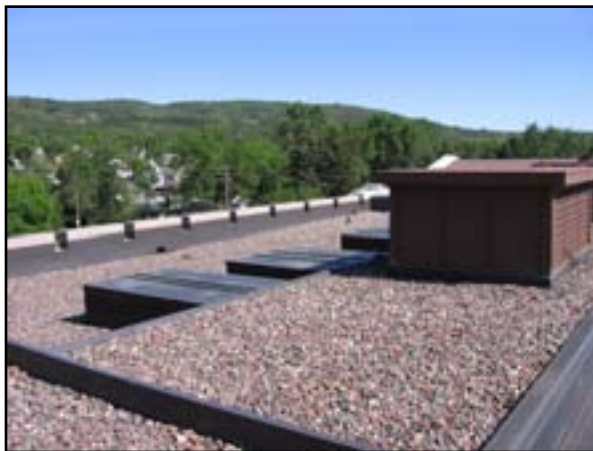
Roof System: Replace Roof

Roof system beyond rated service life.

Replace ballasted EPDM roof in Areas 6,8, and 10. Replace mod bit roof in Areas 7 and 9.

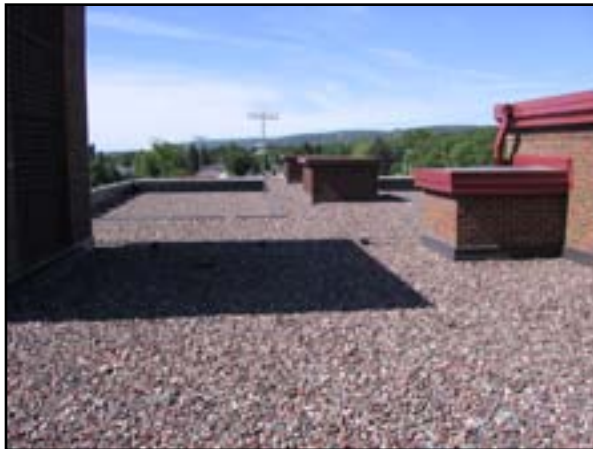
Roof System: Replace Roof

Roof systems beyond rated service life. Includes Areas 11-15 and 17.

Replace the ballasted EPDM roofs (11-15) and the adhered EPDM roof (17) in this area.

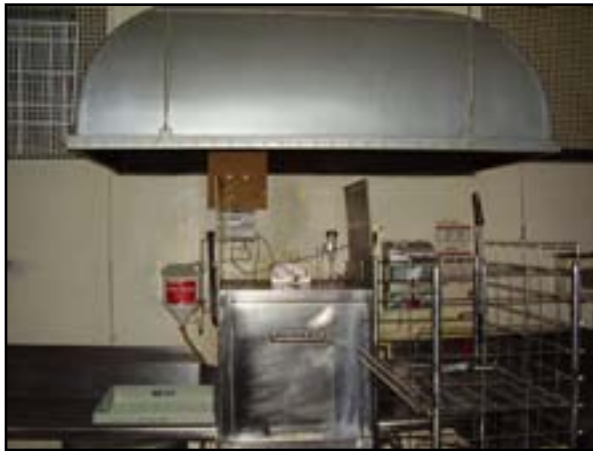
HVAC: Replace Dishwasher Exhaust Hood

The existing dishwasher has an existing exhaust hood but is not tagged as a type II Hood. It does not have an exhaust hood as required by the 2000 International Mechanical Code. Exhausting the dishwasher steam is critical in maintaining proper indoor air quality in the kitchen.

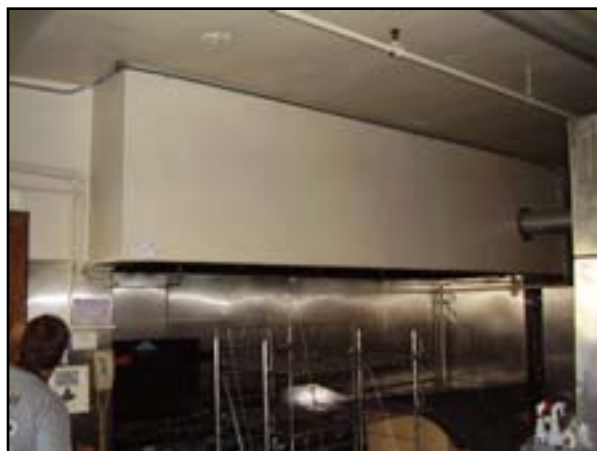
HVAC: Replace Kitchen Grease Exhaust Hood / Add Kitchen Make Up Air

The existing grease exhaust hood has been written up as a non compliant hood by the State Fire Marshall. This hood needs to be replaced with a code compliant grease exhaust hood and fan.

In addition, the kitchen does not have a dedicated make up air unit. Make up air for the kitchen hood is required by the 2000 International Mechanical Code.

Replace the existing grease exhaust hood and fan and grease duct with 2000 International Mechanical Code compliant kitchen grease hood exhaust system.

Add a dedicated make up air unit with dehumidification.

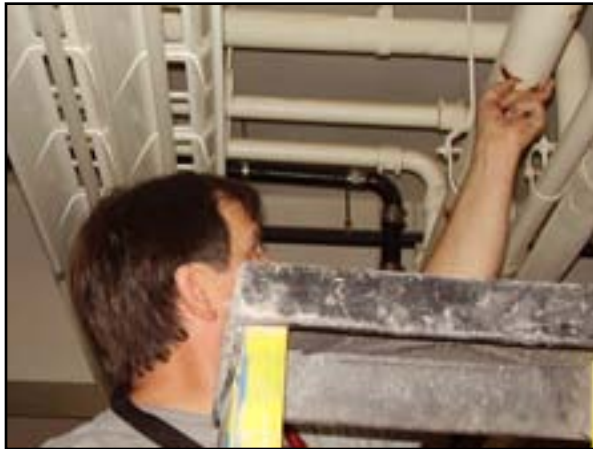
Plumbing: Replace Sanitary Sewer Mains serving the Science Areas

The 80 year old sanitary sewer lines serving the science rooms are not rated for chemical waste, nor is a chemical waste trap present. The sanitary waste lines have degraded to the point of impending piping failure. This condition does not meet the current Plumbing Code.

In addition, the plaster traps require replacement.

Replace the 80 year old science room sanitary waste lines with Plumbing Code approved chemical waste piping.

Replace plaster traps and install new traps in spaces requiring these traps that currently do not have them.

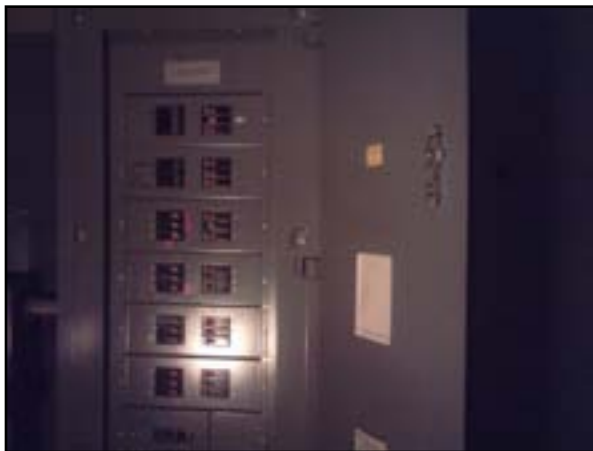
Electrical Distribution: Insufficient Capacity

Existing Branch Panels are lacking capacity for additional circuits. Panels must be added to accommodate circuits needed for additional receptacles in classrooms

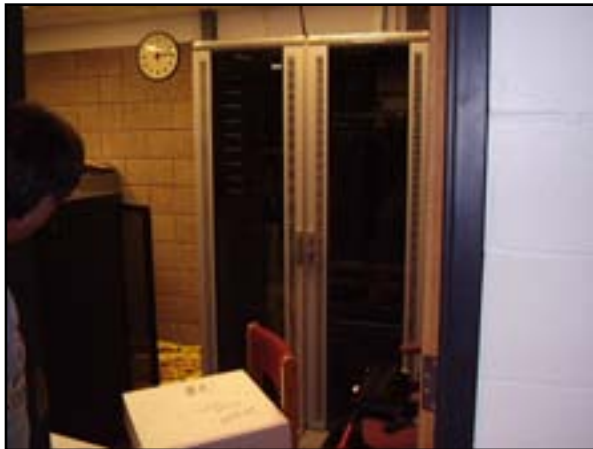
HVAC: Add Cooling Capability to IT Data Rooms

The Computer Labs and IT Data rooms get hot, which could cause technology equipment failure.

Provide a fan coil with a DX cooling coil and full economizer capability to utilize free cooling when outdoor conditions allow.

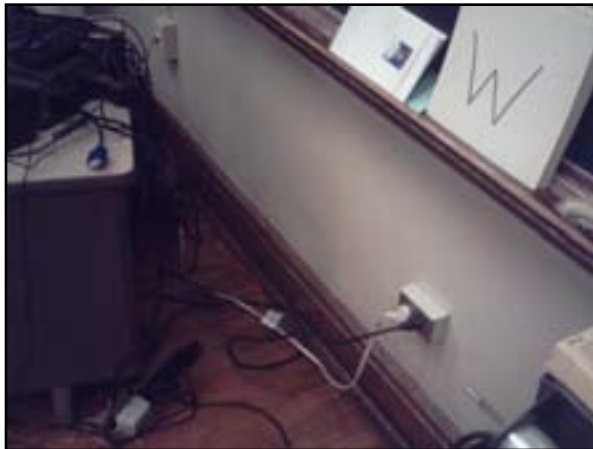
Wiring Devices: Insufficient Receptacles

In general, classrooms have an insufficient number of receptacles. Computers and other electronics are plugged into power strips due to the lack of receptacles. This limits future addition of electronic devices and presents a fire hazard.

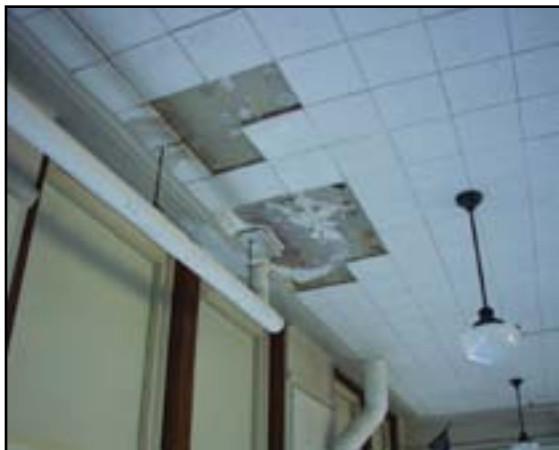
Ceiling Finishes: Replace Ceiling in Cafeteria

Existing ceiling tile is missing along North wall, other areas beginning to sag.

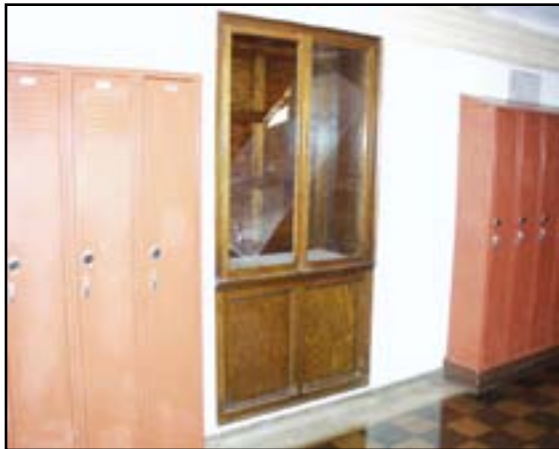
Equipment and Furnishings: Refurbish Hall Display Cabinets

Existing display cabinets have loos/missing glazed panels, glass ones not tempered, wood work should be refinished.

Refinish wood cabinets, replace glazed panels with safety glazing.

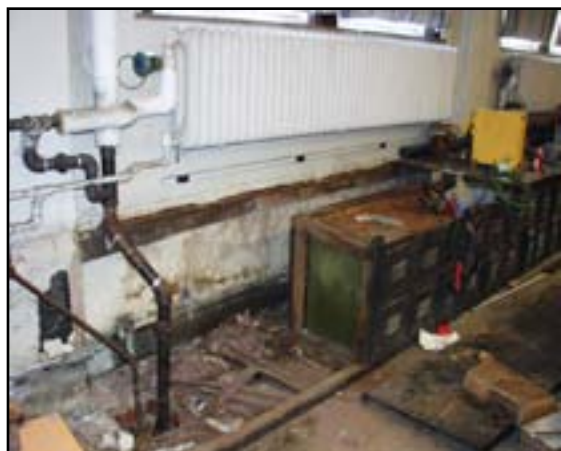
Equipment and Furnishings: Replace Countertops and Project Lockers

Existing work counters and project lockers along East wall are in very poor condition, replace.

Remove existing cabinets repair/replace flooring under cabinets, repair wall, install new cabinets. 50 Ft. Countertop, 50 Lockers

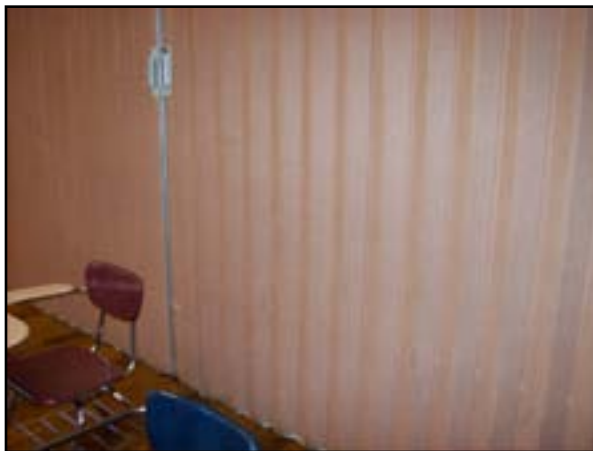
E-Equipment and Furnishings: Replace Folding Acoustical Partition

Folding Acoustical Partition is worn and probably inefficient for sound control.

Replace folding (accordian) acoustical partition with new. Approximately 400 S.F.

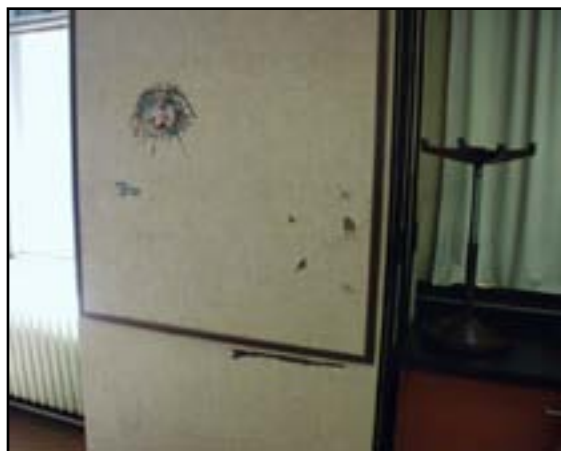
Equipment and Furnishings: Replace Folding Partition

Existing folding partition is worn and torn, replace with new partition.

Remove existing partition and track, replace with new.

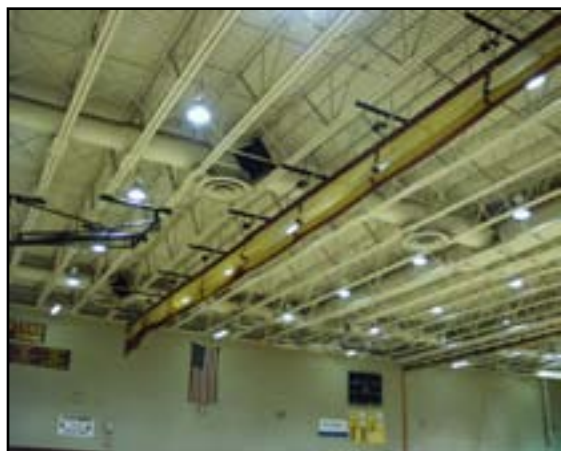
Equipment and Furnishings: Replace Gym Divider

ISD 709 has reported problems with divider hardware failing thus causing curtain to lower, replace divider.

Remove existing divider and replace with new. 3100 SQFT

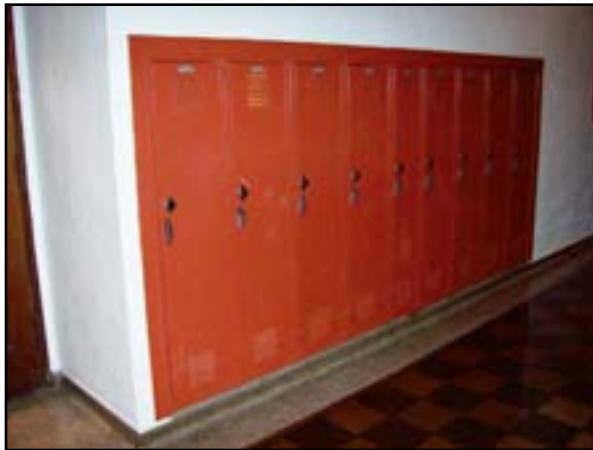
E-Equipment and Furnishings: Replace Lockers
 -

Lockers are old and will need to be eventually replaced.

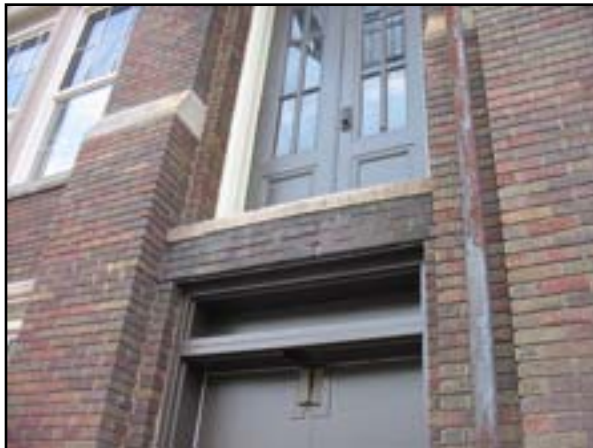
Exterior Walls: Grade-Level Wall Restoration

Deteriorated grade-level walls at North Wing. Deteriorated parapet at Roof Area 17.

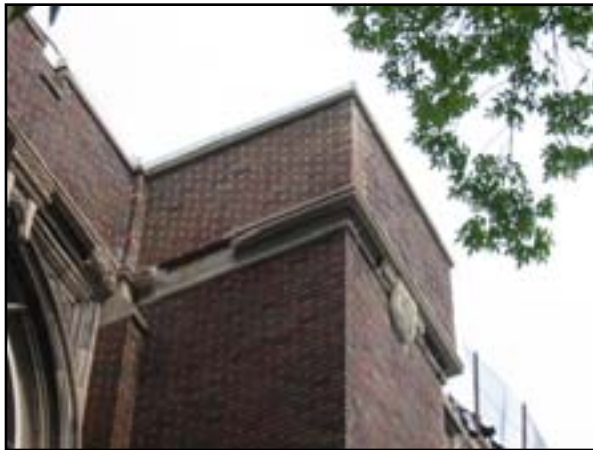
Exterior Walls: Grade-Level Wall Restoration
 -

Deteriorated grade-level walls at auditorium. Severely deteriorated parapet at Areas 4 and 5 of 2004 reroofing.

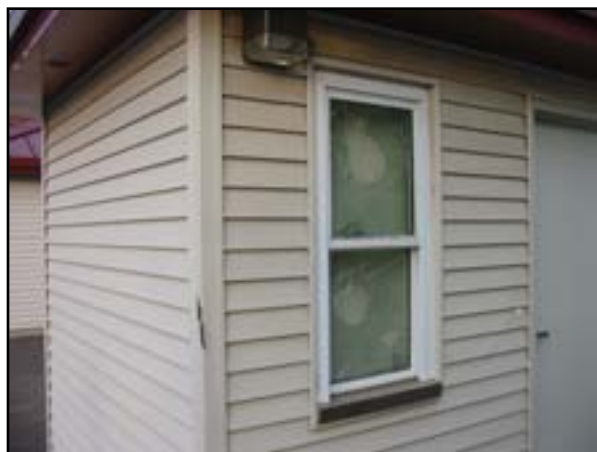
Exterior Walls: Grade-Level Restoration

Deteriorated grade-level walls.

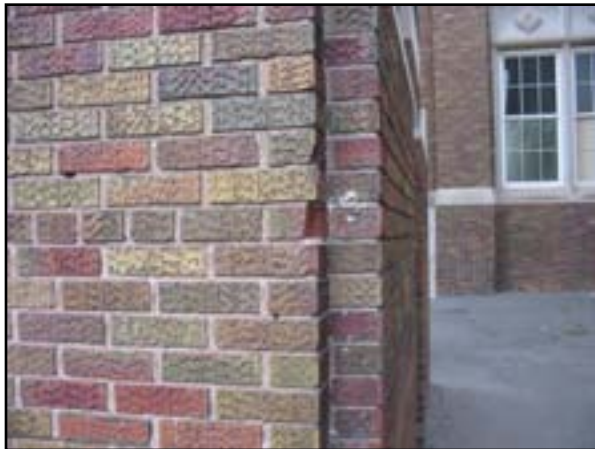
Exterior Walls: Wall Restoration

Deteriorated grade-level walls at South Wing, Center Section and Chimney. Deteriorated roof-level and grade-level walls at 1987 Addition.

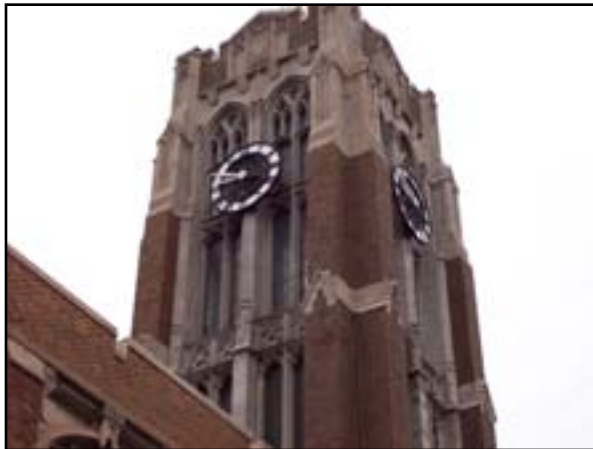
Exterior Windows: Replace Clock Tower Windows

Existing windows leak water and are in poor condition. Replace Windows

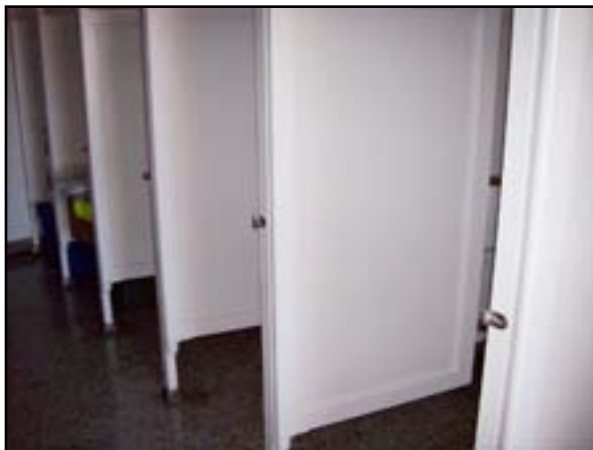
Fittings: Replace Toilet Partitions

Metal toilet partitions are old and worn condition.

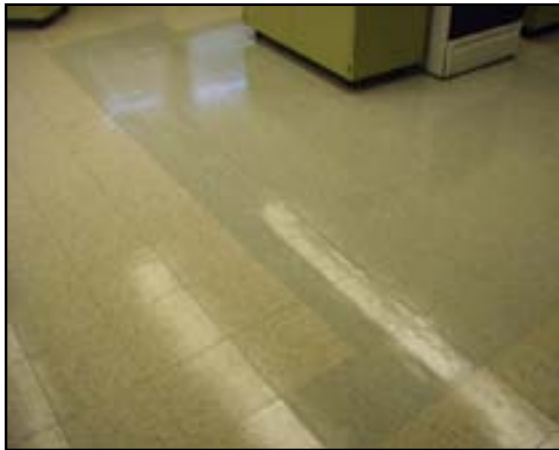
Floor Finishes: Replace VCT

Existing VCT is lifting at edges, cracked, or very worn.

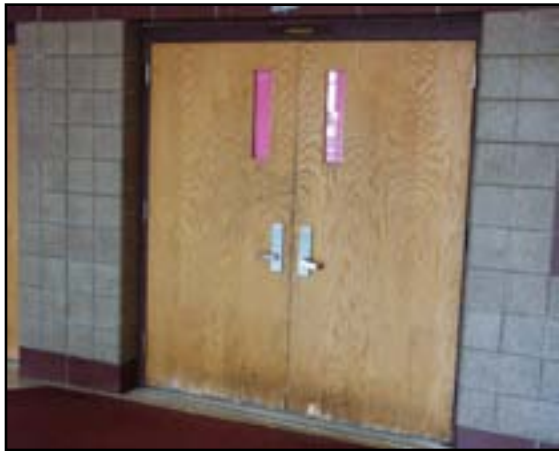
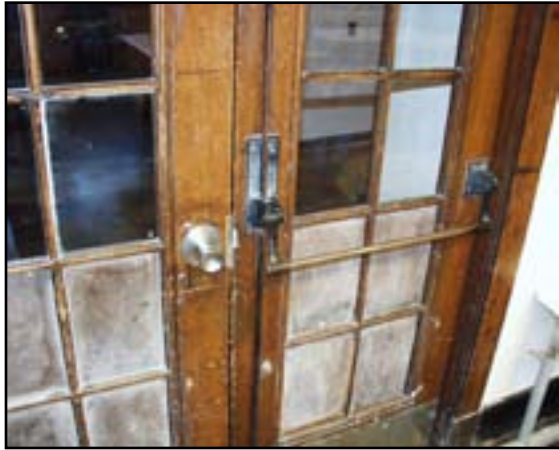
Interior Doors: Replace Wood Doors

Existing wood doors are original and in poor condition, most doors drag on the floor have non-safety glazing, various patterns of glass, all with non-accessible hardware.

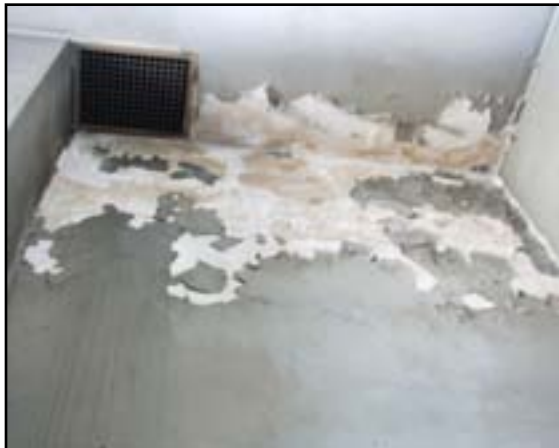
Wall Finishes: Miscellaneous Plaster Repairs

Existing plaster has formed voids behind and is falling out. Perform spot repairs.

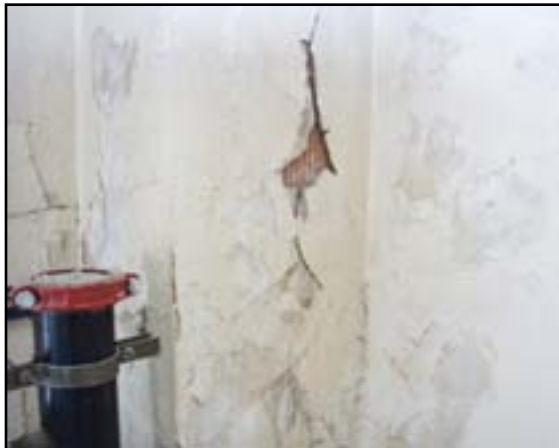
Wall Finishes: Miscellaneous Plaster Repairs

Existing plaster has formed voids behind and is falling out. Perform spot repairs.

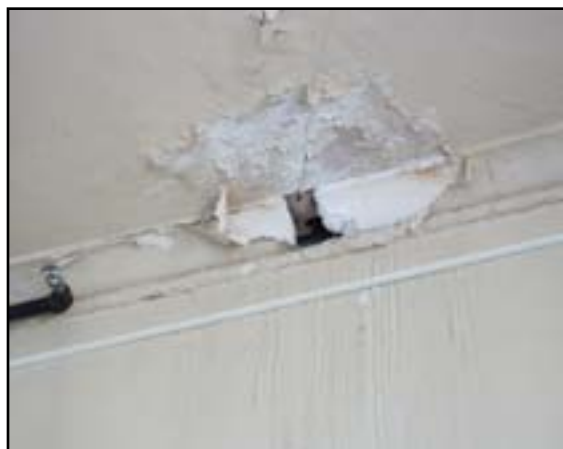
Wall Finishes: Miscellaneous Plaster Repairs

Existing plaster has formed voids behind and is falling out. Perform spot repairs.

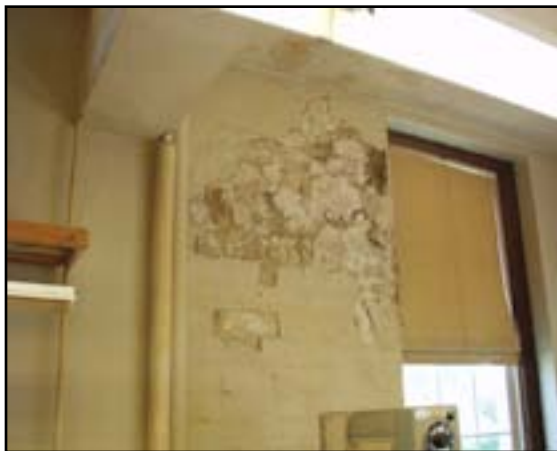
Wall Finishes: Repair Damaged Plaster

Existing plaster is damaged and failing from wall/ceiling.

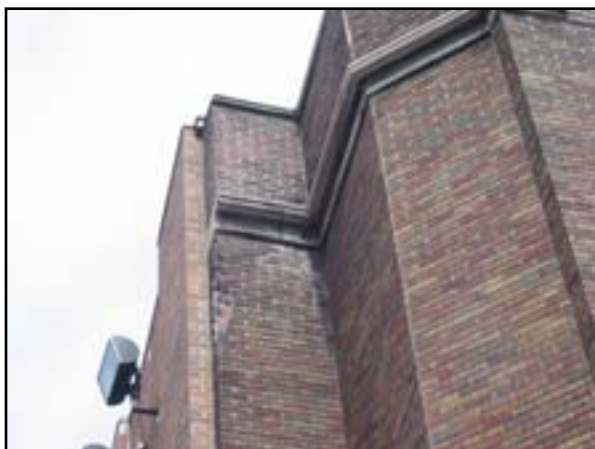
Exterior Walls: Wall Restoration

Severely deteriorated upper corner adjacent "helmet" of south wing.

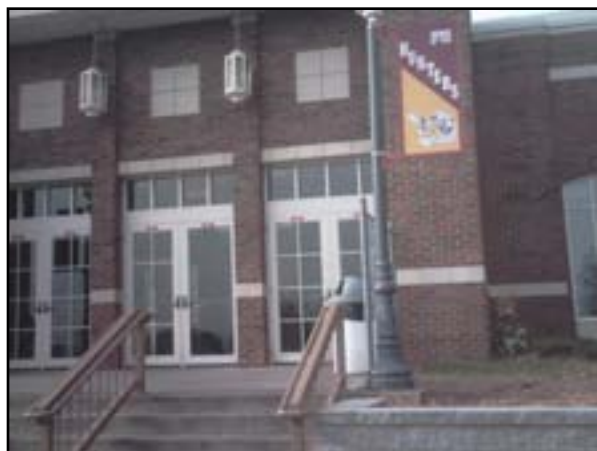
Communication and Security: Access Control

Doors need ability to be locked down with access allowed only to authorized people. Also doors without card readers should be monitored for unauthorized access.

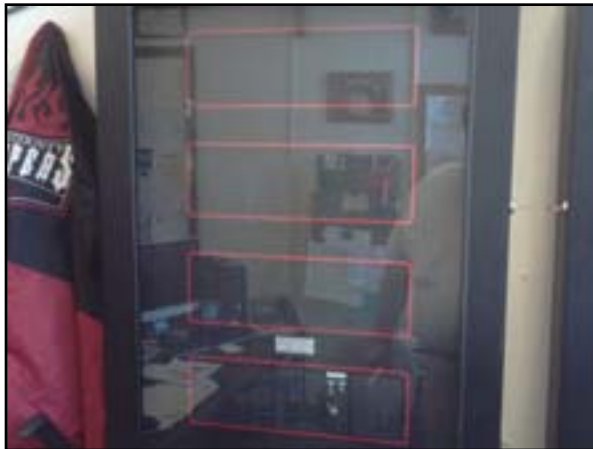
Fire Alarm Systems: Outdated System

Fire alarm systems are old analog system. System is prone to malfunctions and is very hard to identify exact area of alarm. It is also difficult to troubleshoot and find malfunctions.

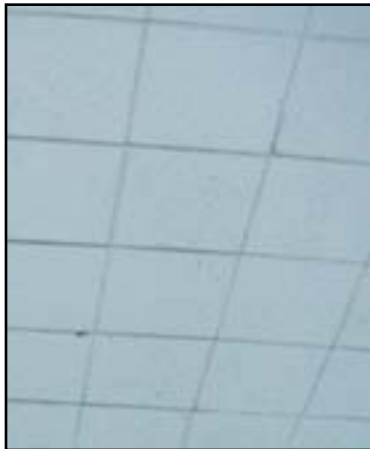
Ceiling Finishes: Replace 12x12 Acoustical Tile

12x12 adhesive applied acoustical tile is aged and inefficient and does not meet district standardization goal to convert to 2x2 suspended acoustical tile.

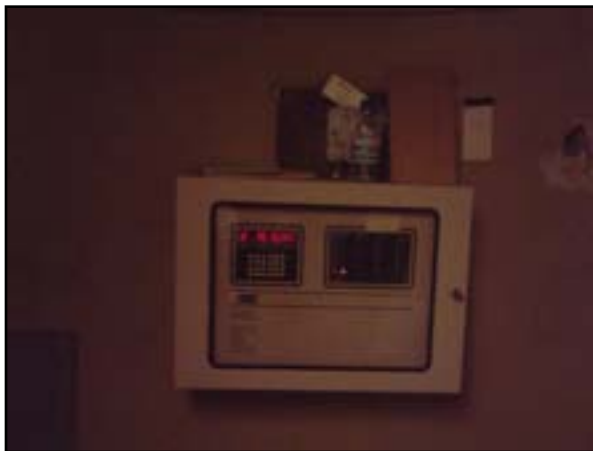
Communications and Security: Clock System

Master clock systems no longer keep clocks in time. Most are only used for running the bells. Atomic clocks may not receive a signal through the brick buildings. Many clocks do not work at all.

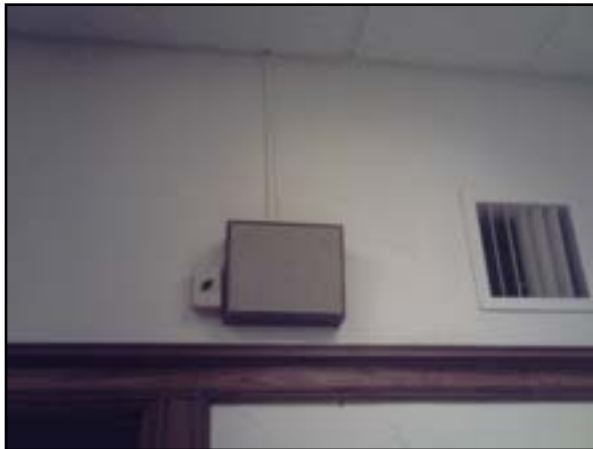
Communication and Security: Public Address and Sound System

The paging is done over the telephone system only. There are no speakers in the hallways or commons area.

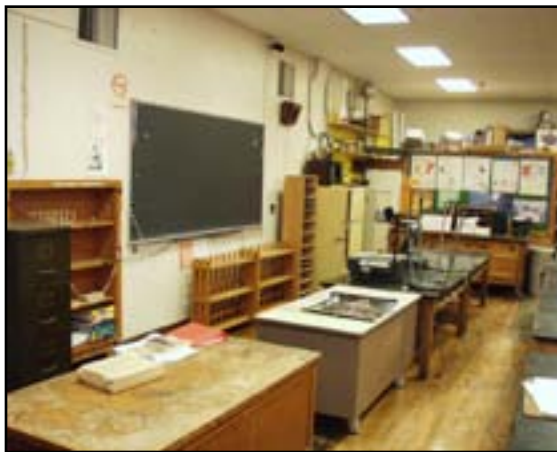
Fittings: Replace Chalkboards and Tackboards

Existing chalkboards and tackboards should be replaced to bring up to modern standards.
