Requirement Detail

LESTER PARK

District: Duluth Public Schools
Facility: Lester Park Elementary School
Category: Upgrades

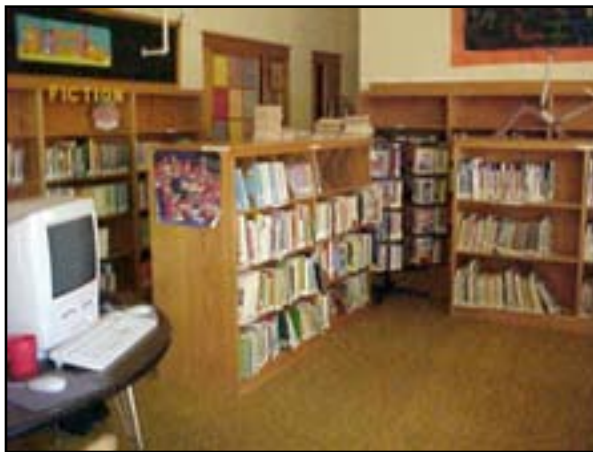
Equipment and Furnishings: Accessibility

It also includes accessibility issues found in Specialty Areas (science labs, cooking labs, industrial arts areas, as well as the media center/library). Items include: providing accessible work stations in kitchens, providing accessible labs and lowering eyewashes.

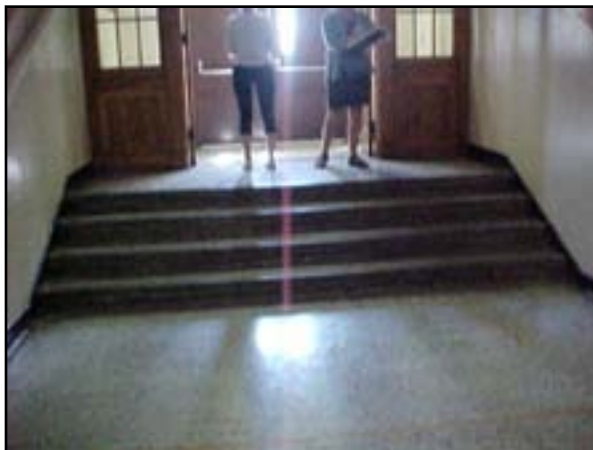
Interior Construction: Accessibility

This requirement includes accessibility issues encountered while you move through the school. Items include: providing elevator or ramp, adding/modifying handrails (only if the level is not served by an elevator or other accessible route), widening doors, replacing door hardware, eliminating protruding hazards and all permanent room identification signage as well as directional signage (adding signs, replacing signs and relocating signs).

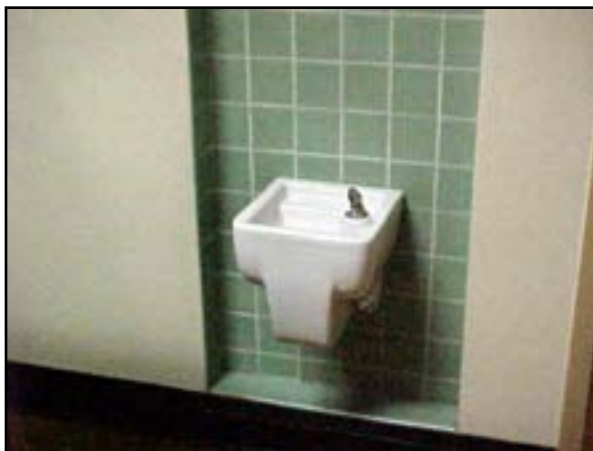
Plumbing: Accessibility

Note: the actual cost to complete work in toilet rooms may be increased by a decision to do work beyond what is required for accessibility, such as re-tiling, replacing all fixtures, replacing all stall partitions, etc.

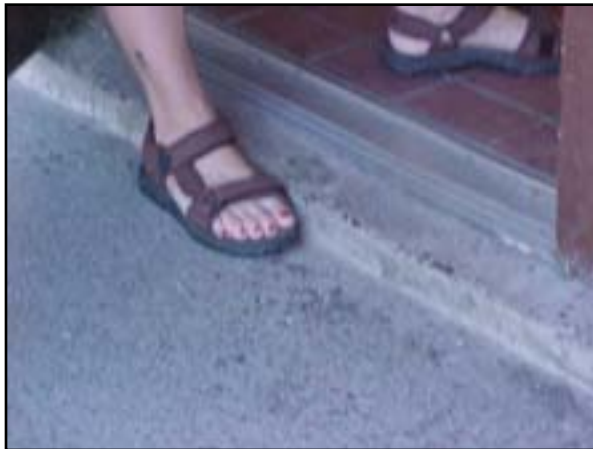
Site Improvements: Accessibility

This requirement includes accessibility issues from the moment you are on school grounds until you get to the front door. Items include: adding and identifying accessible parking and adding or modifying accessible routes (sidewalks).

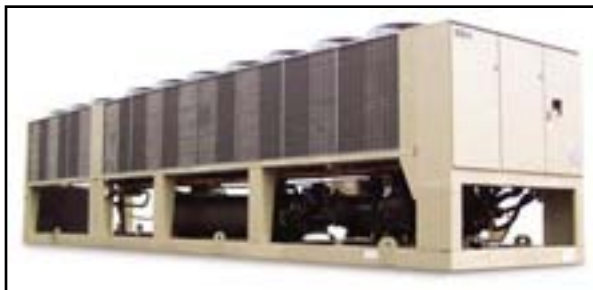
HVAC - Dehumidification Chiller and Piping Mains

Lester Park Elementary School has no means of dehumidification. Without de-humidification capabilities, these spaces cannot meet ASHRAE 55-1992 space design conditions.

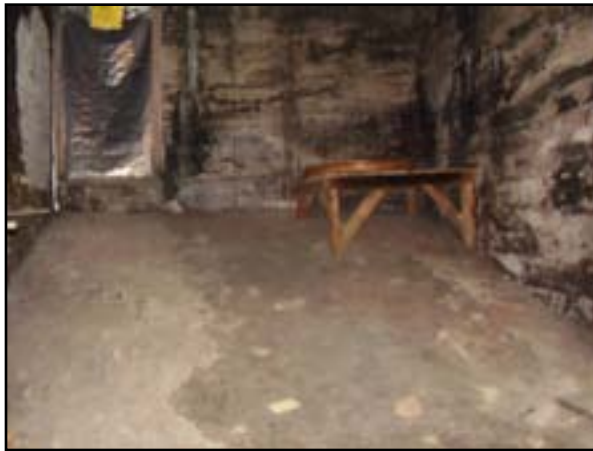
HVAC: Provide Negative Pressure in Crawlspace/Tunnels

The crawl space has dirt floors and if not under negative pressure can transfer odors to the floors above due to the pipe and duct penetrations. The tunnels are also present opportunity for mold growth.

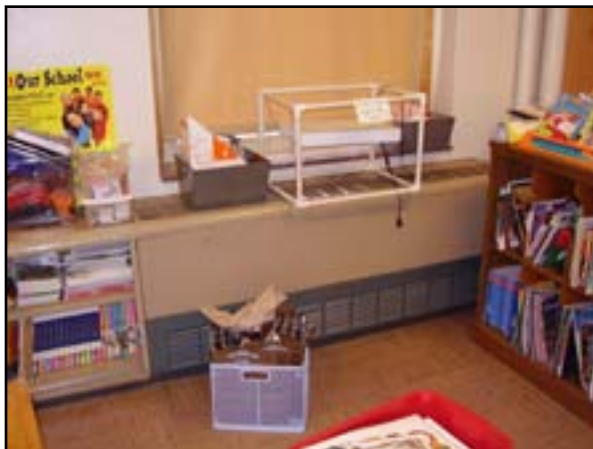
HVAC: Replace Classroom Unit Ventilators

The six (6) classroom unit ventilators are 52 years old and have exceeded the recommended useful life. In addition, these classroom unit ventilators are typically not capable of meeting current ASHRAE indoor air quality standards. As part of this upgrade, the new mechanical system will incorporate heat recovery and classroom occupancy / CO2 controls to save energy.

In addition the old teachers lounge and surrounding area has no means of ventilation. This does not meet 2000 International Mechanical Code.

Remove existing classroom unit ventilators, patch wall to match existing. Replace with modern ventilation system with energy recovery with dehumidification, duct distribution system, and variable air volume boxes with hot water reheat coils and hot water finned tube radiation on exterior walls. Add ventilation to the adjoining offices in the 1954 Addition. Upgrade the controls systems to DDC and commission the new system.

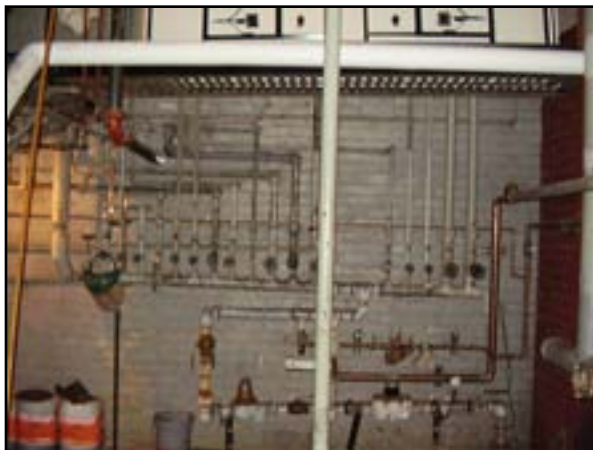
Plumbing: Replace Galvanized Domestic Water Piping

The 89 year old domestic water distribution piping consists of galvanized piping which is connected together via lead based solder. Current flushing procedures have maintained lead levels at an acceptable level. As the piping continues to age, this may not be possible.

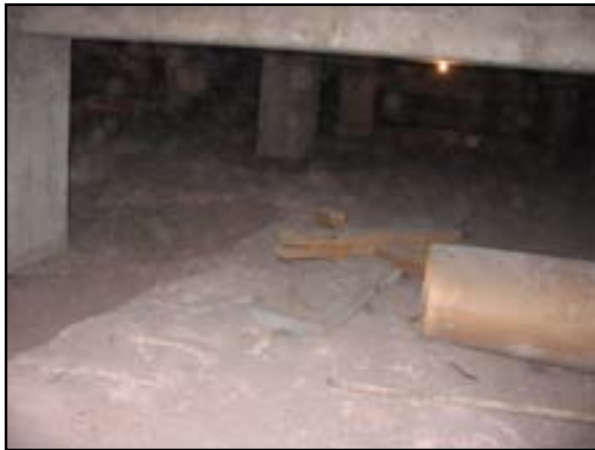
Service Tunnels: Floor Vapor Barrier

Exposed dirt areas contributing to air quality issues.

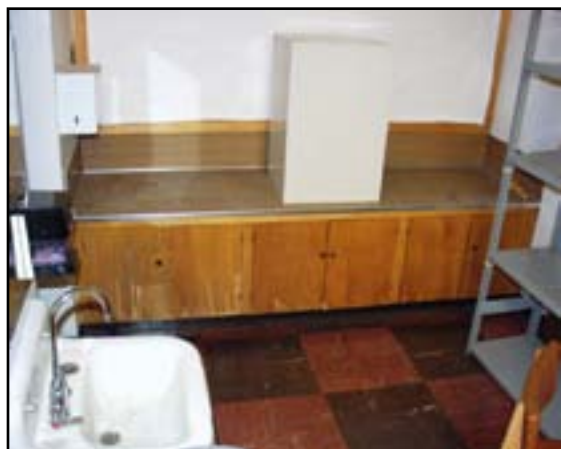
Equipment: Replace Cabinet Doors

Existing low cabinet doors are severely chipped and delaminating.

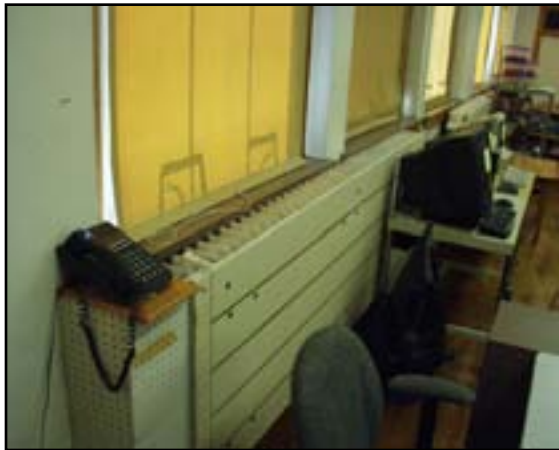
Fittings: Replace Window Blinds
 -

Existing blinds are worn and in poor condition.

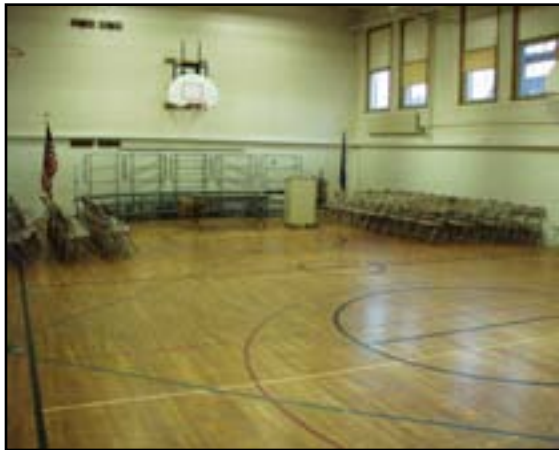
Floor Finishes: Refinish Gymnasium Floor

Existing wood floor needs to be refinished.

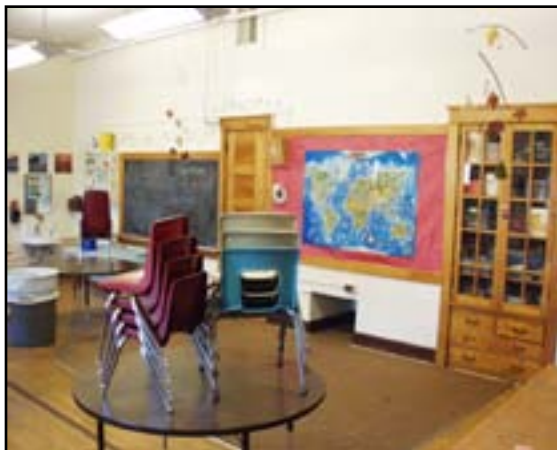
Floor Finishes: Refinish Wood Floors

Existing wood floors need to be sanded and refinished

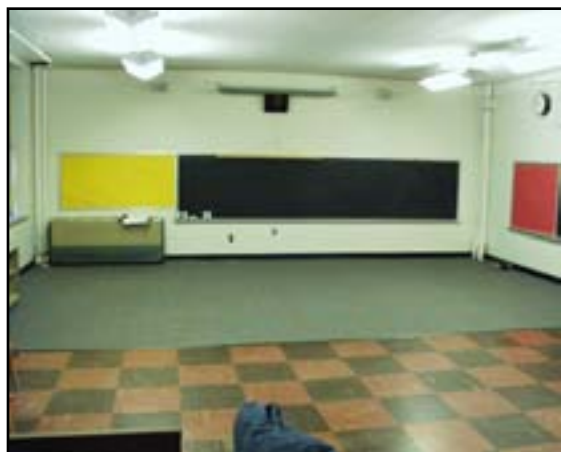
Floor Finishes: Replace Carpet

Existing carpet areas are towards the end of expected life.

Remove existing carpet and replace with new. 4632 SQFT

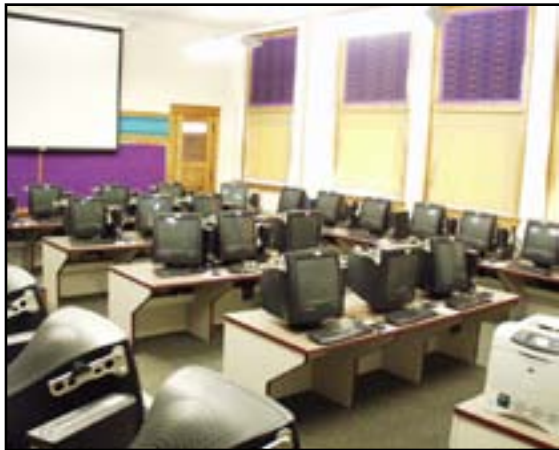
Partitions: Paint Interior All Classrooms

Interior walls and woodwork will need to be repainted as on-going maintenance program.

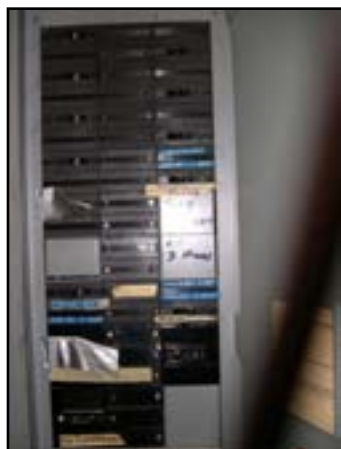
Electrical Distribution: Outdated Panels

Electrical panels have become outdated which make it difficult to maintain and find the correct replacement parts.

New panels will replace outdated panels and new feeders will be pulled where required. The new panels will be easier to find parts for and to maintain.

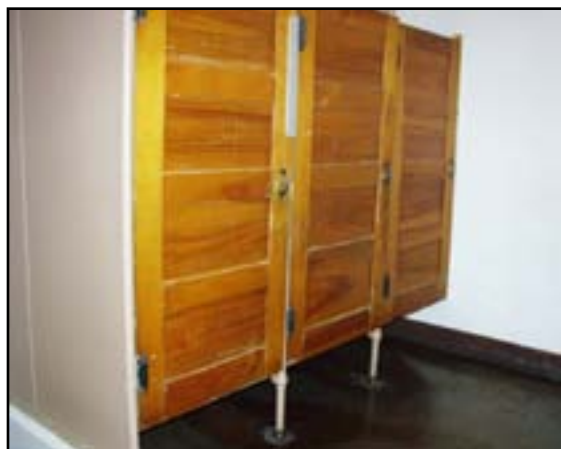
Fittings: Replace Toilet Partitions

Existing toilet partitions are original and are showing their age.

Remove existing toilet partitions and replace with new.

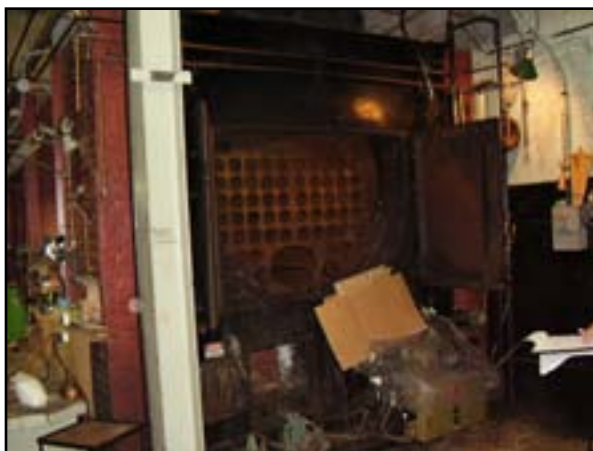
HVAC: Heating System Conversion - Steam to Hot Water

The 89 year old steam system has exceeded the recommended useful life. The 1917 steam system is a one pipe system that requires boiler shut down to bring back condensate. The 1954 area is a two pipe system. In addition the building has only one boiler. A backup boiler is necessary to minimize the chance of building freeze up.

A steam system requires substantially more maintenance than a modern hot water heating system due to steam traps, condensate pumps, and chemical treatment.

Install new high efficiency hot water condensing boilers and hot water piping system. Add medium efficiency boiler for dual fuel rates. Replace all steam terminal heating devices and coils with hot water devices and coils.

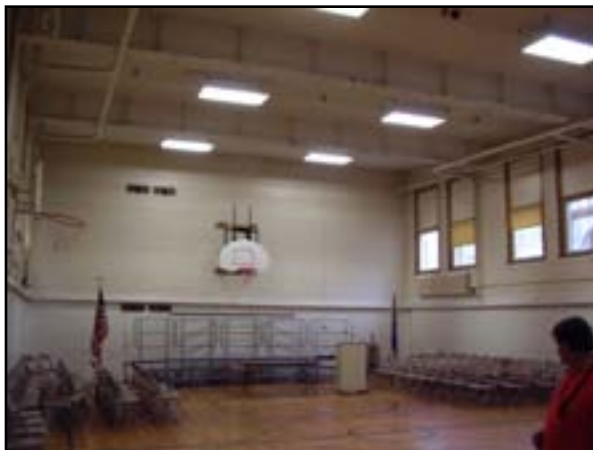
HVAC: Replace Ventilation in the Gym Auditorium/Cafeteria Areas

The air handling systems serving the gym and auditorium/cafeteria is 89 years old and has exceed it's recommended service life. In addition the air handling unit has no means of dehumidification. Without dehumidification capabilities, these spaces cannot meet ASHRAE 55-1992 space design conditions.

Addition of two air handling unit with dehumidification capability. One AHU to serve the Gym and one to serve the Auditorium/Cafeteria Installation of new external insulated supply duct systems. Upgrade Controls System. Test and Balance and Commissioning of air handling units.

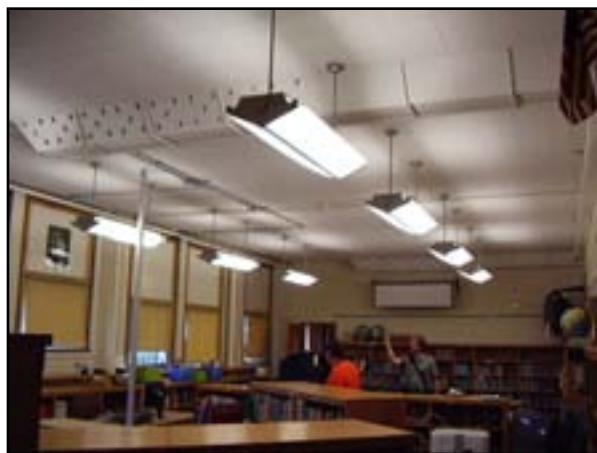
HVAC: Replace Ventilation All Floors 1917 Building

The 89 year old ventilation system has exceeded the recommended useful life expectancy and currently poorly distributes ventilation air.

Replacement of the Existing Ventilation System with a Modern Ventilation System consisting of Air Handling Units with Energy Recovery, Duct Distribution System, and Variable Air Volume Boxes with Hot Water Reheat Coils and Hot Water Finned Tube Radiation.

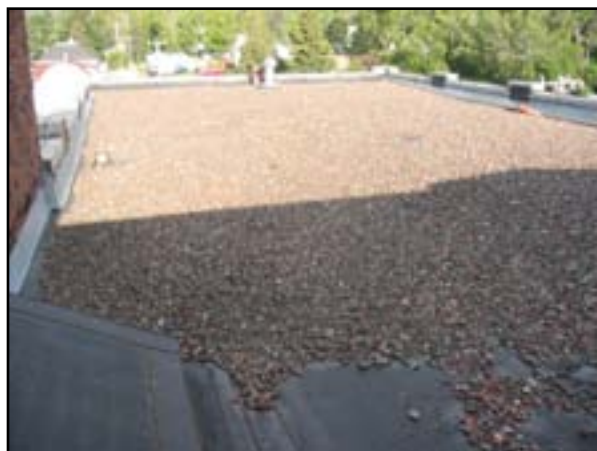
Roof System: Replace Roof

Roof system beyond rated life. Includes roof Area 4.

Replace EPDM roof system. Sequence work with roof-level wall restoration.

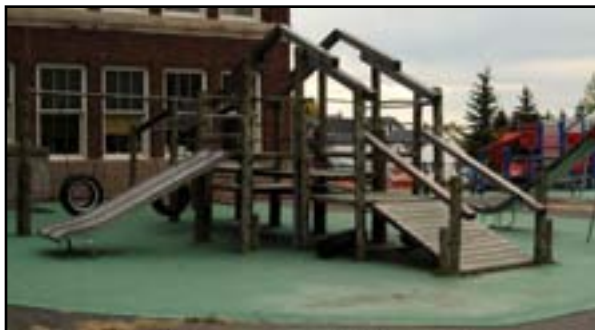
Site Furnishings: Playground Upgrade / Replacement

The newer part of the Playground equipment was built in 1990. The wood structure is even older. The playground equipment does not meet current safety and ADA requirements. Therer serious issues with wood structure. Swings are non-conforming. The playground equipment does not meet current safety and ADA requirements.

Replace existing playground with new equipment to meet needs of enrollment. Replace surface material with district standard and replace edging as needed.

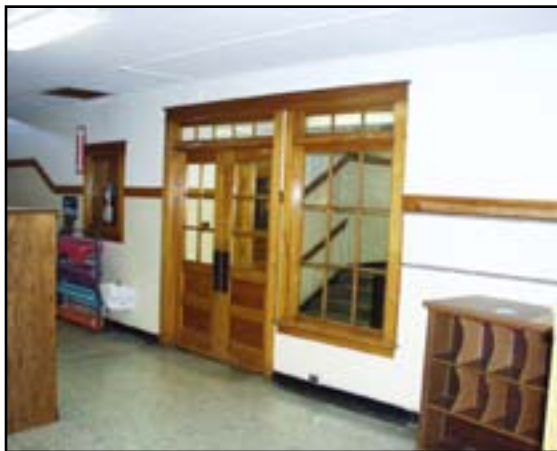
Interior Doors: Replace All Classroom Doors, Stairway Doors and Side Windows

Existing doors are non-rated including side windows, all glass panels do not have safety glazing.

Remove all existing wood doors and windows and replace with new. 40 Doors

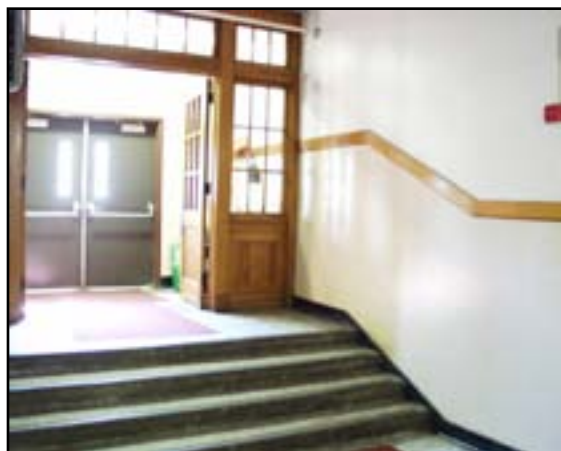
Interior Doors: Replace Vestibule Doors and Sidelights

Existing vestibule doors are original and glazed with non-safety glazing.

Remove existing doors, frames, sidelights and replace with new aluminum entrance system. 10 Doors

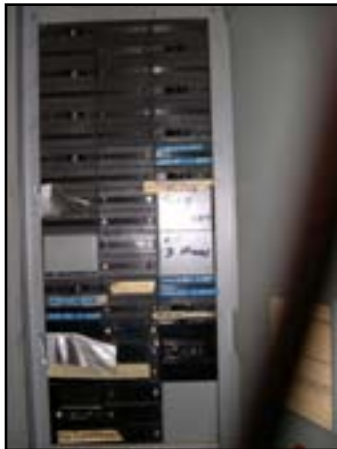
Electrical Distribution: Insufficient Capacity

Existing Branch Panels are lacking capacity for additional circuits. Panels must be added to accommodate circuits needed for additional receptacles in classrooms.

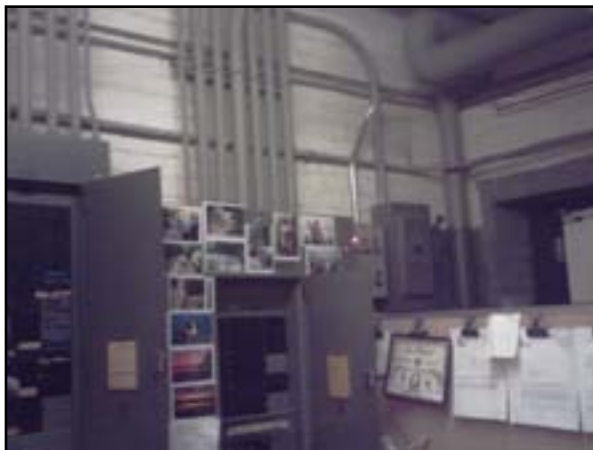
Electrical Service: Insufficient Capacity

The existing 300 amp service panel has insufficient capacity and could not feed any additional panels or equipment.

The existing 300 amp service panel will be replaced by a new 600 amp panel which will allow additional panels and equipment to be fed. New service entrance conductors will be required and all existing loads will need to be refed.

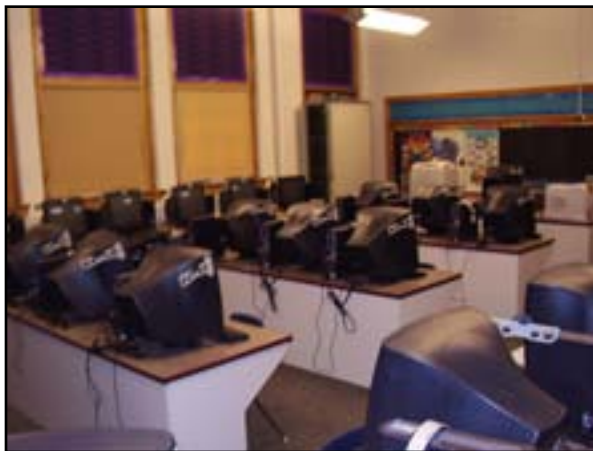
HVAC: Add Cooling Capability to IT Data Room

The Computer Lab and IT Data rooms get hot, which could cause technology equipment failure. This room also is the computer lab.

Provide a fan coil with a DX cooling coil and full economizer capability to utilize free cooling when outdoor conditional allow.

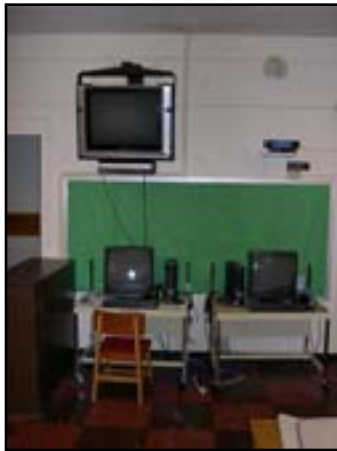
Wiring Devices: Insufficient Receptacles

Classrooms have an insufficient number of receptacles. Computers and other electronics are plugged into power strips due to the lack of receptacles. This limits future addition of electronic devices and presents a fire hazard.

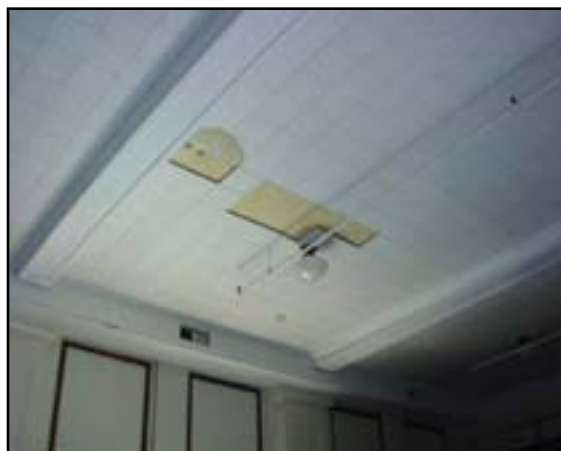
Ceiling Finishes: Repair Missing/Damaged Ceiling Tile

Portions of existing ceiling tile are missing or water damaged.

Repair damaged substrate and replace missing or water damaged ceiling tile.

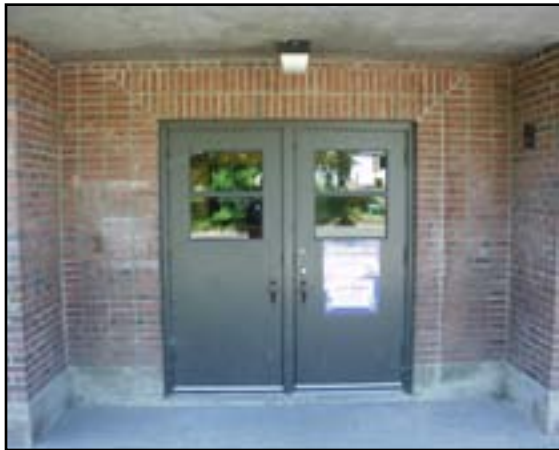
Exterior Doors: Replace Exterior Doors

Existing hollow metal doors and frames are rusted at bottom.

Remove existing hollow metal doors and frames and replace with new aluminum entrance system.

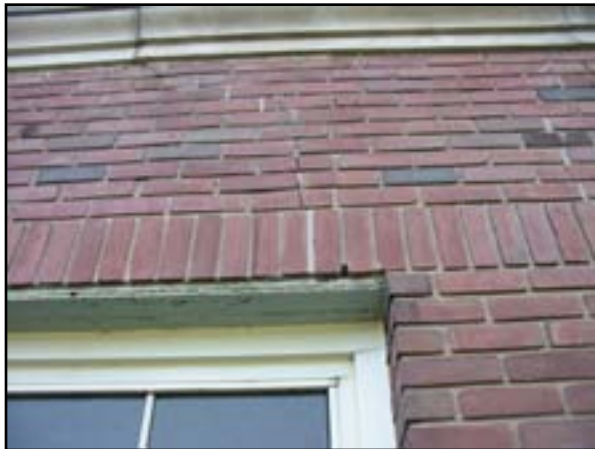
Exterior Walls: Grade-Level Wall Restoration

Deteriorated grade-level walls at the entire building perimeter. Leakage reported at Boiler Room by parking lot and during a driving rain at the east elevation of the 1917 Building.

Tuck pointing, spot brick replacement, stone repair, joint sealant replacement, painting, through-wall flashing installation at window lintels.

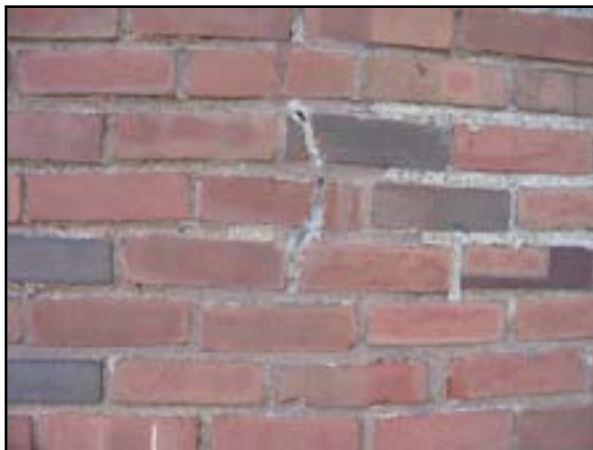
Exterior Walls: Roof-Level Wall Restoration

Deteriorated roof-level walls and chimney at roof areas 1-4.

Tuck pointing, spot brick replacement, joint sealant replacement, and new chimney cap. Sequence work with reroofing Areas 1,2,and 4.

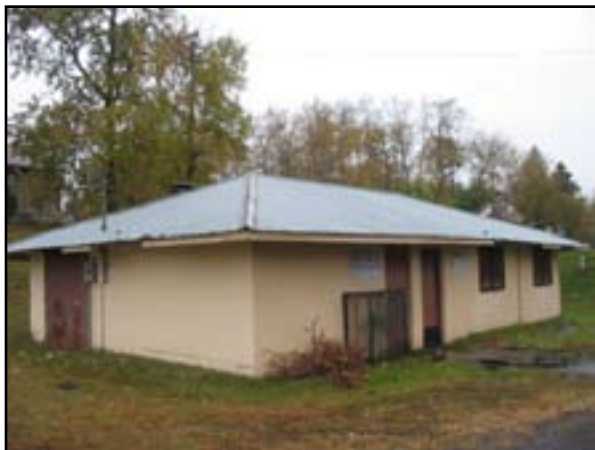
Exterior Walls: Wall Restoration

Open mortar and broken CMU's.

Tuck pointing, spot CMU replacement, joint sealant replacement, painting, and other misc. items.

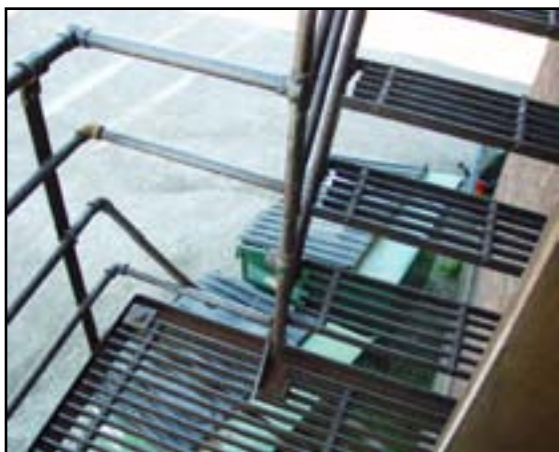
Stairs: Refurbish West Fire Escape

Existing steel fire escape needs to be repaired and repainted.

Repair deteriorated/ broken stair components and definish.

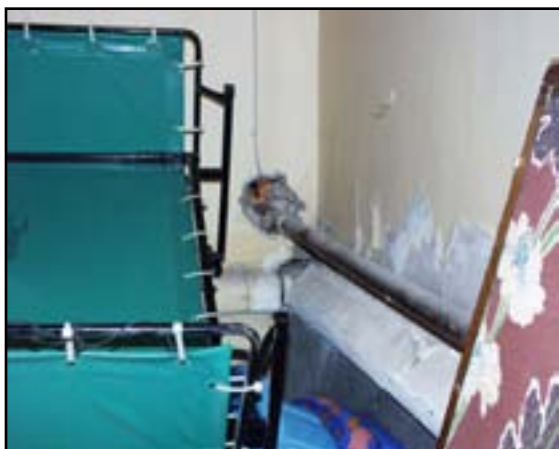
Substructure: Repair Below Grade Walls

Existing below grade walls leak and have loosened plaster.

Investigate source of water, waterproof walls and repair plaster.

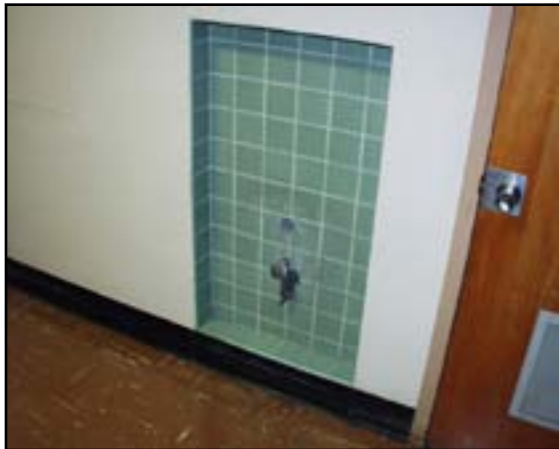
Wall Finishes: Repair Ceramic Tile at Drinking Fountain Recesses

Existing drinking fountain recesses have had drinking fountain and piping removed, wall needs to be repaired.

Remove existing ceramic tile repair/patch wall.

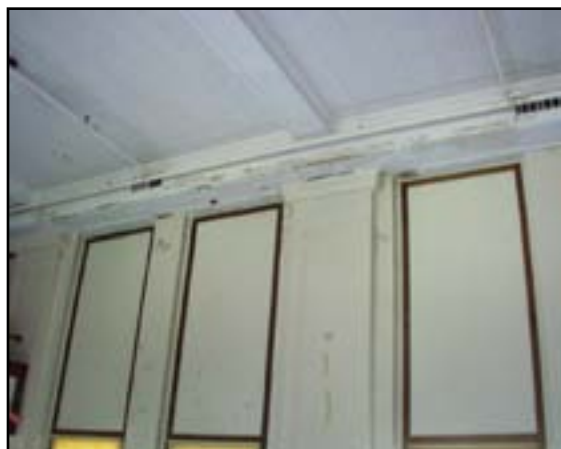
Wall Finishes: Repair Plaster

Existing plaster is damaged due to water leakage from roof/ exterior wall.

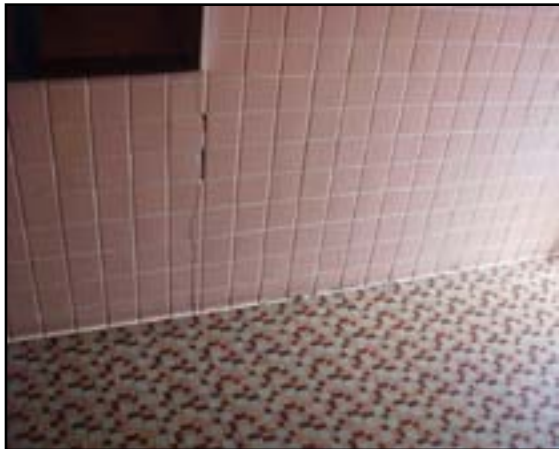
Wall Finishes: Replace Wall Tile in Boys and Girls Toilet Rooms

Existing wall tile is cracked or broken

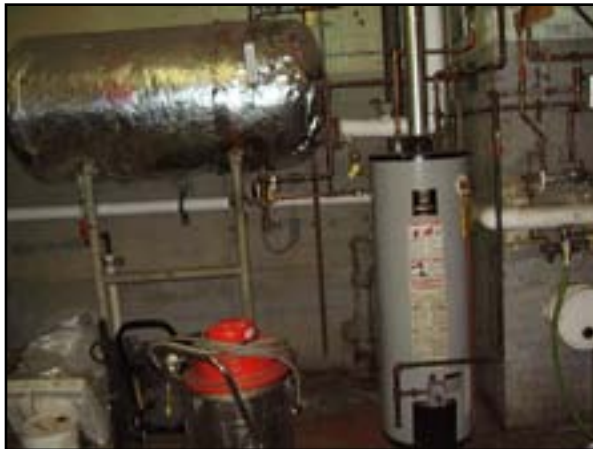
Plumbing: Add Domestic Water Heat Exchanger

Provide a domestic hot water heat exchanger. This will allow for an interruptible natural gas rate.

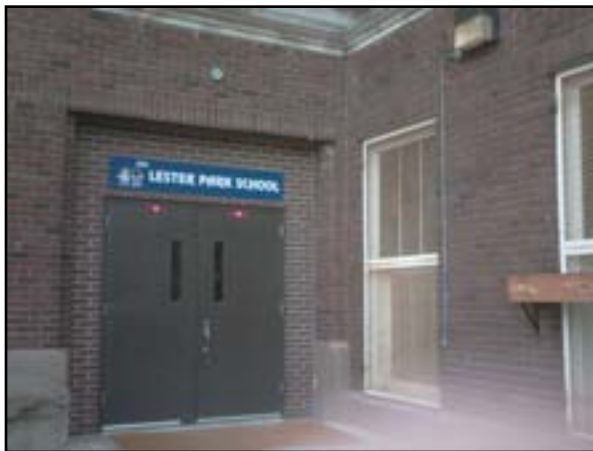
Communication and Security: Access Control

Doors need ability to be locked down with access allowed only to authorized people. Also doors without card readers should be monitored for unauthorized access.

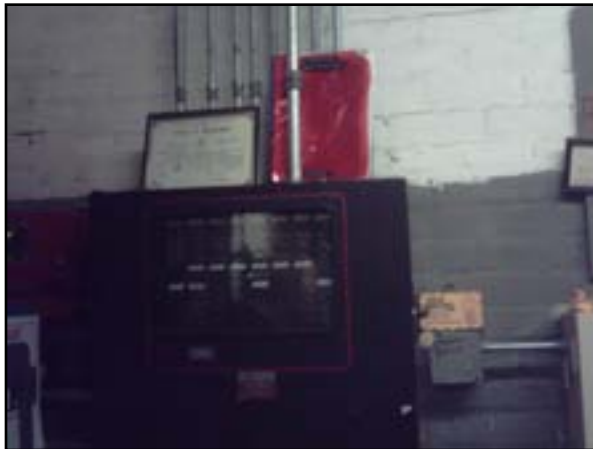
Fire Alarm Systems: Outdated System

Fire alarm systems are old analog system. System is prone to malfunctions and is very hard to identify exact area of alarm. It is also difficult to troubleshoot and find malfunctions.

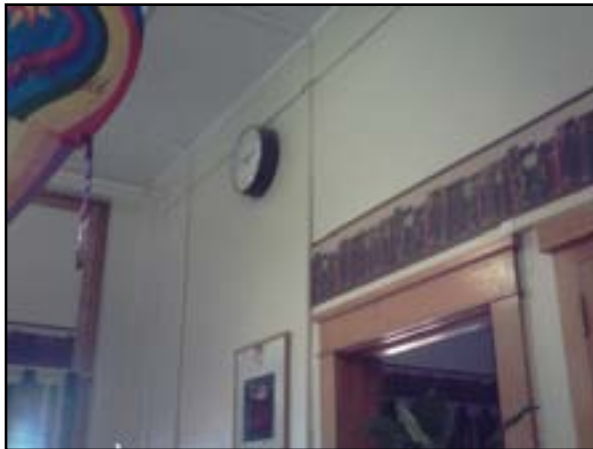
Communication and Security: Clock System

Master clock systems no longer keep clocks in time. Most are only used for running the bells. Atomic clocks may not receive a signal through the brick buildings. Many clocks do not work at all.

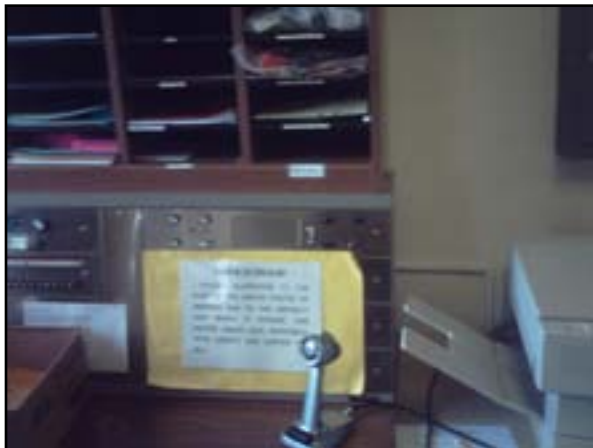
Communication and Security: Public Address and Sound System
 -

PA system is 25+ years old but is still functional.
 There are no speakers located in hallways or commons areas.

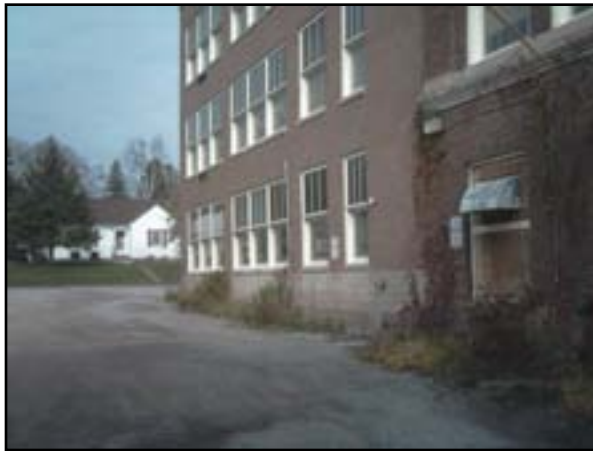
Emergency Power Distribution: Generator Backup

School currently has no backup power system to be used during a power failure. To keep students in school during power outage sufficient lighting must be maintained along with necessary life safety systems.

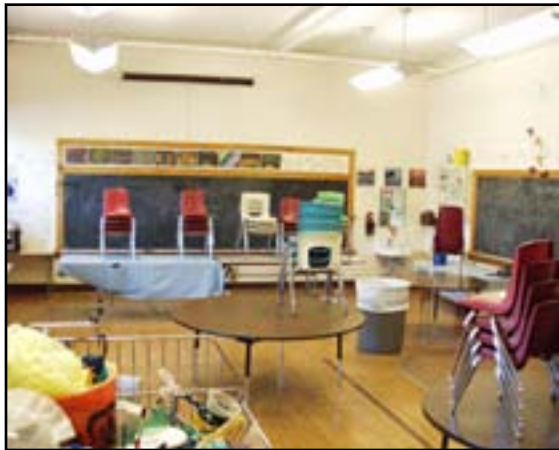
Fittings: Replace Blackboards/Tackboards
 -

Existing blackboards and tackboards should be replaced to bring up to modern district standards.
