Requirement Detail

PIEDMONT

District: Duluth Public Schools
Facility: Piedmont Elementary School
Category: Beyond Rated Life

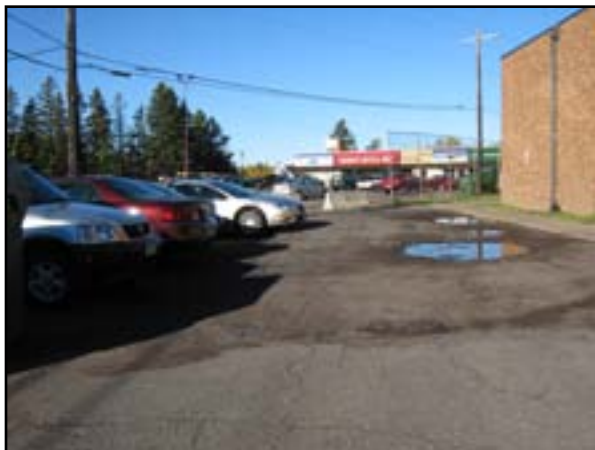
Parking Lot

Deteriorated parking lot.

Reconstruct bituminous pavement and replace portland cement concrete curbs and gutter and improve drainage.

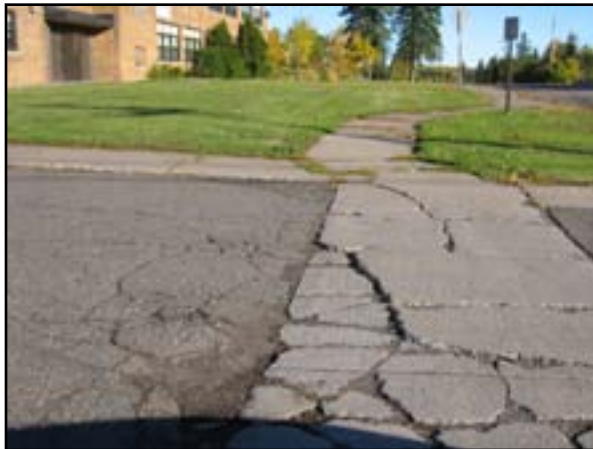
Pedestrian Paving: Sidewalks

Deteriorated sidewalks.

Replace/Reconstruct broken and unlevel areas of portland cement concrete sidewalk along Chambersburg Ave/Main Entrance/Bus Loading Area.

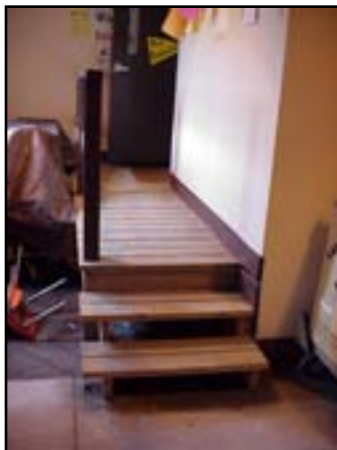
Interior Construction: Accessibility

This requirement includes accessibility issues encountered while you move through the school. Items include: providing elevator or ramp, adding/modifying handrails (only if the level is not served by an elevator or other accessible route), widening doors, replacing door hardware, eliminating protruding hazards and all permanent room identification signage as well as directional signage (adding signs, replacing signs and relocating signs).

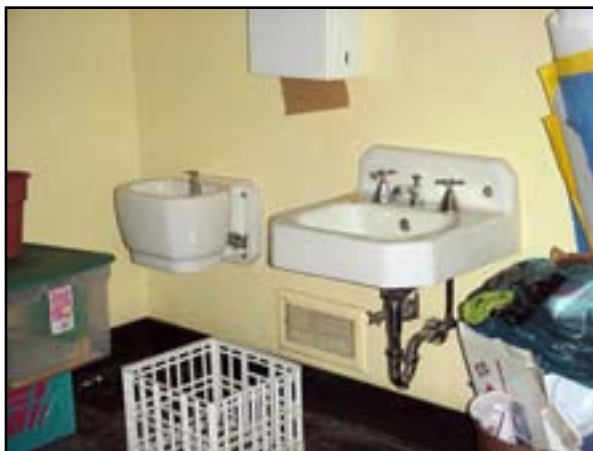
Plumbing: Accessibility

Note: the actual cost to complete work in toilet rooms may be increased by a decision to do work beyond what is required for accessibility, such as re-tiling, replacing all fixtures, replacing all stall partitions, etc.

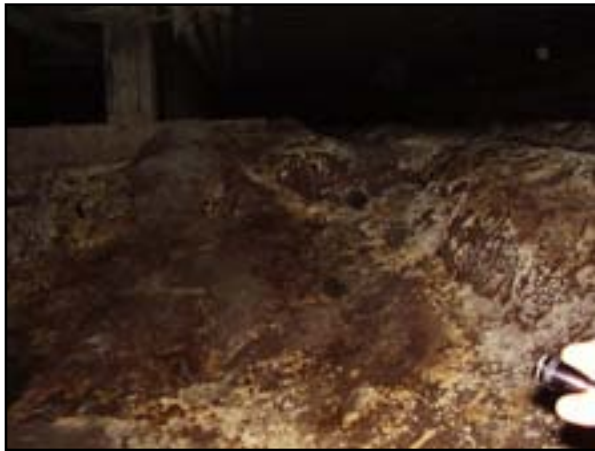
HVAC: Provide Negative Pressure in Crawlspace/Tunnels

The tunnels have dirt floors and if not under negative pressure can transfer odors to the floors above due to the pipe and duct penetrations. The tunnels are also present opportunity for mold growth.

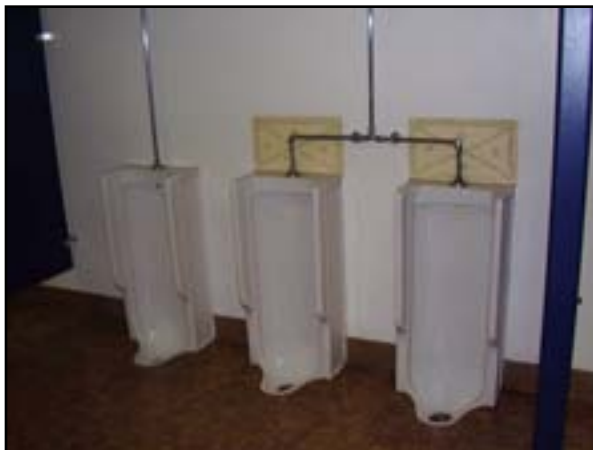
Plumbing: Replace Galvanized Domestic Water Piping

The 56 year old domestic water distribution piping consists of galvanized piping which is connected together via lead based solder. Current flushing procedures have maintained lead levels at an acceptable level. As the piping continues to age, this may not be possible.

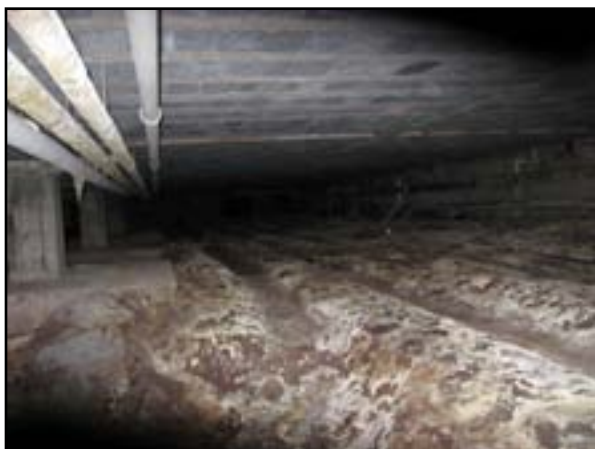
Service Tunnels: Floor Vapor Barrier

Exposed dirt areas contributing to air quality issues.

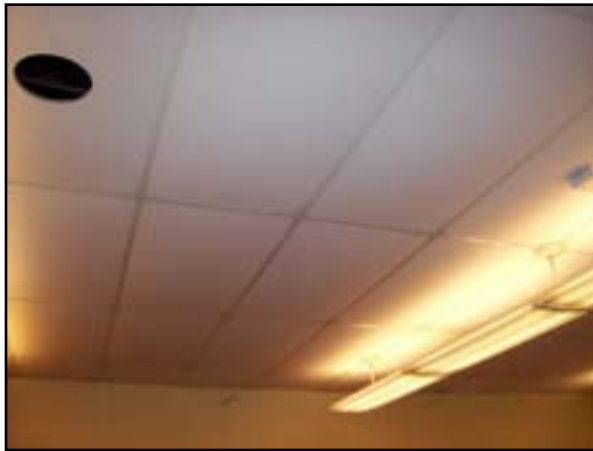
Ceiling Finishes: Replace Ceilings

Classrooms have 12x12 adhesive applied perforated acoustical tile that is dated, dirty and inefficient. Gymnasium and Cafeteria have 4x8 acoustical panels in similar condition.

Replace al ceilings with 2x2 suspended acoustic board ceiling.

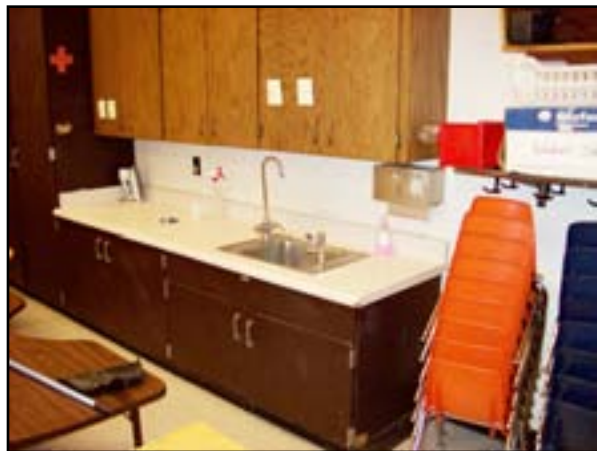
Fittings: Refurbish Wood Casework

Wood casework finish is worn and dated in appearance. Plastic laminate tops in classrooms are worn and beyond rated life.

Refinish wood casework. Replace plastic laminate countertops typical.

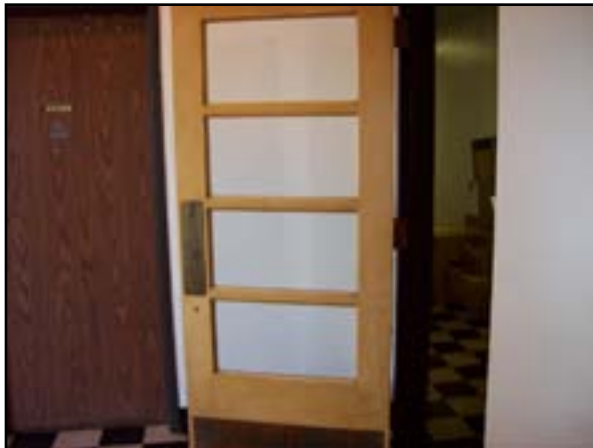
Interior Doors: Refinish Doors

Most interior wood doors exhibit faded, soiled and dated finish.

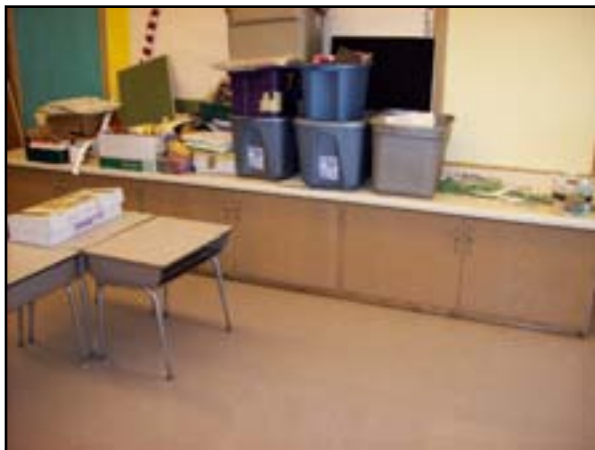
Wall Finishes: Paint Interior

Paint finishes are dated in color and condition.

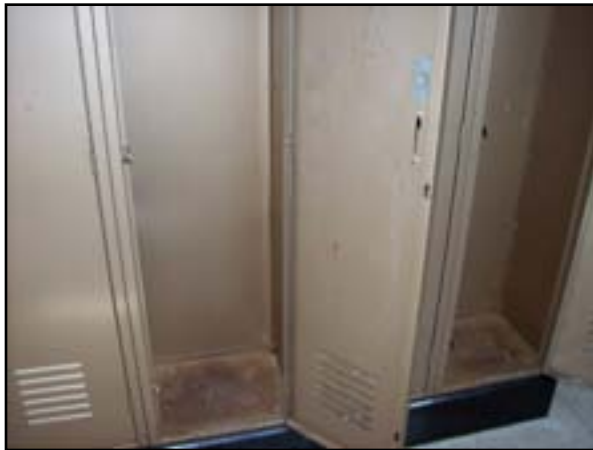
Fittings: Replace Lockers

Lockers are rusted, drab with many in need of repair.

Replace metal lockers with new metal lockers. 400 Total

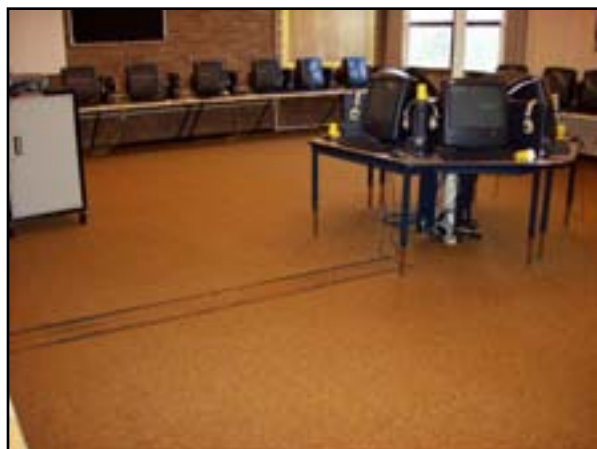
Floor Finishes: Replace Carpet

Carpet is worn, torn, deteriorated, and beyond rated life.

Replace existing carpet with new carpet. Approximately 6000 S. F.

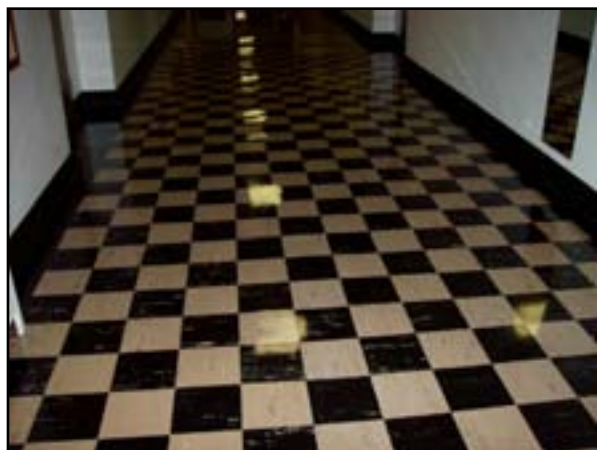
Floor Finishes: Replace Vinyl Asbestos Tile (VAT)

Vinyl Asbestos Tile exists, and is in need of replacement.

Replace existing Vinyl Asbestos Tile with Vinyl Composition Tile (VCT). Approximately 9700 S.F.

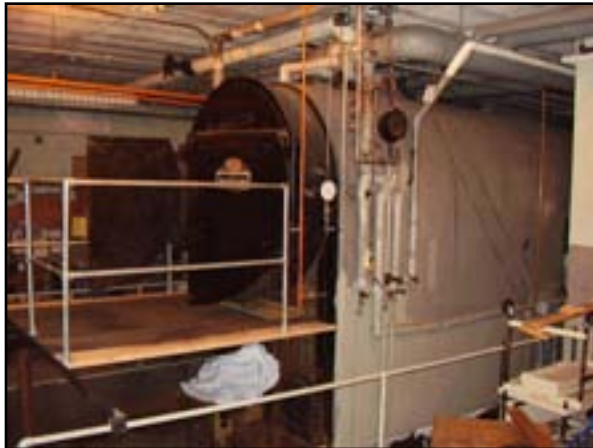
HVAC: Heating System Conversion - Steam to Hot Water

The 56 year old steam system has exceeded the recommended useful life. The steam system is a two pipe system. In addition the building has only one boiler. A backup boiler is necessary to minimize the chance of building freeze up.

A steam system requires substantially more maintenance than a modern hot water heating system due to steam traps, condensate pumps, and chemical treatment.

Install new high efficiency hot water condensing boilers and hot water piping system. Add medium efficiency boiler for dual fuel rates. Replace all steam terminal heating devices and coils with hot water devices and coils.

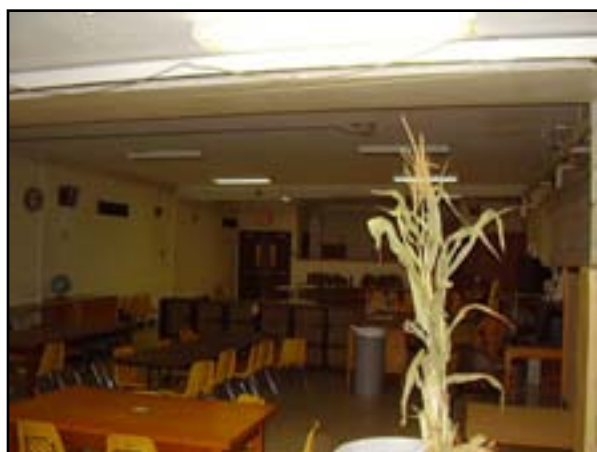
HVAC: Replace Ventilation in Classrooms

The 56 year old ventilation system has exceeded the recommended useful life expectancy and currently poorly distributes ventilation air. As part of this upgrade, the new mechanical system will incorporated heat recovery and classroom occupancy / CO2 controls to save energy.

Replacement of the Existing Ventilation System with a Modern Ventilation System consisting of Air Handling Units with Energy Recovery, Duct Distribution System, and Variable Air Volume Boxes with Hot Water Reheat Coils and Hot Water Finned Tube Radiation.

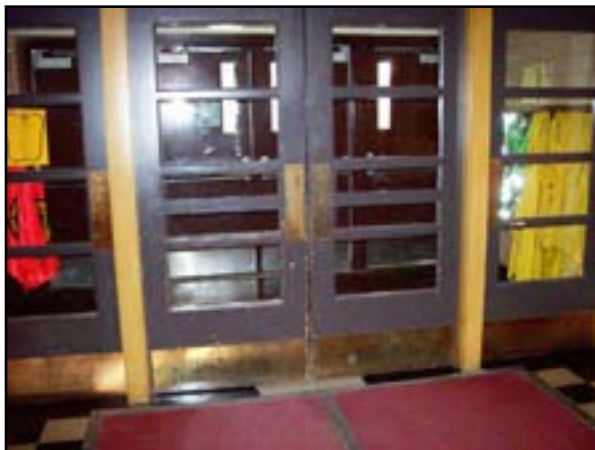
Interior Doors: Replace Doors

Doors are old wood with glass (non-tempered) and in need of repair

Replace wood doors with new wood doors, less glass area and safety glazing. 7 doors

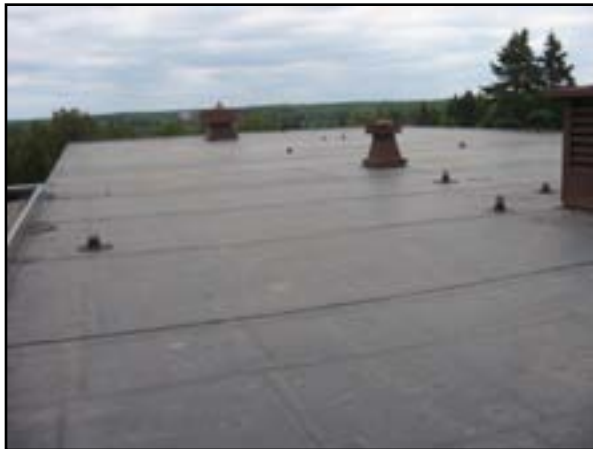
Roof System: Replace Roof

Roof system beyond rated life. Includes roof Areas 4-9.

Replace EPDM roof system. Sequence work with roof-level wall restoration.

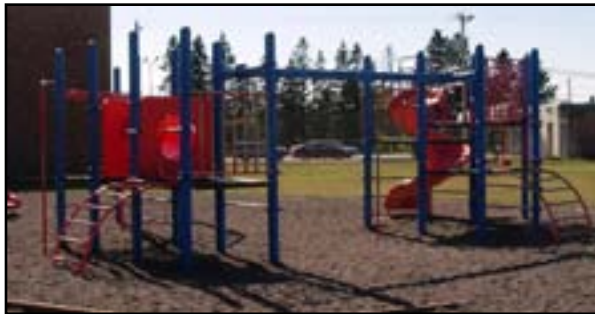
Site Furnishings: Playground Upgrade / Replacement

Playground equipment was built in 1990 and 1996. The majority of the playground equipment (except the newer equipment) does not meet current safety and ADA requirements. The playground has a "pea rock" surface which does not meet ADA. Some of the equipment is for pre-school.

Replace existing playground with new equipment to meet needs of enrollment. Replace surface material with district standard and replace edging as needed.

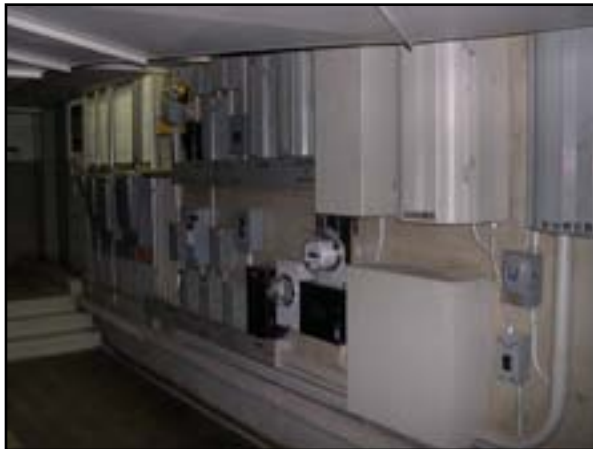
Electrical Service: Code Violation

Main service is fed unfused through the building which is a violation of the National Electric Code. The service is also lacking capacity to feed additional branch panel boards.

To feed the new branch panel boards a new 800 amp service panel will replace the existing service. New breakers will be installed to refeed the existing busway and new branch panels.

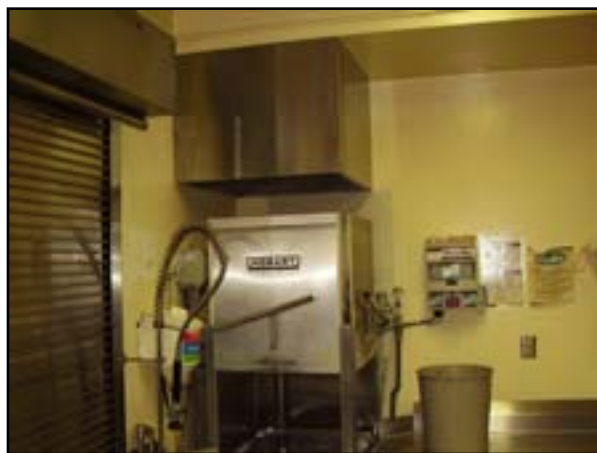
HVAC: Replace Dishwasher Exhaust Hood

The existing dishwasher has an existing exhaust hood but is not tagged as a type II Hood. It does not have an exhaust hood as required by the 2000 International Mechanical Code. Exhausting the dishwasher steam is critical in maintaining proper indoor air quality in the kitchen.

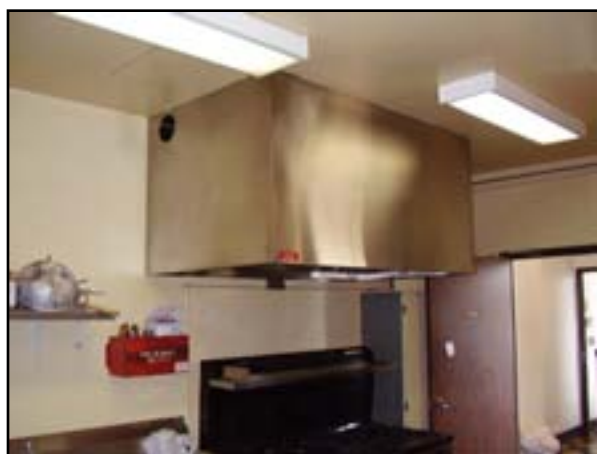
HVAC: Replace Kitchen Grease Exhaust Hood / Add Kitchen Make Up Air

The existing grease exhaust hood does not appear to be drawing the exhaust airflow as required by the 2000 Uniform Mechanical Code. The hood has been tagged non compliant by the State Fire Marshall and utilizes an Ansul system. This hood needs to be replaced with a code compliant grease exhaust hood and fan.

In addition, the kitchen does not have a dedicated make up air unit. Make up air for the kitchen hood is required by the 2000 International Mechanical Code.

Replace the existing grease exhaust hood and fan and grease duct with 2000 International Mechanical Code compliant kitchen grease hood exhaust system.

Add a dedicated make up air unit with dehumidification.

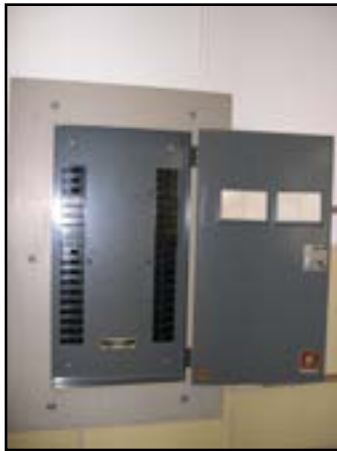
Electrical Distribution: Insufficient Capacity

Existing Branch Panels are lacking capacity for additional circuits. Panels must be added to accommodate circuits needed for additional receptacles in classrooms.

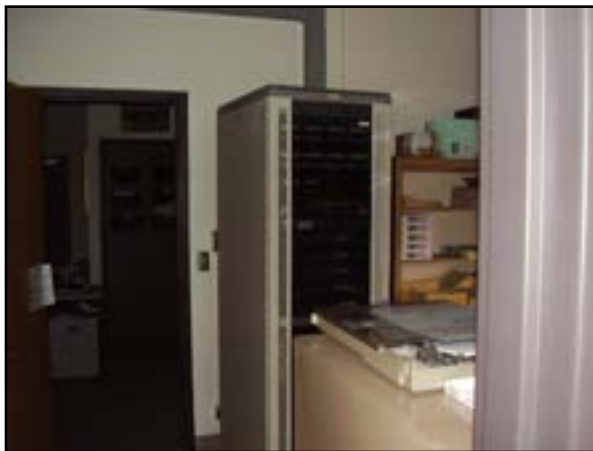
HVAC: Add Cooling Capability to IT Data Room

The Computer Lab and IT Data rooms get hot, which could cause technology equipment failure.

Provide a fan coil with a DX cooling coil and full economizer capability to utilize free cooling when outdoor conditional allow.

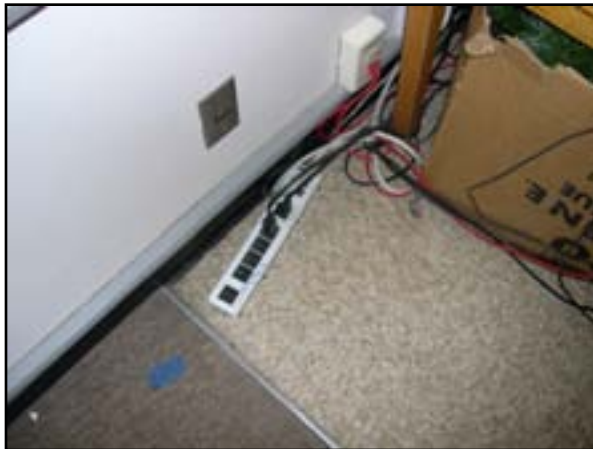
Wiring Devices: Insufficient Receptacles

In general, classrooms have an insufficient number of receptacles. Computers and other electronics are plugged into power strips due to the lack of receptacles. This limits future addition of electronic devices and presents a fire hazard.

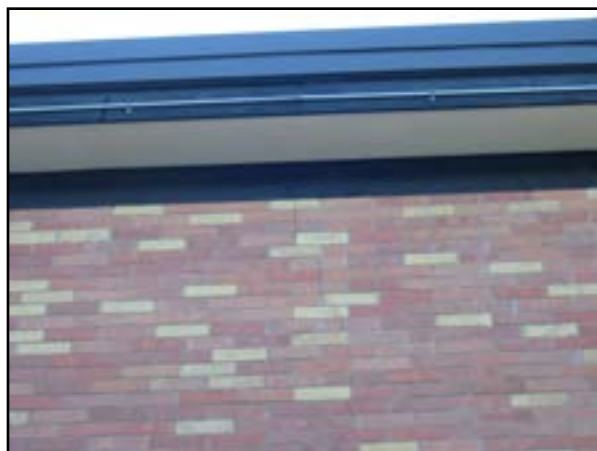
Exterior Walls: Wall Restoration

Deteriorated walls at roof-level and around the entire perimeter of building. Leakage reported at east elevation of 1950 Building during driving rain. I-beam detail at top of 1964 Addition is suspect for leakage and efflorescence.

Tuck point, spot brick replacement, through-wall flashing replacement, joint sealant replacement, stone patch repair, paint, and new drip edge at I-beam. Sequence work with reroofing of Areas 4 and 5.

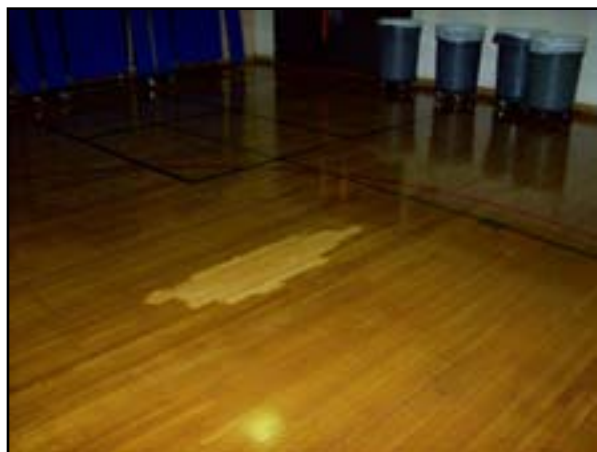
Floor Finishes: Refinish Wood Flooring

Hardwood flooring finish is worn and unsightly.

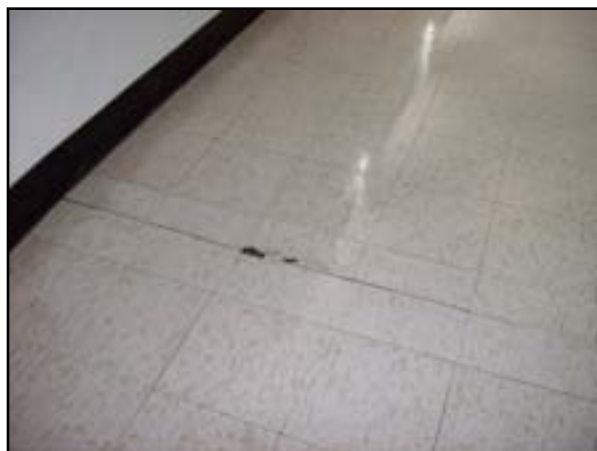
Floor Finishes: Replace Vinyl Composition Tile

Vinyl tile is worn and in poor condition.

Replace VCT with new VCT. Approximately 1750 S.F.

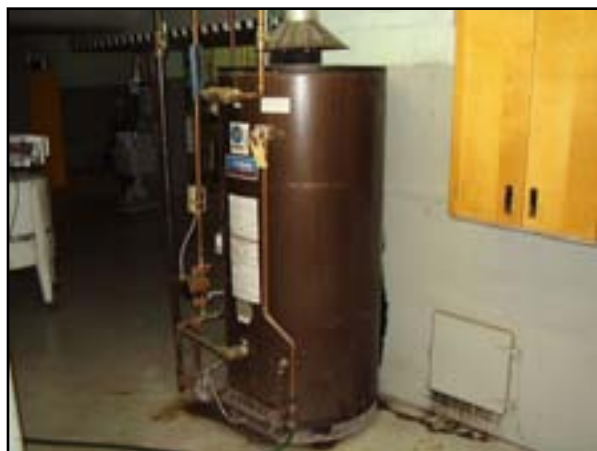
Plumbing: Add Domestic Water Heat Exchanger

Provide a domestic water heat exchanger. This will allow for an alternate fuel source selection.

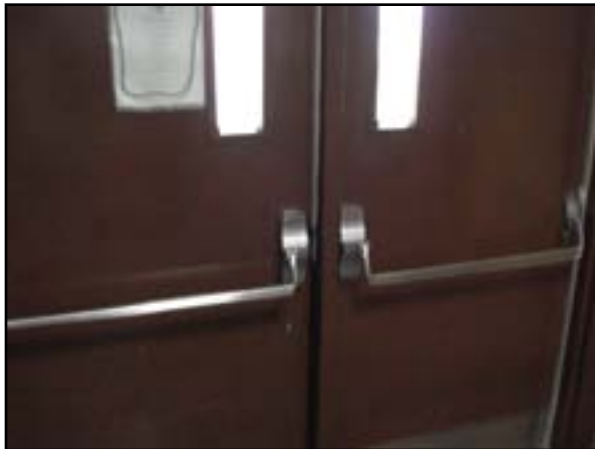
Communication and Security: Access Control

Doors need ability to be locked down with access allowed only to authorized people. Also doors without card readers should be monitored for unauthorized access.

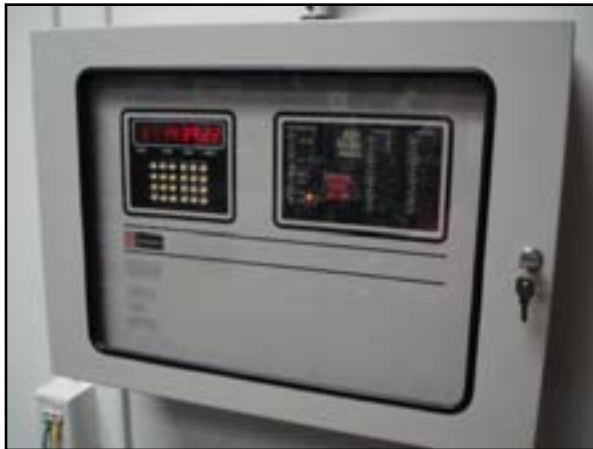
Fire Alarm Systems: Outdated System

Fire alarm systems are old analog system. System is prone to malfunctions and is very hard to identify exact area of alarm. It is also difficult to troubleshoot and find malfunctions.

Replace fire system with a fully addressable fire system.
 This will allow for quick response to exact alarm device
 And allow for better maintenance and safety

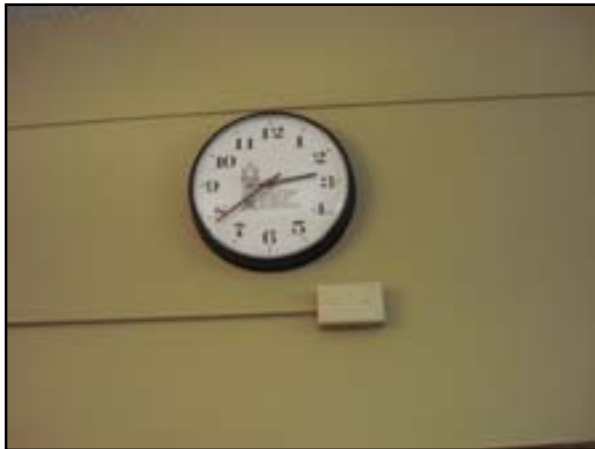
Communication and Security: Clock System

Master clock systems no longer keep clocks in time. Most are only used for running the bells. Atomic clocks may not receive a signal through the brick buildings. Many clocks do not work at all.

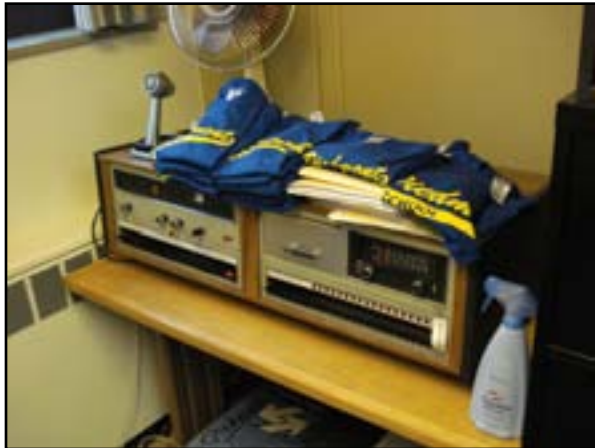
Communication and Security: Public Address and Sound System
 -

PA system is 25+ years old but is still functional.
 There are no speakers located in hallways or commons areas.

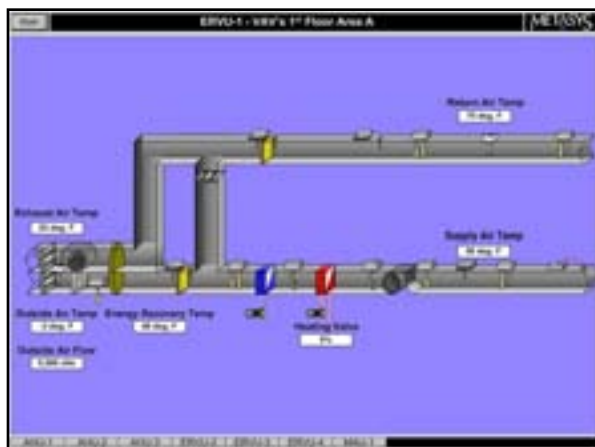
BAS Graphic

Upgrade/replace existing temperature control valves, dampers, and actuators. The majority are beyond rated life and many are disconnected and not functioning, thus not operating as energy efficiently as possible.

Repair existing control air line leaks. This will improve the energy efficiency of the existing control system.

The existing controls shall be recommissioned to verify proper sequence of operation and optimize energy efficiency. Additional control and monitoring points shall also be added to the BAS system to optimize HVAC system performance.

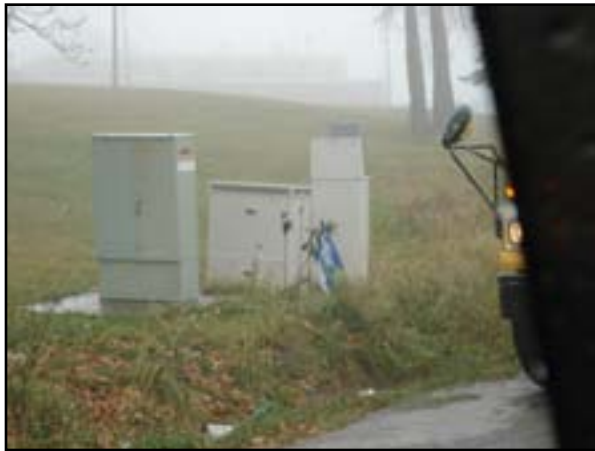
Emergency Power Distribution: Generator Backup

School currently has no backup power system to be used during a power failure. To keep students in school during power outage sufficient lighting must be maintained along with necessary life safety systems.

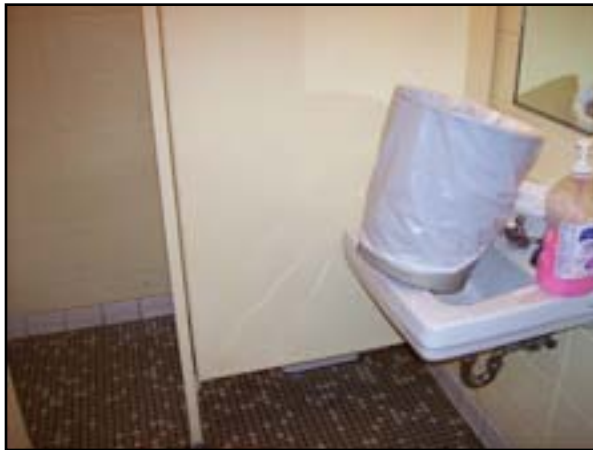
Fittings: Replace Toilet Partitions

Existing metal toilet partitions are old, dated and district goal is to standardize to plastic partitions.
