# Requirement Detail

**District:** Duluth Public Schools  
**Facility:** Grant Elementary School  
**Category:** Deferred Maintenance

**Asset Name:** Grant - Parking  
**Asset Number:** 470b

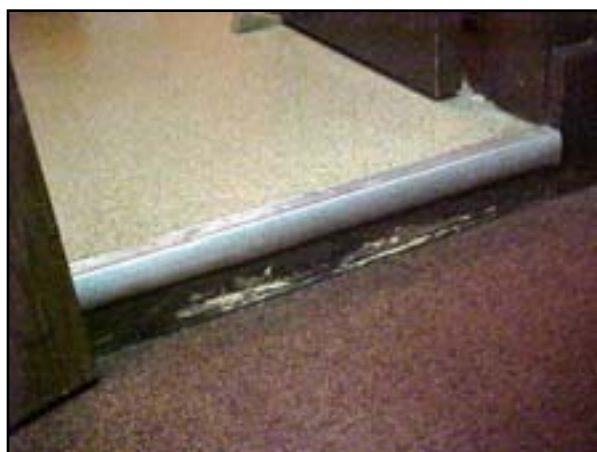
Interior Construction: Accessibility

This requirement includes accessibility issues encountered while you move through the school. Items include: providing elevator or ramp, adding/modifying handrails (only if the level is not served by an elevator or other accessible route), widening doors, replacing door hardware, eliminating protruding hazards and all permanent room identification signage as well as directional signage (adding signs, replacing signs and relocating signs).

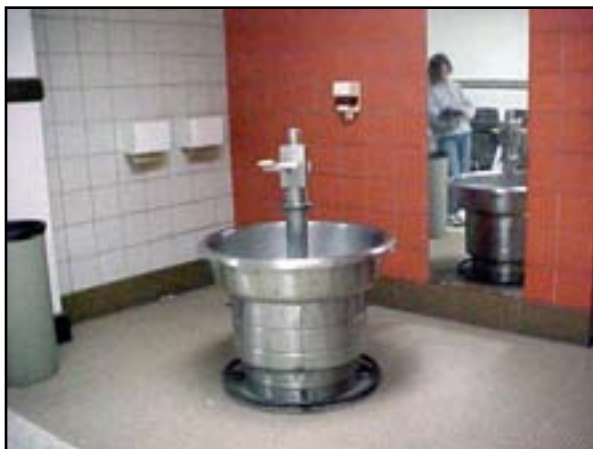
Plumbing: Accessibility

Note: the actual cost to complete work in toilet rooms may be increased by a decision to do work beyond what is required for accessibility, such as re-tiling, replacing all fixtures, replacing all stall partitions, etc.

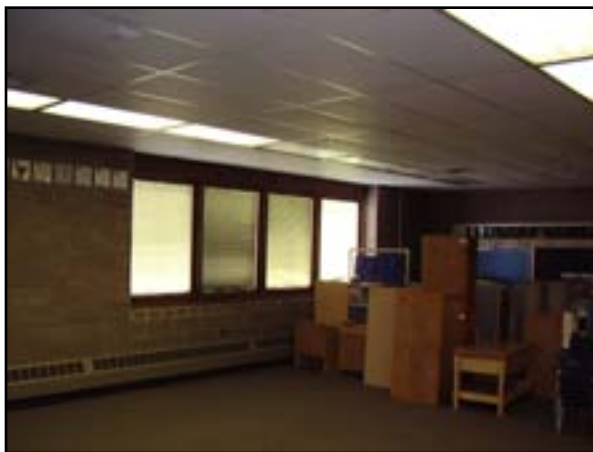
HVAC: Add Dehumidification to the 1991/1993 Additions

The air handling unit serving all three floors of classrooms have no means of dehumidification. Without dehumidification capabilities, these spaces cannot meet ASHRAE 55-1992 space design conditions. As part of this upgrade, the new mechanical system will incorporated heat recovery and classroom occupancy / CO2 controls to save energy.

Addition of a dehumidification coil to the air handling unit serving the classrooms for the 1991/1993 Additions via modification and internal closed cell AHU liner. The supply duct would be externally insulated in mechanical rooms and  
*All Costs in USD.*

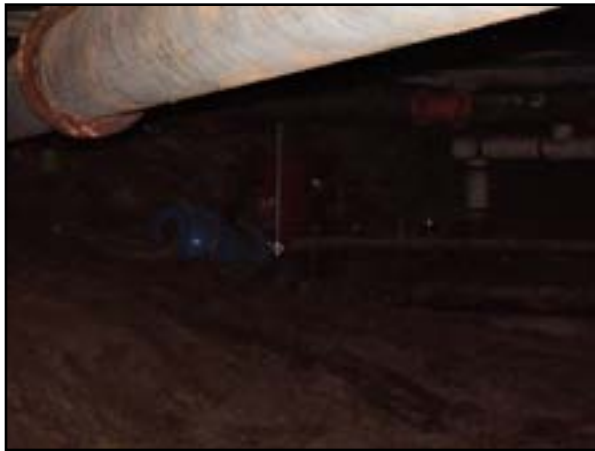
HVAC: Provide Negative Pressure in Crawlspace/Tunnels

The tunnels have dirt floors and if not under negative pressure can transfer odors to the floors above due to the pipe and duct penetrations. The tunnels are also present opportunity for mold growth.

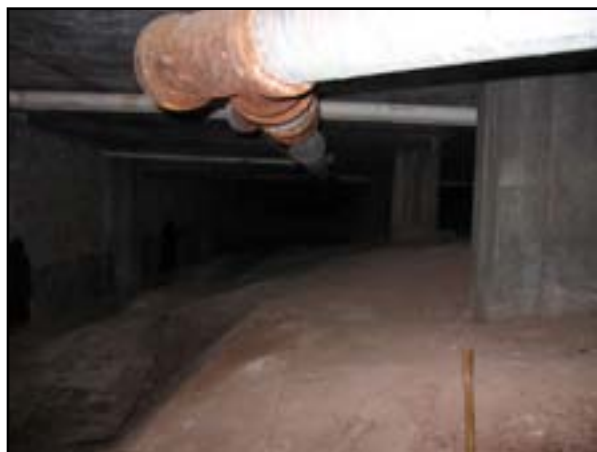
Service Tunnels: Floor Vapor Barrier

Exposed dirt areas contributing to air quality issues.

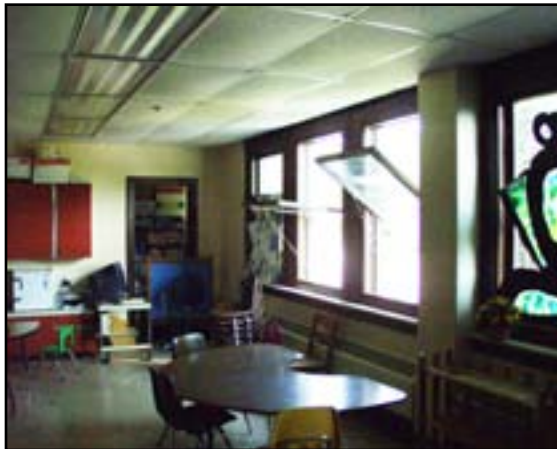
Ceiling Finishes: Replace All Suspended Acoustical Board Ceilings

Existing suspended 2 X 4 acoustical tile ceiling panels severely sagged.

Existing suspended ceiling tiles are sagging, remove and replace existing grid and tiles in entire building except for 91/93 addition. 40120 SQFT

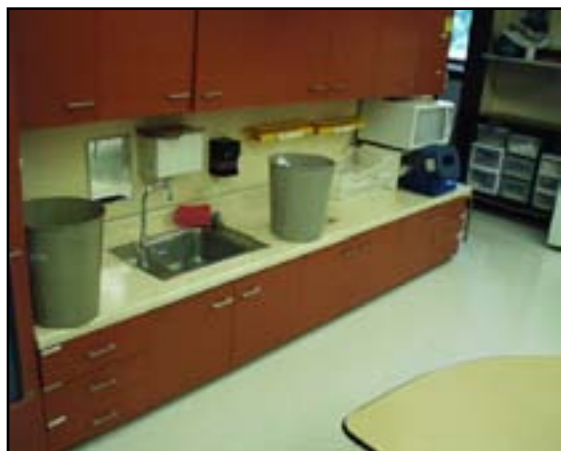
Equipment and Furnishings: Replace Countertops

Replace all plastic laminate countertops on steel cabinets in 1918 portion.

Remove existing plastic laminate countertops and replace with new. 391 L.F.

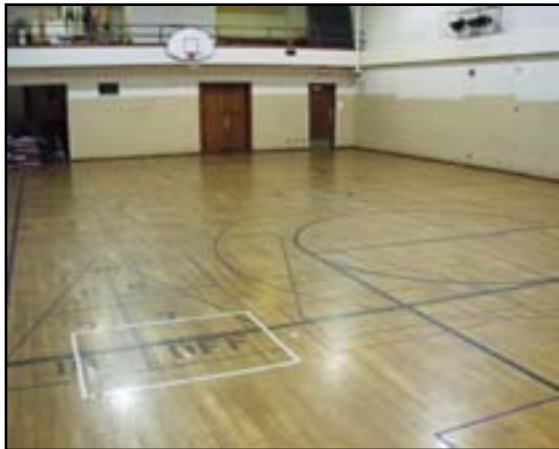
Floor Finishes: Refinish Gymnasium Wood Floor

Existing gym floor needs to be refinished and have new court markings.

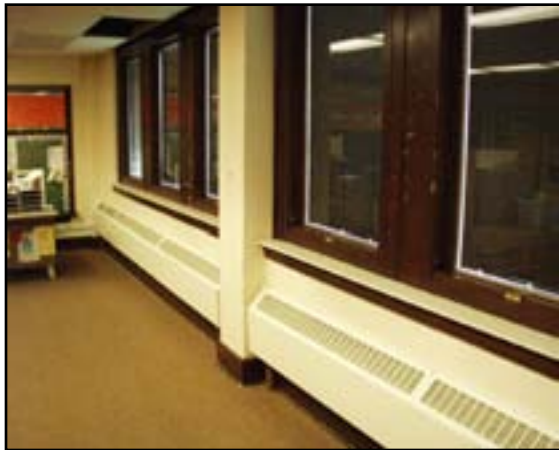
Floor Finishes: Replace All Carpet

Existing carpet is worn and in need of replacement

Remove existing carpet and replace with new. 11000 SQFT

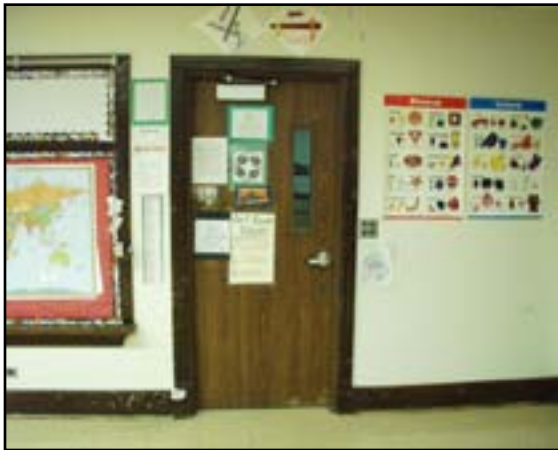
Interior Doors: Replace Classroom Entry Doors

Existing plastic laminate doors are severely chipped.

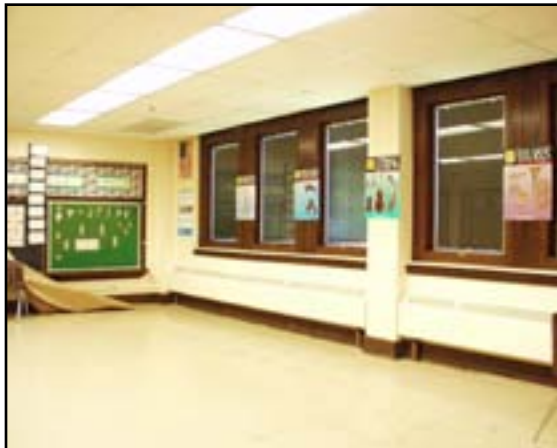
Wall Finishes: Painting

Re-paint all interior wall surfaces within classrooms including wood trim and cabinet refinishing

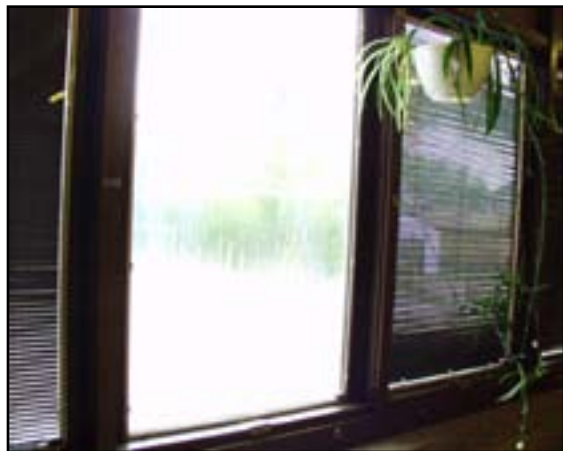
Exterior Windows: Replace Existing Windows

Existing metal clad wood windows are beginning to show age. Some insulated glass units are falling.

Remove existing windows and replace with new aluminum windows with insulating glass. 5500 SQFT

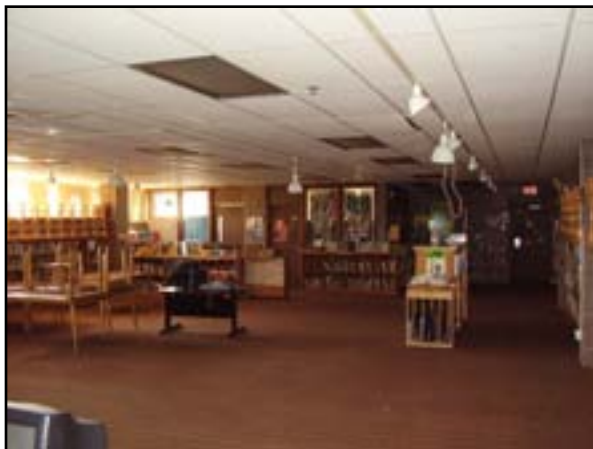
HVAC: Replace Ventilation All Floors 1918 and 1982 Building

The 88 year old ventilation system has exceeded the recommended useful life expectancy and currently poorly distributes ventilation air.

A booster fan was added for the 1982 Addition Library, but fails to provide proper ventilation.

Ceiling space lends itself well to retrofit.

Replacement of the existing ventilation system with a modern ventilation system consisting of air handling units with energy recovery, duct distribution systems, variable air volume boxes with hot water reheat coils, and hot water finned tube radiation.

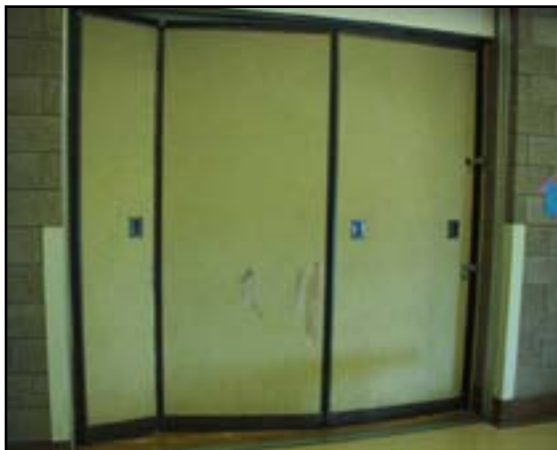
Interior Doors: Replace Folding Doors

Existing building doors in poor condition and need to be replaced.

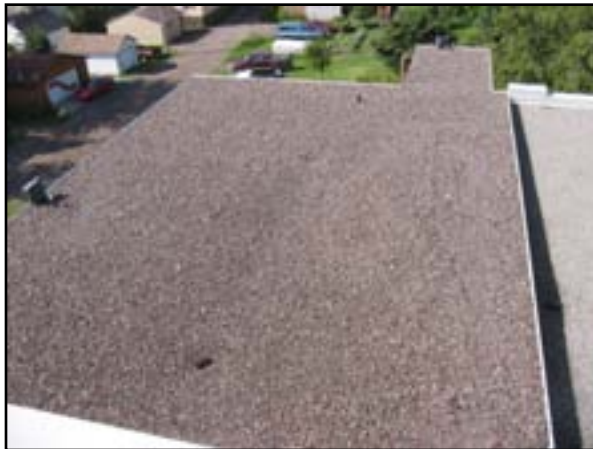
Roof System: Replace Roof

Roof system beyond rated service life. Includes roof Areas 3,4, and 5.

Replace the EPDM roof. Sequence work with roof-level wall restoration.

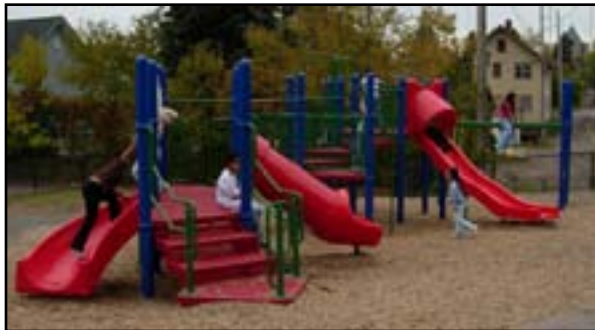
Site Furnishings: Playground Upgrade / Replacement

Playground equipment was installed in 1996. It does have an ADA component, but partially missed. The amount of equipment is not very adequate for the existing school population.

Replace existing playground with new equipment to meet needs of enrollment. Replace surface material with district standard and replace edging as needed.

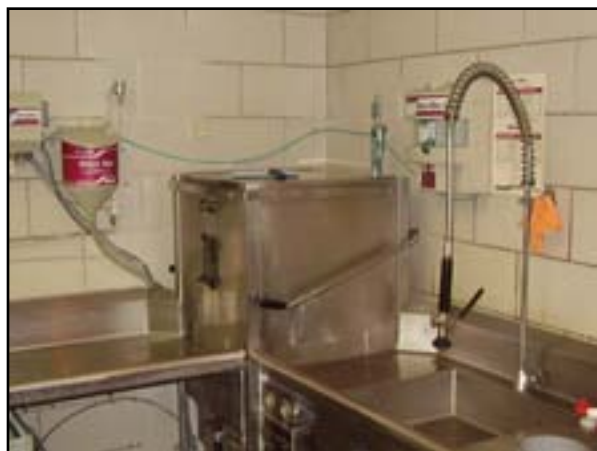
HVAC: Add Exhaust Hood to Dishwasher

The existing dishwasher does not have an exhaust hood as required by the 2000 International Mechanical Code. Exhausting the dishwasher steam is critical in maintaining proper indoor air quality in the kitchen.

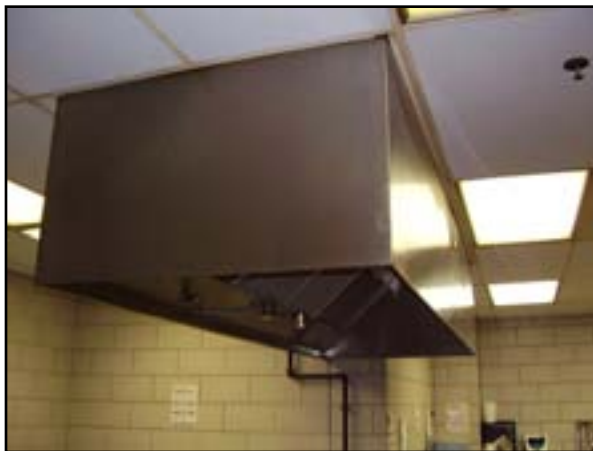
HVAC: Replace Kitchen Grease Exhaust Hood

The existing grease exhaust hood does not appear to be exhausting the code required air for an island hood application. This hood should be replaced with a code compliant grease exhaust hood and fan.

Replace the existing grease exhaust hood and fan and grease duct with 2000 International Mechanical Code compliant kitchen grease hood exhaust system.

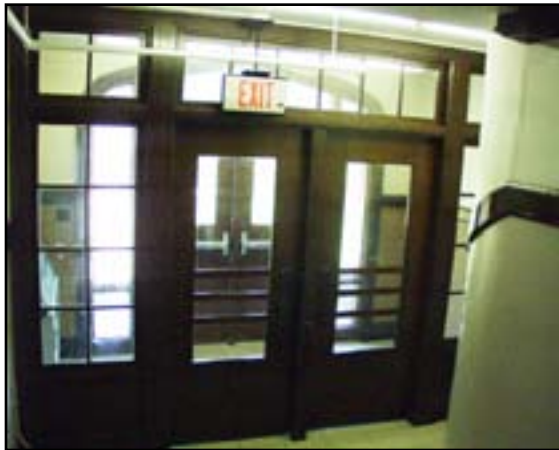
Interior Doors: Replace Vestibule Doors

Existing vestibule doors are original and do not have required safety glazing installed.

Existing vestibule door, sidelights and frame to be removed and replaced with new aluminum system.

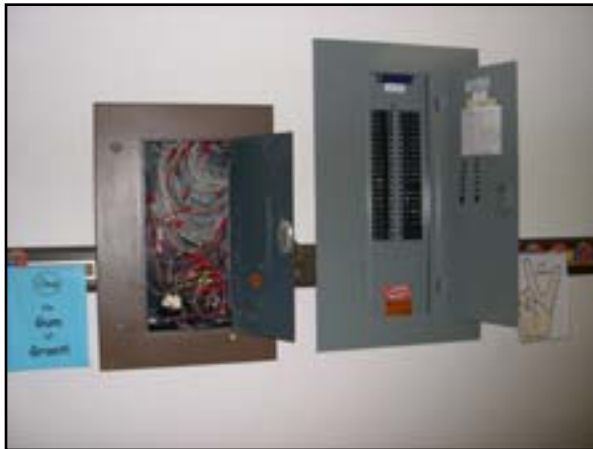
Electrical Distribution: Insufficient Capacity

Existing Branch Panels are lacking capacity for additional circuits. Panels must be added to accommodate circuits needed for additional receptacles in classrooms.

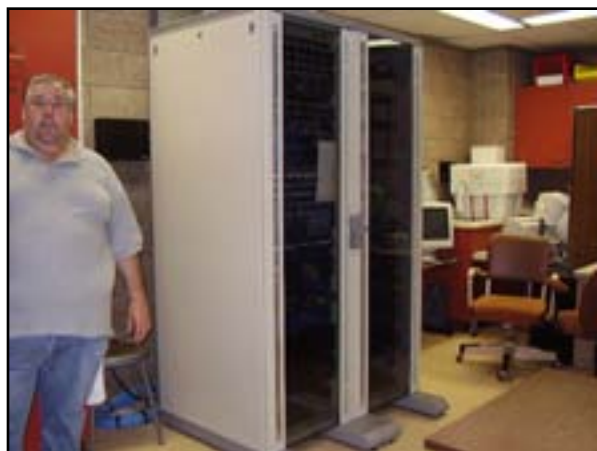
HVAC: Add Cooling Capability to IT Data Room

This Computer Lab and IT Data room gets hot, which could cause technology equipment failure.

Provide a fan coil with a DX cooling coil with full economizer capability to utilize free cooling when outdoor conditions allow.

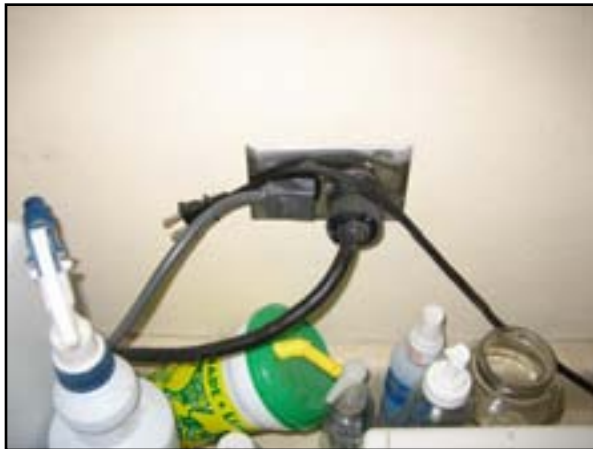
Wiring Devices: Insuficient Receptacles

With rapid advances in technology, additional receptacles may be required in 6 to 10 years. The Addition of receptacles will require additional electrical panels.

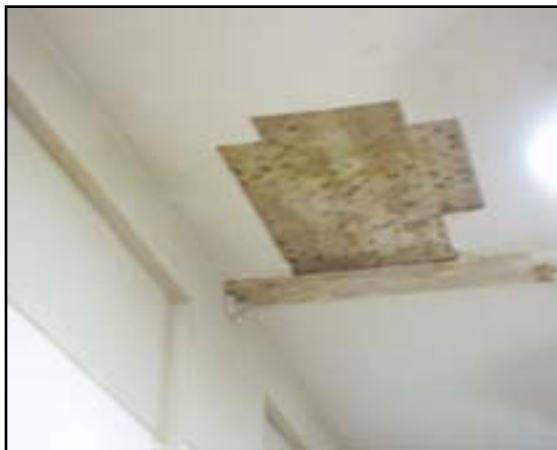
Ceiling Finishes: Replace Gymnasium Ceiling

Existing ceiling has missing 12 X 12 acoustical tiles entire ceiling should be replaced.

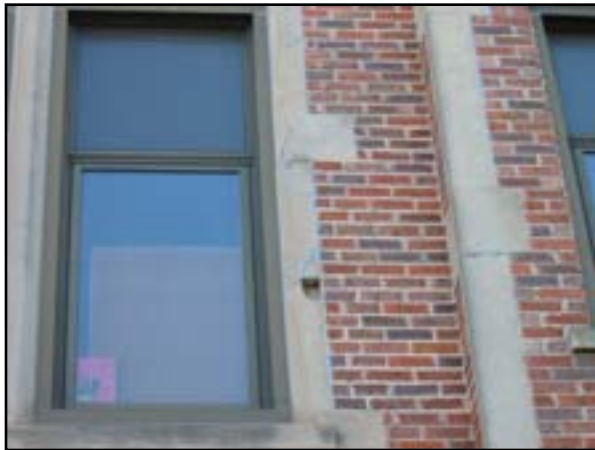
Exterior Walls: Wall Restoration

Deteriorated roof-level and grade-level walls and chimney.

Tuck pointing, spot brick replacement, joint sealant replacemen, new chimney cap, and mics. items. Sequence work with reroofing at Areas 2-5.

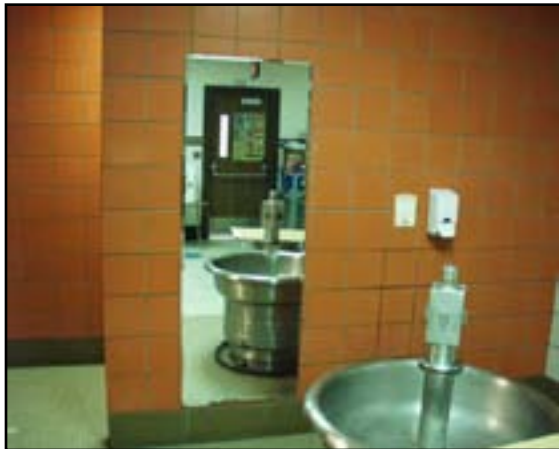
Fittings: Replace Mirrors At Toilet Room Alcoves

Existing mirrors are in poor condition and reflective surfacing is coming off.

Remove existing mirrors and replace with new metal framed mirrors.

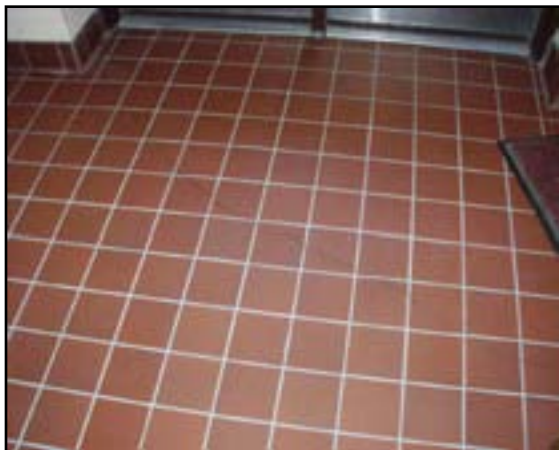
Floor Finishes: Replace Quarry Tile

Existing quarry tile has a large crack through it.

Remove existing floor tile, repair crack in substructure and replace quarry tile floor and base.

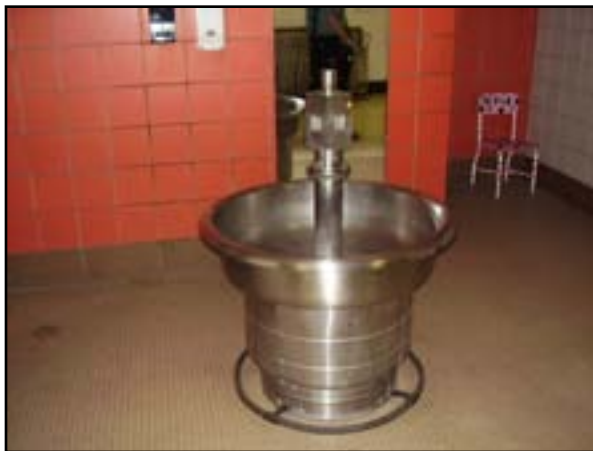
Plumbing: Replace Lavatory Wash Fountains

The six lavatory wash fountains are in need of constant maintenance and most leak water. These wash fountains have exceeded the recommended useful life.

Replace six wash fountains with new wash fountains with infrared mixing stations.

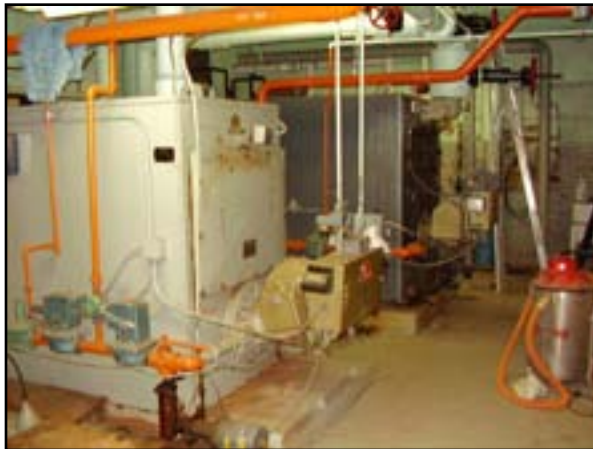
HVAC: Boiler Room Upgrades

The existing boilers have exceeded the recommended useful life expectancy. Both existing boilers have fuel oil backup. The smaller one should be replaced with two high efficiency hot water boilers to increase the efficiency of the boiler plant.

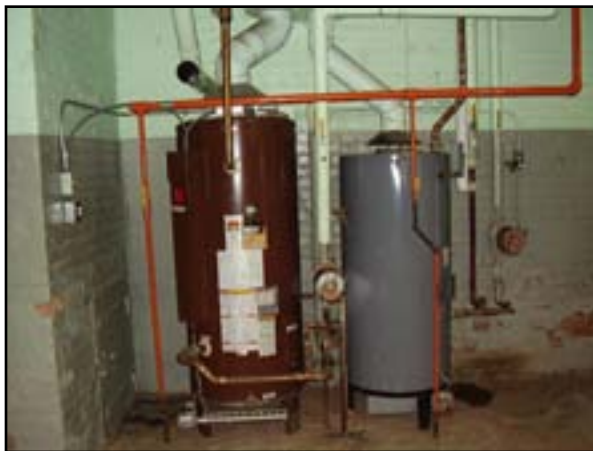
Plumbing: Add Dometic Water Heat Exchanger

Provide a hot water to hot water for domestic hot water. This will allow for an interruptible natural gas rate.

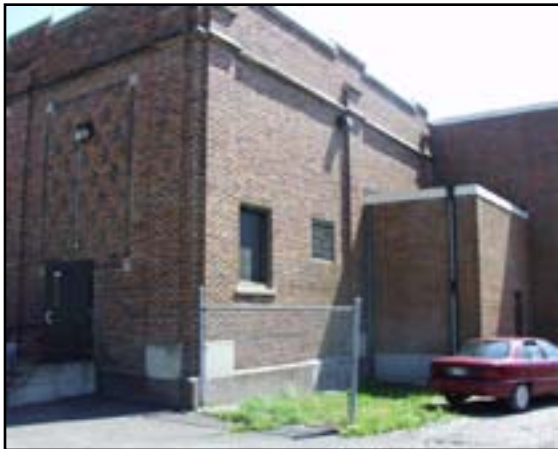
Superstructure: Construct Second Exit From Boiler Room

Existing boiler room has only one exit, second exit required.

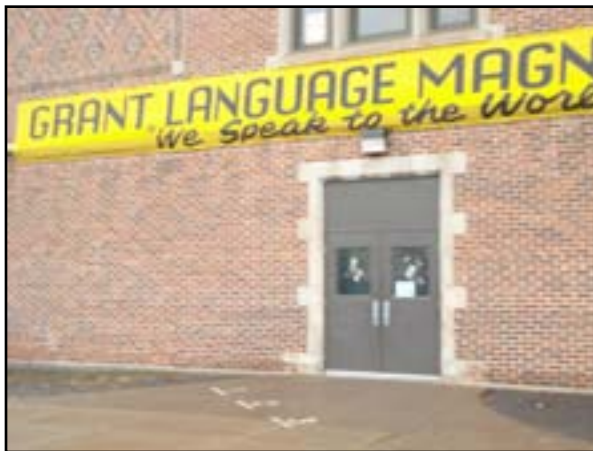
Communication and Security: Access Control

Doors need ability to be locked down with access allowed only to authorized people. Also doors without card readers should be monitored for unauthorized access.

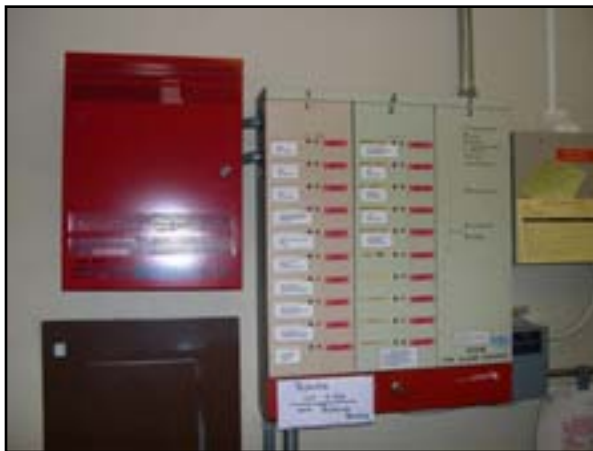
Fire Alarm Systems: Outdated System

Fire alarm systems are old analog system. System is prone to malfunctions and is very hard to identify exact area of alarm. It is also difficult to troubleshoot and find malfunctions.

Replace fire system with a fully addressable fire system.  
 This will allow for quick response to exact alarm device  
 And allow for better maintenance and safety

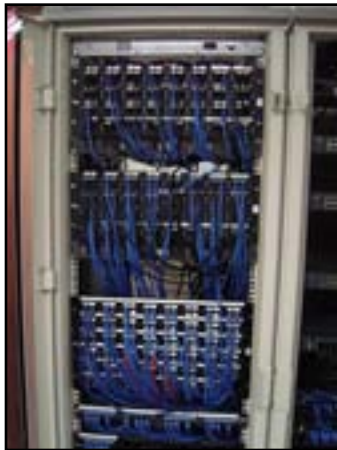
Communication and Security: Cabling Upgrade

Existing building cabling has older categories of cabling.

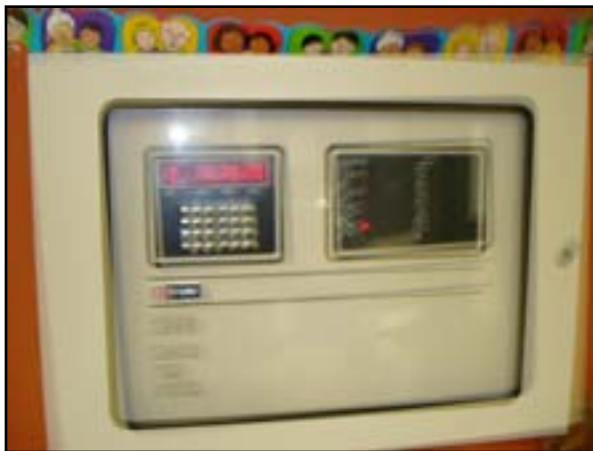
Communication and Security: Clock System

Master clock systems no longer keep clocks in time. Most are only used for running the bells. Atomic clocks may not receive a signal through the brick buildings. Many clocks do not work at all.

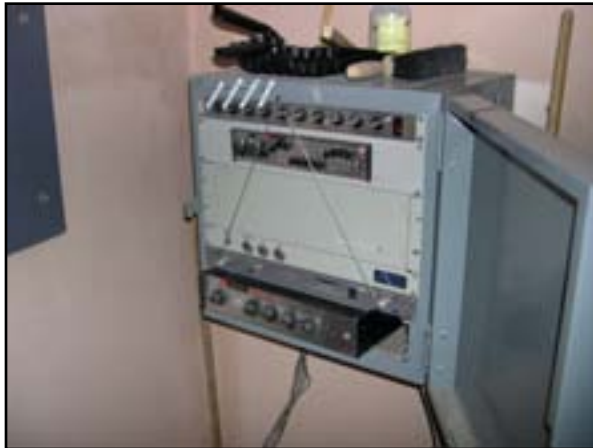
Communication and Security: Public Address and Sound System  
 -

PA system is 25+ years old but is still functional.  
 There are no speakers located in hallways or commons areas.

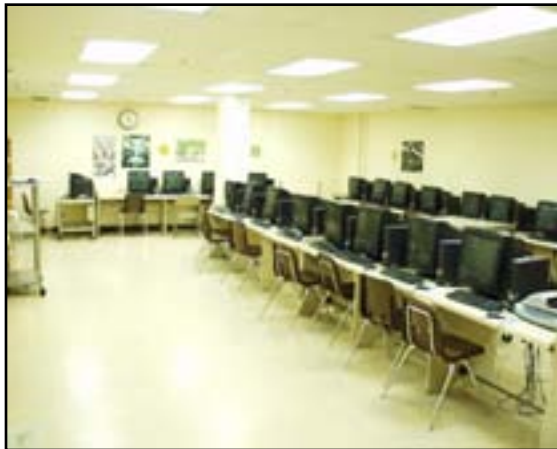
Equipment and Furnishings: Construct Computer Workstations

Existing computer workstations are of average quality and do not meet District standards.

Remove existing workstations and replace with new.

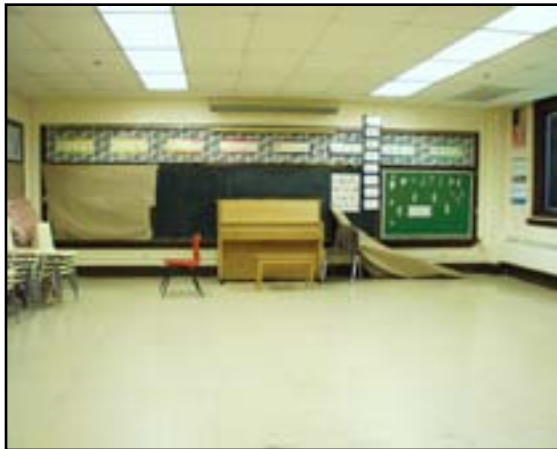
Fittings: Replace Existing Blackboards and Tackboards

Existing blackboard and tackboards are in need of replacement to modernize and bring up to district standard.

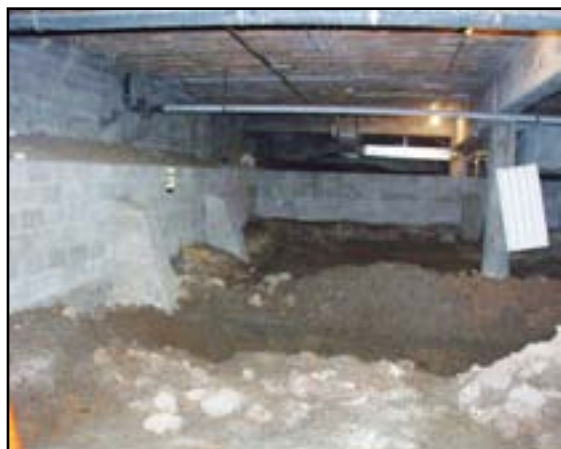
Floor finishes: Install Concrete Slab

Existing storage area has a dirt floor. A concrete slab should be installed to make room functional.

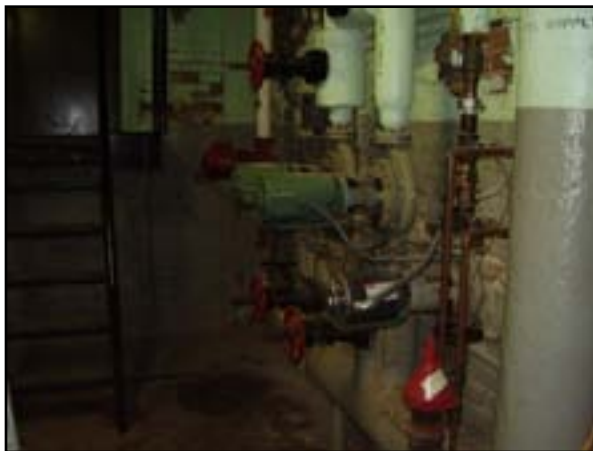
HVAC: Add Propylene Glycol to Heating System

The heating system currently serving the air handling units does not contain glycol, which creates the opportunity for heating coil freeze up.
