Requirement Detail

HISTORIC OLD CENTRAL

District: Duluth Public Schools
Facility: Historic Old Central High School
Category: Deferred Maintenance

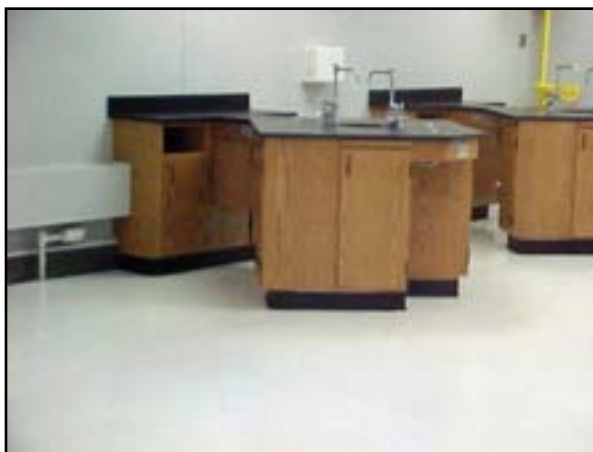
Equipment and Furnishings: Accessibility

It also includes accessibility issues found in Specialty Areas (science labs, cooking labs, industrial arts areas, as well as the media center/library). Items include: providing accessible work stations in kitchens, providing accessible labs and lowering ewashes.

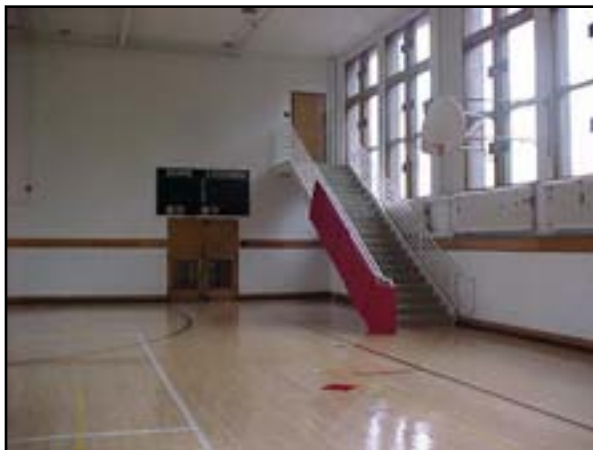
Interior Construction: Accessibility

This requirement includes accessibility issues encountered while you move through the school. Items include: providing elevator or ramp, adding/modifying handrails (only if the level is not served by an elevator or other accessible route), widening doors, replacing door hardware, eliminating protruding hazards and all permanent room identification signage as well as directional signage (adding signs, replacing signs and relocating signs).

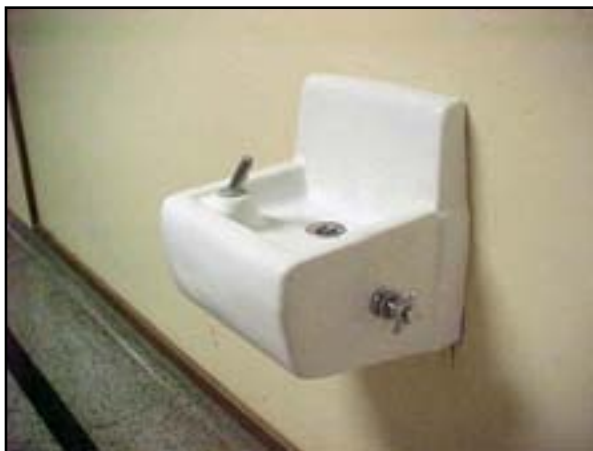
Plumbing: Accessibility

Note: the actual cost to complete work in toilet rooms may be increased by a decision to do work beyond what is required for accessibility, such as re-tiling, replacing all fixtures, replacing all stall partitions, etc.

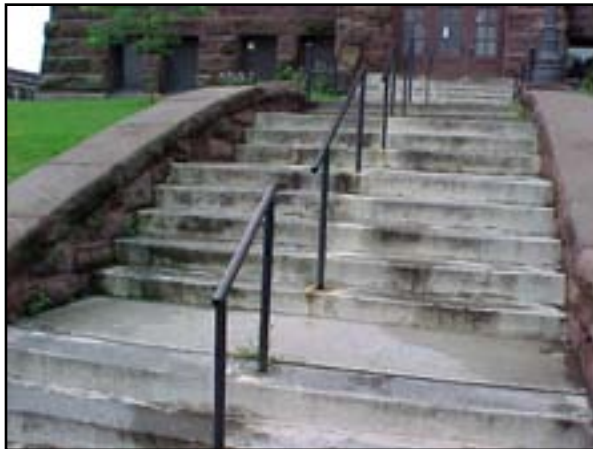
Site Improvements: Accessibility

This requirement includes accessibility issues from the moment you are on school grounds until you get to the front door. Items include: adding and identifying accessible parking and adding or modifying accessible routes (sidewalks).

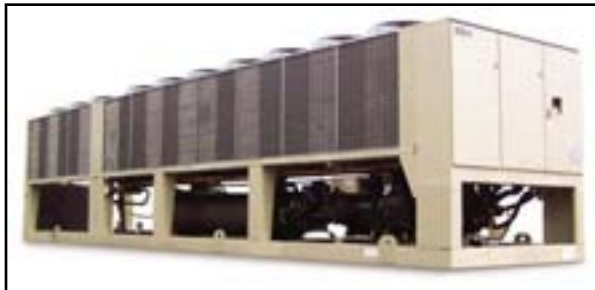
HVAC - Dehumidification Chiller and Piping Mains

Historic Old Central High School has no means of dehumidification. Without de-humidification capabilities, these spaces cannot meet ASHRAE 55-1992 space design conditions.

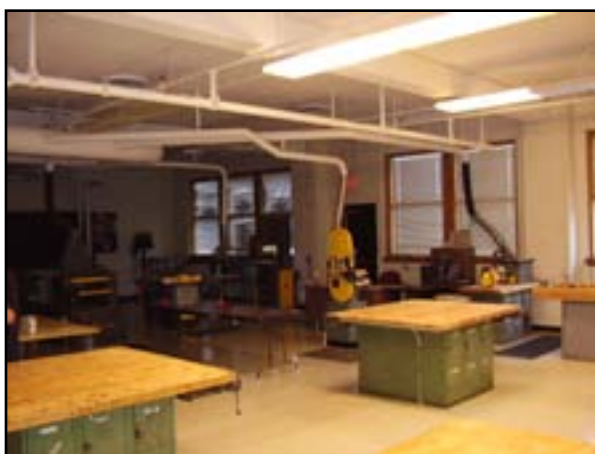
HVAC - Upgrade Ventilation and Replace Wood Shop Dust Collector and Upgrade Weld Hood Exhaust

The dust collector for the wood shop has been replaced within the last 20 years and has had filters added to the re-circulated supply air. This exhaust system appears to be operating well, but planned replacement is required.

The air handling unit has exceeded it's recommended useful life and needs to be replaced in order to provide the 2000 International Mechanical Code required ventilation air.

Replace the wood shop dust exhaust system with a new re-circulating dust collector and pipe the exhaust duct overhead.

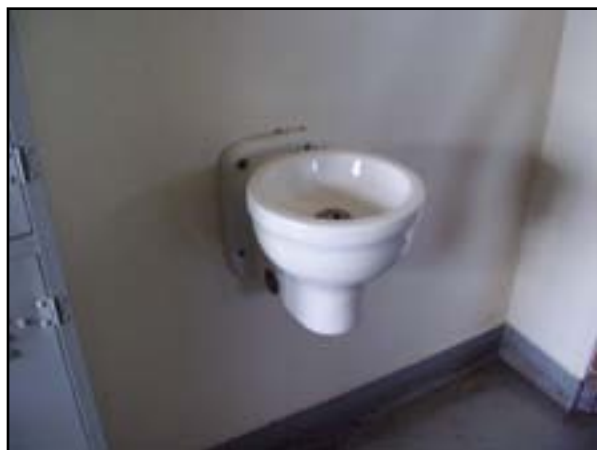
Plumbing: Replace Galvanized Domestic Water Piping

The 80-116 year old domestic water distribution piping consists of galvanized piping which is connected together via lead based solder. Current flushing procedures have maintained lead levels at an acceptable level. As the piping continues to age, this may not be possible.

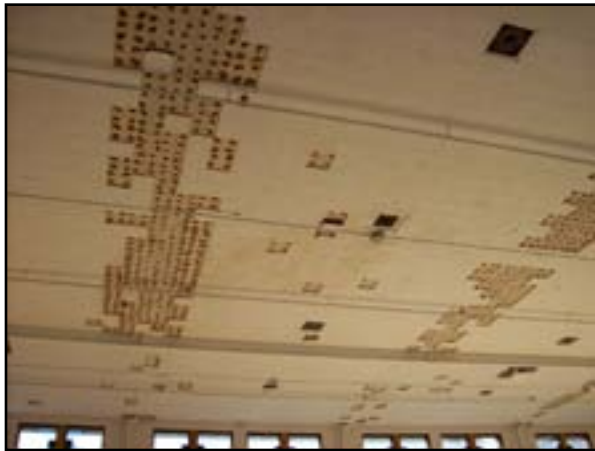
Ceiling Finishes: Replace Gymnasium Acoustical Tile

12 X 12 adhesive applied acoustical tile is damaged, unsightly. Replacement required.

Replace 12 x 12 adhesive applied acoustical tile
 2 x 2 suspended acoustical tile. Approximately 7000 S.F.

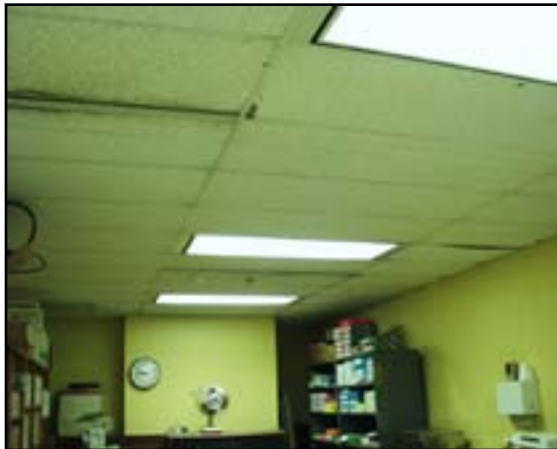
Ceiling Finishes: Replace Suspended Ceiling Tile

Existing ceiling tile is dirty/worn. Recommend panel replacement.

Remove existing panels and replace with new.

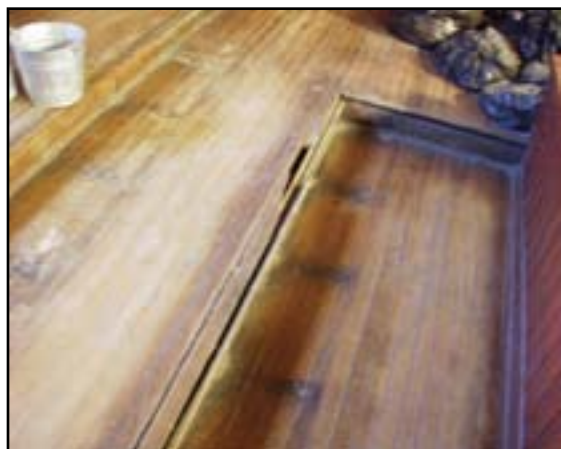
Floor Finishes: Refinish Hardwood Floor

Hardwood flooring is worn and unsightly.

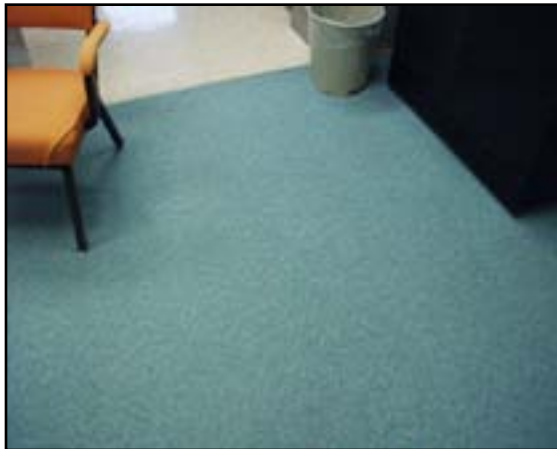
Floor Finishes: Replace Carpet Areas with VCT

Existing carpet is worn and not suited for current use, replace carpet with VCT.

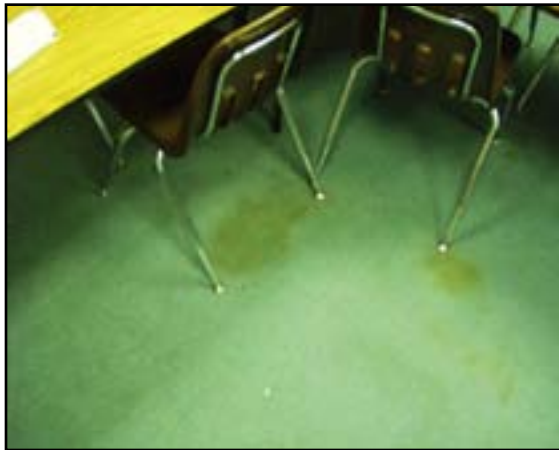
Floor Finishes: Replace Carpet

Carpet is exhibiting wear at normal and accelerated levels.

Replace carpet with new. Approximately 45,000 S.F.

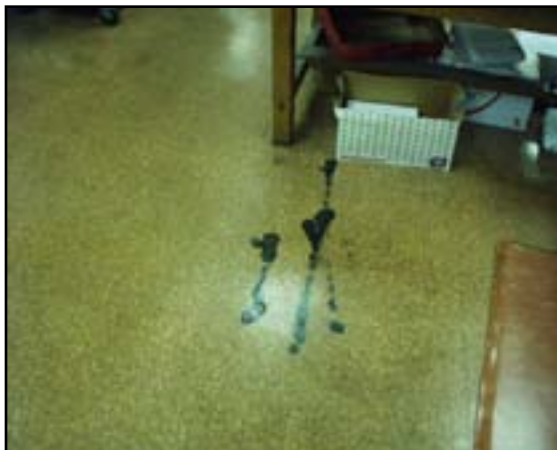
Floor Finishes: Replace VCT

Existing VCT is dated and currently in serviceable condition, but should be replaced for long term use.

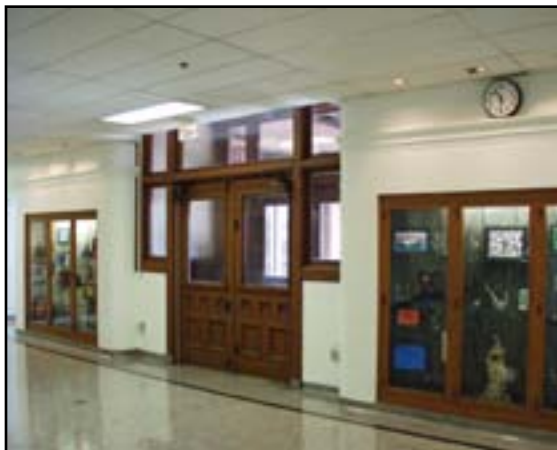
Interior Doors: Refurbish Wood Doors

Wood panel doors and sidelights are old and in need of refinishing. Glass lites do not have safety glazing.

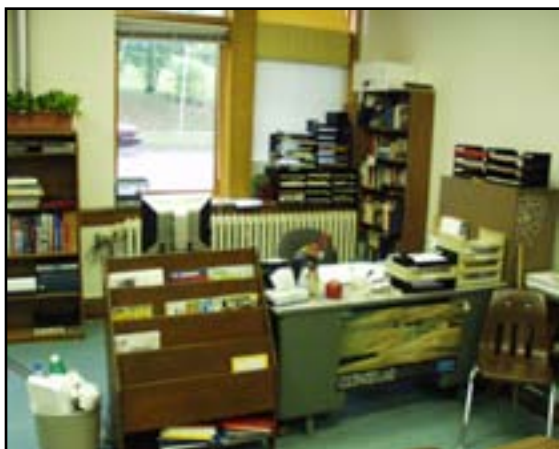
Wall Finishes: Repaint Interior

All interior surfaces will require repainting at some point to maintain appearance.

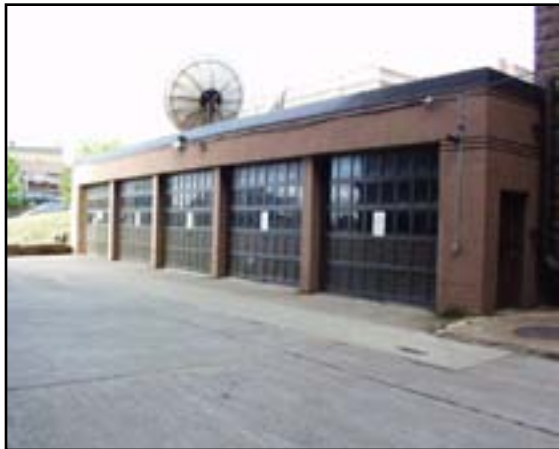
Exterior Doors: Replace Overhead Doors

Existing overhead doors appear to be the original wood doors, doors are showing their age and should be replaced.

Remove (5) overhead doors and replace with new.

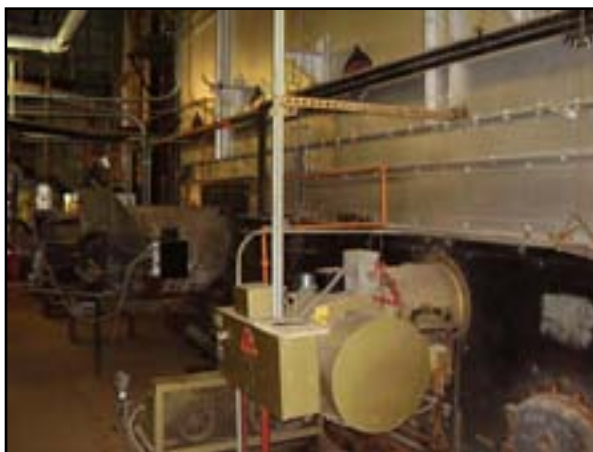
HVAC: Heating System Conversion - Steam to Hot Water

The steam system which is 80-116 years old has exceeded the recommended useful life. A steam system requires substantially more maintenance than a modern hot water heating system due to steam traps, condensate pumps, and chemical treatment.

Install a steam to hot water heat exchanger and hot water piping system. Replace all steam terminal heating devices and coils with hot water devices and coils.

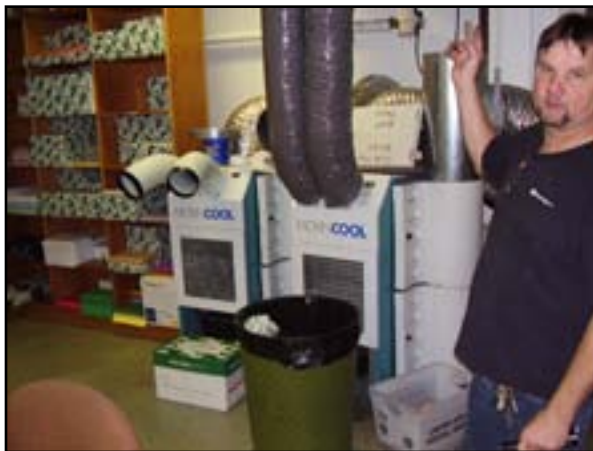
HVAC: Install Ventilation Storage and Print Shop Areas

There is one air handling unit serving this area which has exceeded the recommended useful life expectancy and currently poorly distribute ventilation air.

Much of the supply duct consists of fiberglass ductboard, which is failing.

In addition, the lack of dehumidification capability is creating "musty" areas in many of the paper and record storage areas. Spot coolers have been added to some of the areas, but the remaining spaces require not only improved ventilation, but dehumidification in order to help protect the documents.

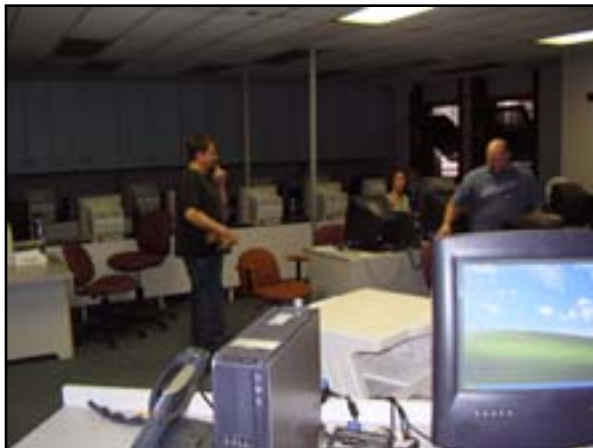
HVAC: Replace Ventilation All Floors 1890 and 1926 Classroom and Administration Areas

The 80-116 year old ventilation systems have exceeded the recommended useful life expectancy and currently poorly distribute ventilation air.

Much of the supply and return duct consists of fiberglass ductboard, which is failing.

There are three air handling units currently serving these areas, two of which are extremely large. Not only would these units be removed but more units would be added to provide improved air handling unit zoning.

Replacement of the Existing Ventilation System with a Modern Ventilation System consisting of Air Handling Units with Energy Recovery, Duct Distribution System, and Variable Air Volume Boxes with Hot Water Reheat Coils and Hot Water Finned Tube Radiation.

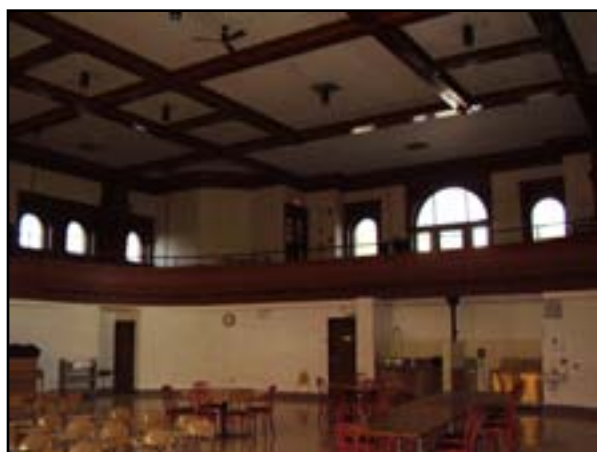
HVAC: Replace Ventilation Venditeria Area

The 33 year old ventilation system has exceeded the recommended useful life expectancy and currently poorly distribute ventilation air. Much of the supply duct consists of fiberglass ductboard, which is failing. As part of this upgrade, the new mechanical system will incorporated heat recovery and classroom occupancy / CO2 controls to save energy.

Replacement of the Existing Ventilation System with a Modern Ventilation System consisting of Air Handling Units with Energy Recovery, Duct Distribution System, and Variable Air Volume Boxes with Hot Water Reheat Coils and Hot Water Finned Tube Radiation.

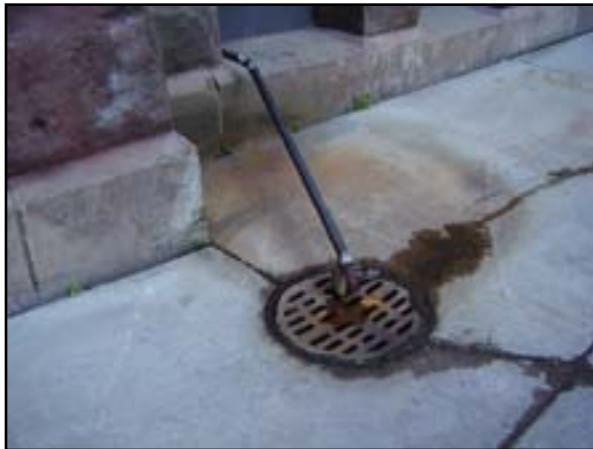
Plumbing - Sump Pump Replacement

The sump pump in the boiler room is utilized to transfer some ground water overflow from the loading dock. The piping needs to be reconfigured to discharge in an alternate location and the pump should be replaced.

Replace the existing vertical sump pumps with a new vertical duplex set of sump pumps with new duplex control panel.

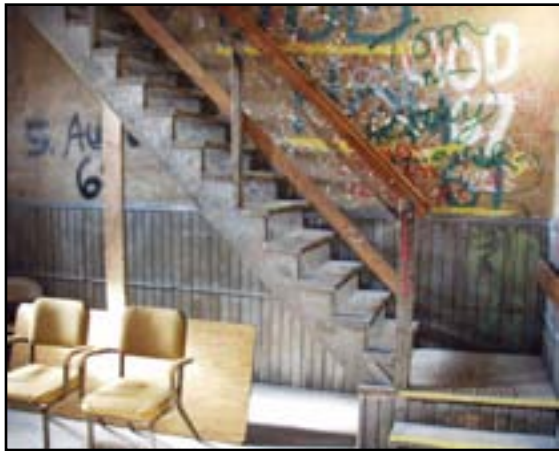
Superstructure: Preserve/ Refurbish Clock Tower Stairway and Room

Existing wood stair and railing is original; treads are cupped from wear, railing are non-code compliant floor boards are questionable.

Replace stair treads and enclose risers. Replace stair railing and guard railing at landings. Install plywood over entire landing.

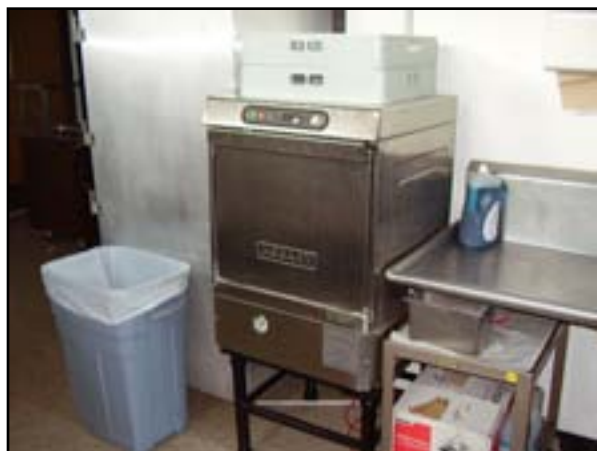
HVAC: Add Exhaust Hood to Dishwasher

The existing dishwasher does not have an exhaust hood as required by the 2000 International Mechanical Code. Exhausting the dishwasher steam is critical in maintaining proper indoor air quality in the kitchen.

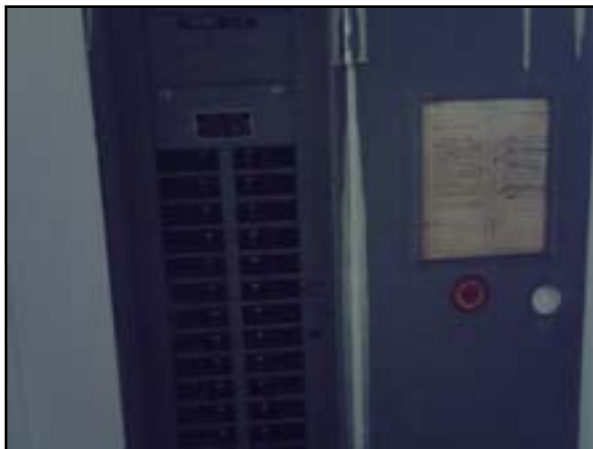
Electrical Distribution: Insufficient Capacity

Existing Branch Panels are lacking capacity for additional circuits. Panels must be added to accommodate circuits needed for additional receptacles in classrooms.

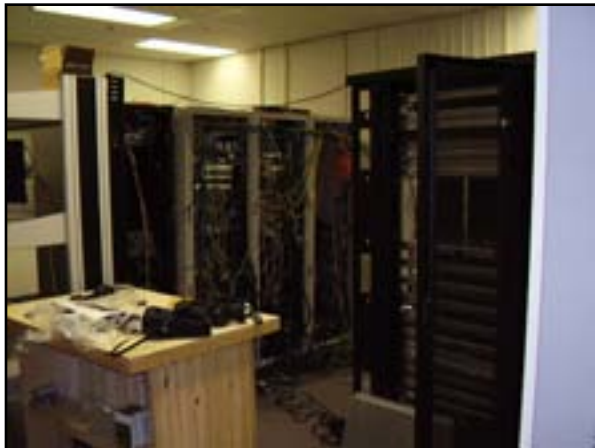
HVAC: Add Cooling Capability to IT Data Rooms

The Computer Labs and IT Data rooms gets hot, which could cause technology equipment failure.

In the main IT Data room, two (2) spot coolers and two (2) window air conditioners have been added, but even these have a difficult time keeping up with the heat load and can't make use of free cooling when outdoor conditions allow.

There are three IT data rooms in Historic Old Central High School.

Provide a fan coil with a DX cooling coil and full economizer capability to utilize free cooling when outdoor conditions allow.

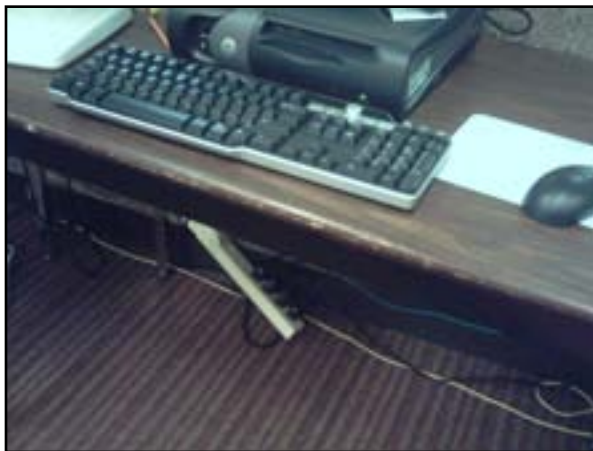
Wiring Devices: Insufficient Receptacles

In general, offices have an insufficient number of receptacles. Computers and other electronics are plugged into power strips due to the lack of receptacles. This limits future addition of electronic devices and presents a fire hazard.

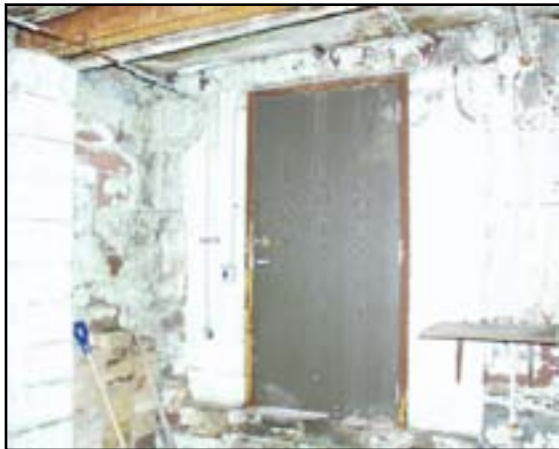
Exterior Doors: Replace Basement Door at Main Entrance

Existing door is an old interior door that has been modified for opening. Gap all around. Replace door and frame.

Remove exist door/frame and replace with new galvanized frame, and exterior hollow metal door, paint.

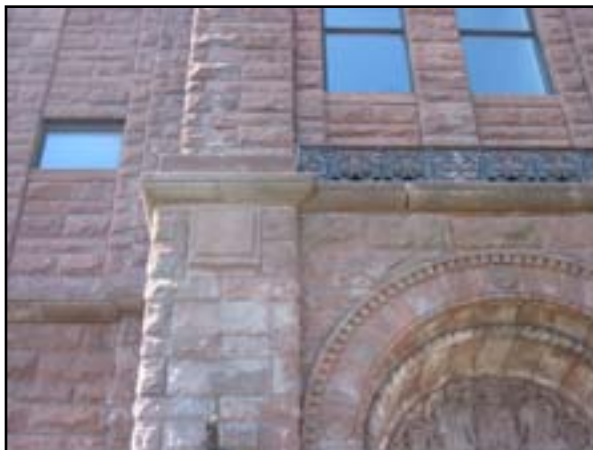
Exterior Grade-Level Walls

Deteriorated grade-level walls. Efflorescence is present at several locations.

Tuck pointing, spot brick and stone replacement, joint sealant replacement, and misc. items.

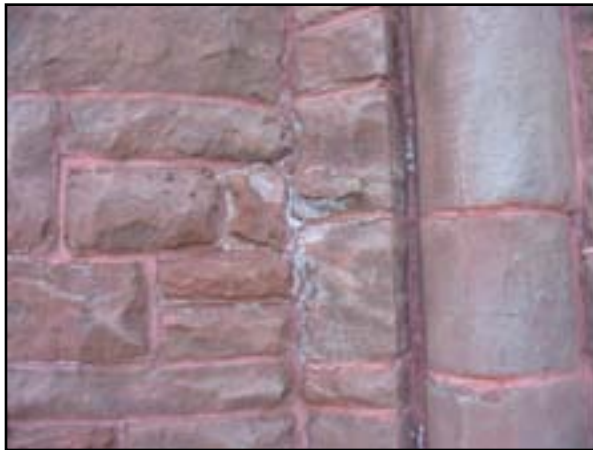
Roof-Level Wall Restoration

Deteriorated roof-level walls at the entire building. Leakage reported at Boiler Room.

Tuck point, spot brick replacement, stone repair, resetting and replacement; joint sealant replacement and misc. items. Sequence work with reroofing in these areas.

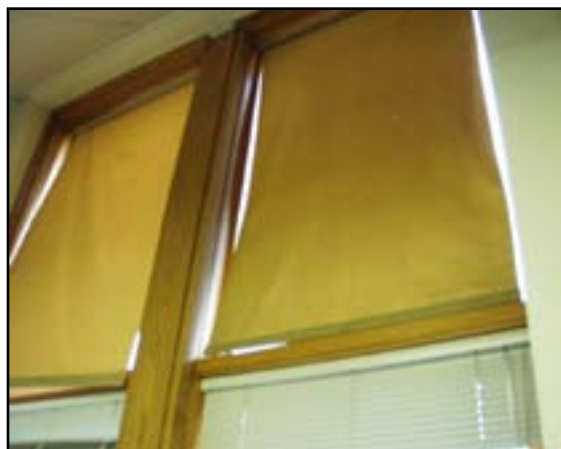
Exterior Windows: Replace Blinds

Existing roller blinds are very yellowed and torn. Replace with new.

Remove existing blinds and replace with new.

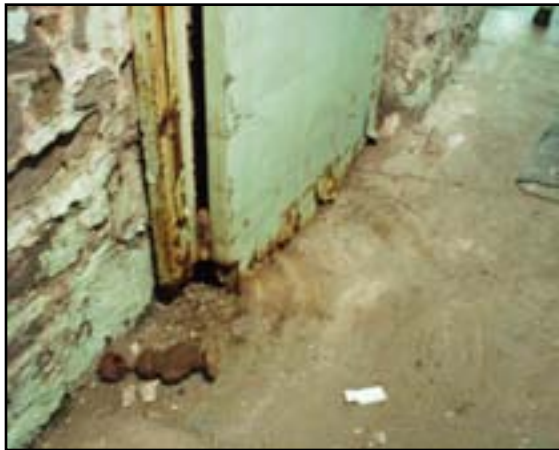
Interior Doors: Replace Boiler Room Door

Existing fire door is very rusted and in poor condition. Replacement required.

Remove existing door and frame, replace with new rated hollow metal door and frame.

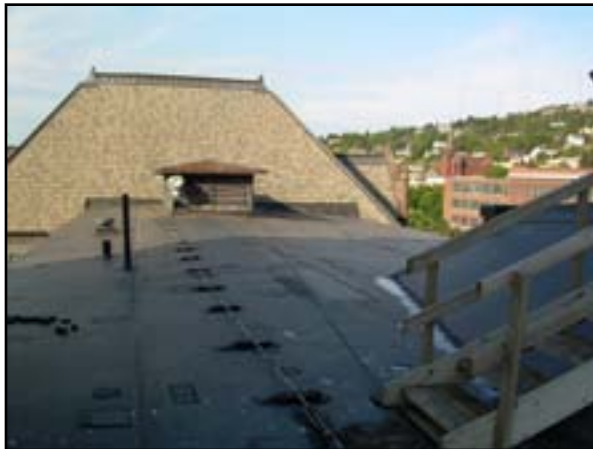
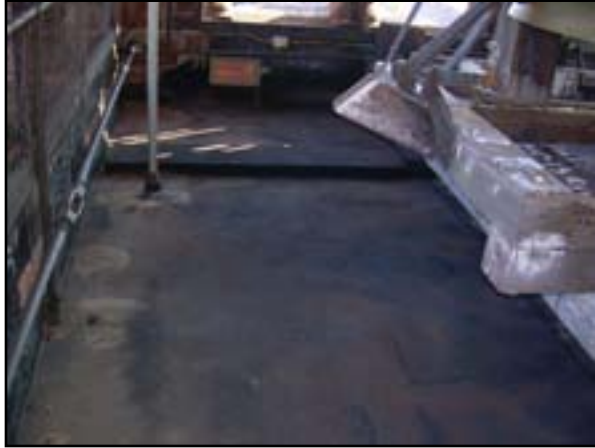
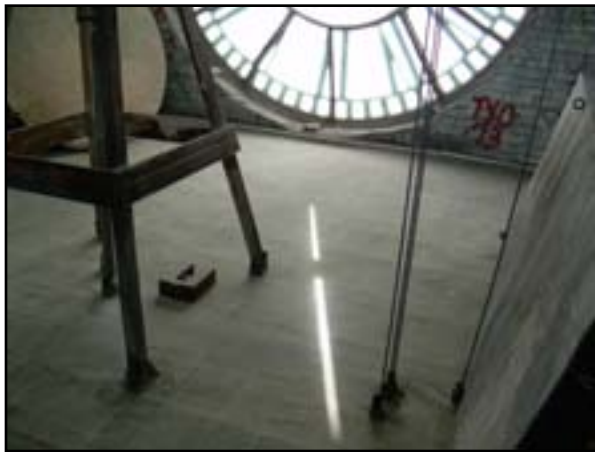
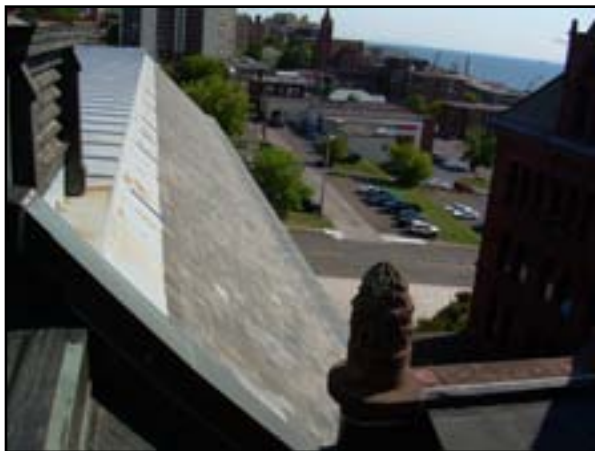
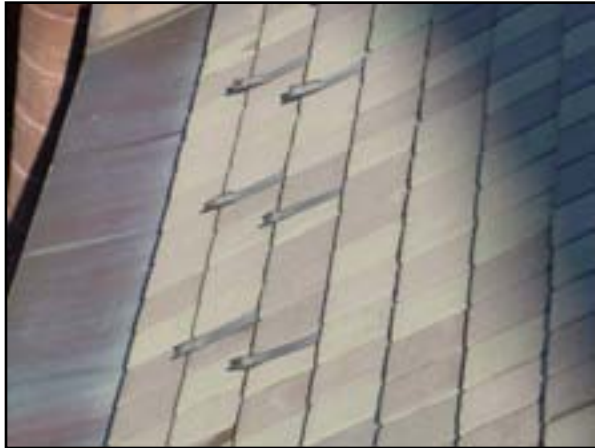
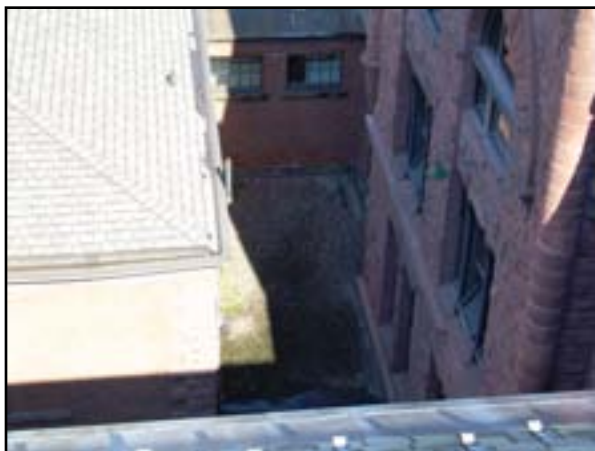
Roof System: Replace Roof

Roof system beyond rated service life. Includes Areas 2B, 7B, 7C, 8, 3A, 4A.

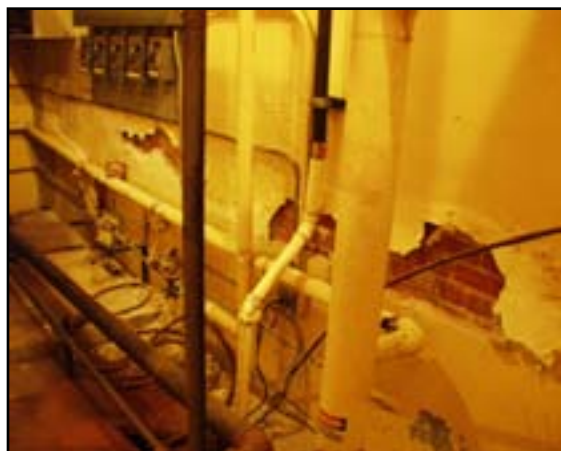
Superstructure: Patch Miscellaneous Walls

Existing walls have various degrees of deterioration and should be repair to stop or slow further degradation.

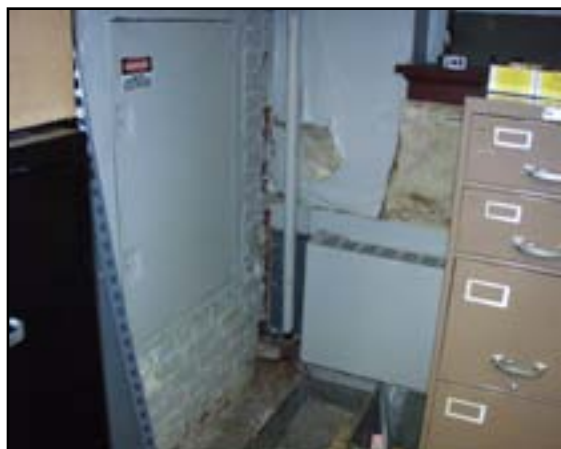
Superstructure: Patch Plaster at Exterior Walls

Existing plaster is damaged from water through walls, at partial basement.

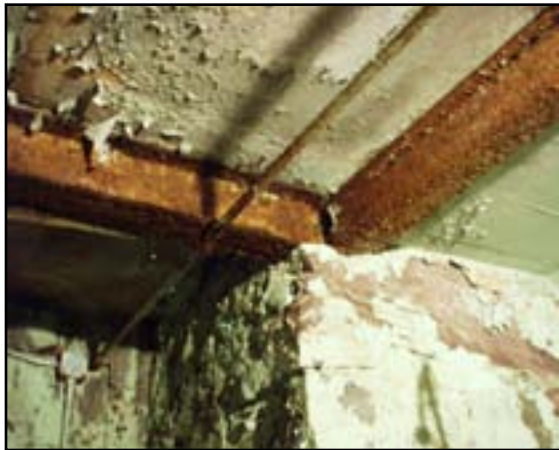
Superstructure: Refinish Steel Beams

Existing steel beams are severely rusted from room moisture, and leakage from exterior plaza above.

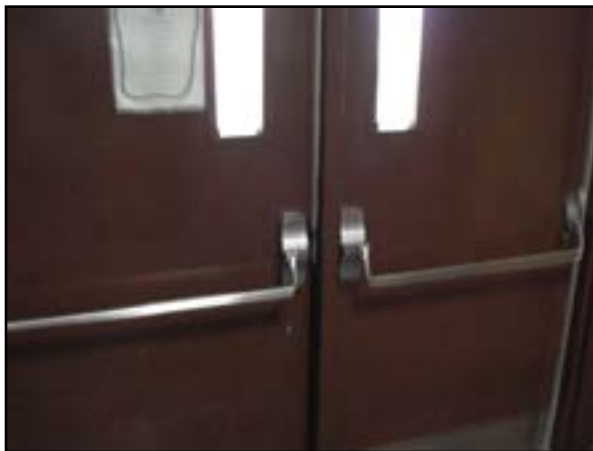
Communication and Security: Access Control

Doors need ability to be locked down with access allowed only to authorized people. Also doors without card readers should be monitored for unauthorized access.

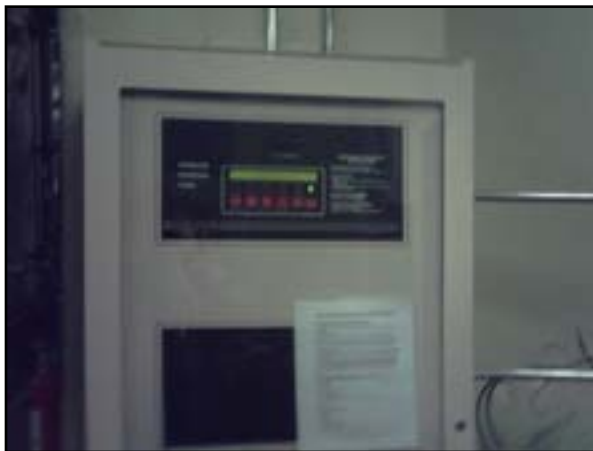
Fire Alarm Systems: Outdated System

Fire alarm systems are old analog system. System is prone to malfunctions and is very hard to identify exact area of alarm. It is also difficult to troubleshoot and find malfunctions.

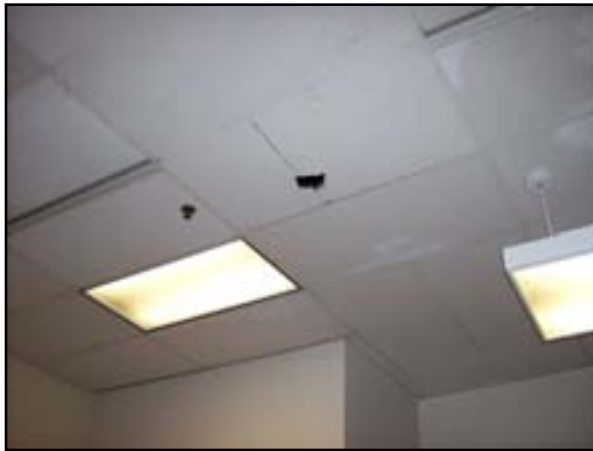
Ceiling Finishes: Replace 2 x 4 and 2 x 5 Suspended Acoustical Tile

Existing 2 x 4 and 2 x 5 suspended acoustical tile is damaged at various locations and does not meet districts standardization goal to convert to 2 x 2 suspended acoustical tile.

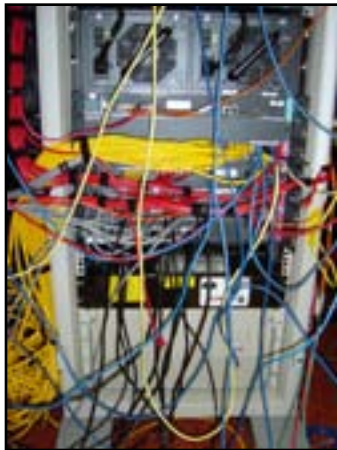
Communication and Security: Cabling Upgrade

Existing building has older categories of cabling.

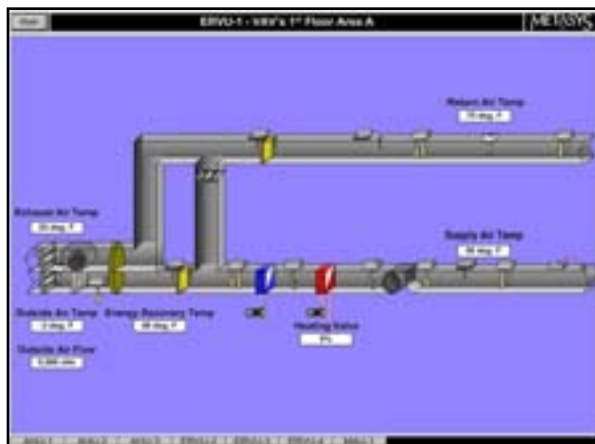
Controls and Instrumentation: BAS and Controls Upgrade

The existing controls shall be recommissioned to verify proper sequence of operation and optimize energy efficiency. Additional control and monitoring points shall also be added to the BAS system to optimize HVAC system performance.

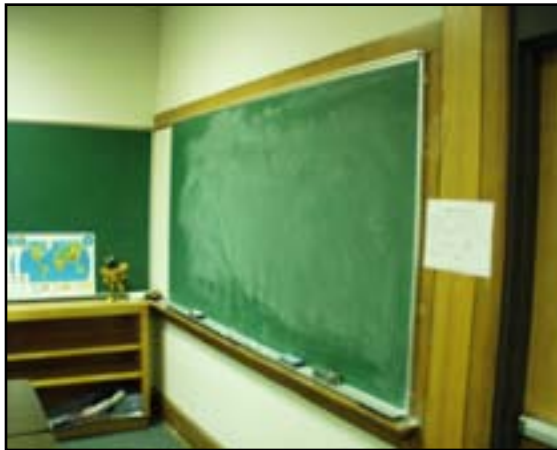
Fittings: Replace Chalkboards and Tackboards
 -

Chalkboards do not meet district's standardization goal to convert to markerboard.
