Requirement Detail

ROCKRIDGE

District: Duluth Public Schools
Facility: Rockridge Elementary School
Category: Beyond Rated Life

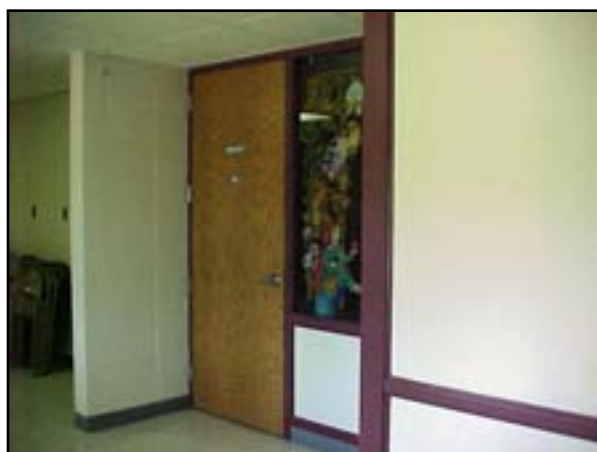
Interior Construction: Accessibility

This requirement includes accessibility issues encountered while you move through the school. Items include: providing elevator or ramp, adding/modifying handrails (only if the level is not served by an elevator or other accessible route), widening doors, replacing door hardware, eliminating protruding hazards and all permanent room identification signage as well as directional signage (adding signs, replacing signs and relocating signs).

Make necessary modifications to correct accessibility issues as needed.

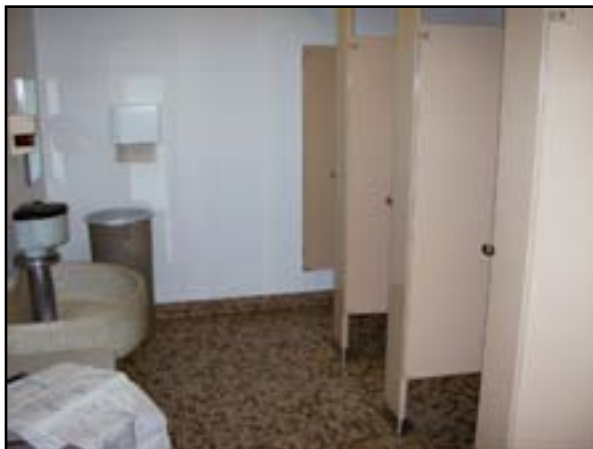
Superstructure: Reconstruct Toilet Rooms for Accessibility

Toilet stalls, urinals and lavatories need to be reconfigured to meet current accessibility (ADA) standards.

Modify toilet stalls and plumbing fixtures for accessibility.

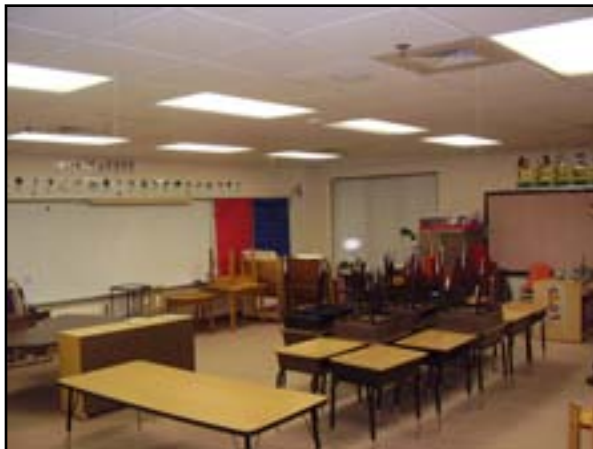
HVAC: Add Dehumidification to the 1965 Building and 1992 Addition Classrooms

The air handling unit serving the all of the 1992 Addition and all of the 1965 Building (except for the gym, kitchen, and latchkey room) has no means of dehumidification. Without dehumidification capabilities, these spaces cannot meet ASHRAE 55-1992 space design conditions. As part of this upgrade, the new mechanical system will incorporated heat recovery and classroom occupancy / CO2 controls to save energy.

Addition of a dehumidification coil to the air handling unit serving the classrooms for this area via modification and internal closed cell AHU liner. The supply duct would be externally insulated in mechanical rooms and above ceilings. Upgrade the controls system. Test and Balance and Commissioning of the air handling systems.

VAV boxes with hot water reheat coils would be added to the ductwork in the classrooms. New acoustical tile ceilings would be installed. New lighting as well.

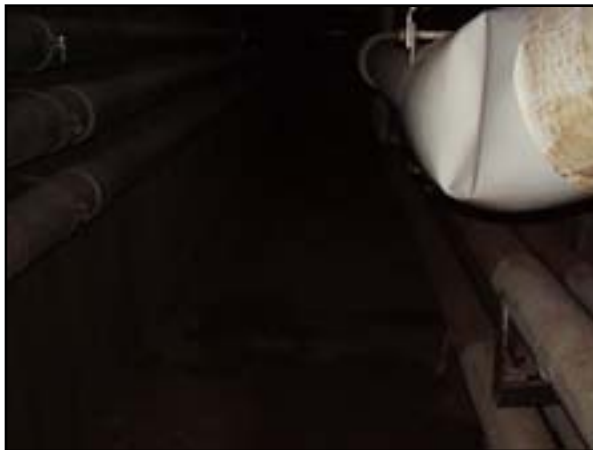
HVAC: Provide Negative Pressure in Crawlspace/Tunnels

The tunnels have concrete floors and are wet. If not under negative pressure can transfer odors to the floors above due to the pipe and duct penetrations. The tunnels are also present opportunity for mold growth.

In addition, there is a ground water issue on site and additional sump pumps are required in the tunnels.

Install exhaust fans and outdoor air intakes as required to ventilate tunnels, as well as maintain negative pressure. Plan on 4 areas.

In addition, 5 more sump pumps are budgeted to be added.

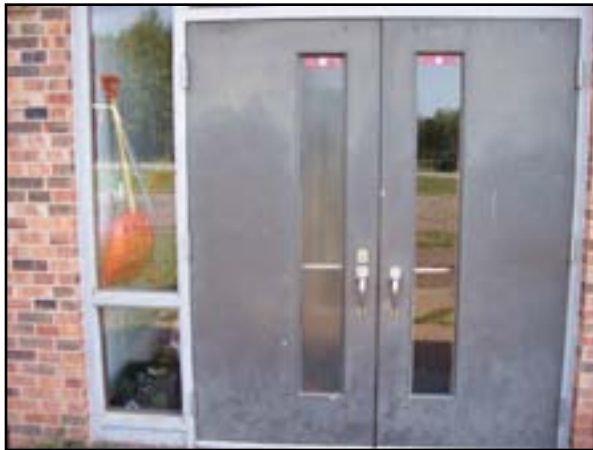
Exterior Doors: Paint Doors

Metal exterior and interior vestibule doors and frames exhibit damaged finish and rust.

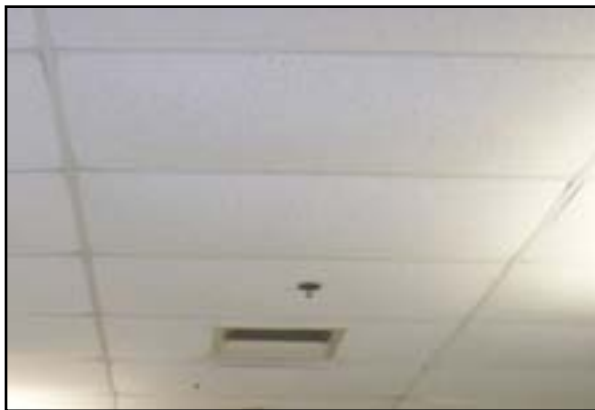
Ceiling Finishes: Replace Acoustical Tile

Existing 2 X 4 suspended acoustical tile is beyond rated life and does not meet district standardization/modernization plan to convert to 2 X 2 suspended acoustical tile.

Replace 2 X 4 suspended acoustical tile with 2 X 2 suspended acoustical tile approximately 1700 S.F.

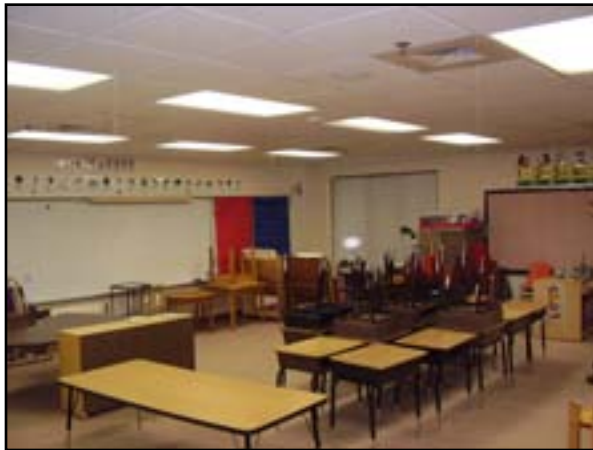
Floor Finishes: Carpet

Carpet in classrooms is worn and beyond rated life.

Replace classroom carpet with new carpet, approximately 11,000 S.F.

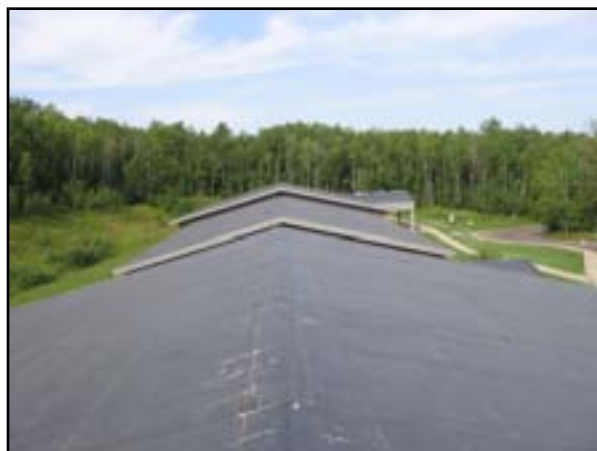
Roof System: Replace Roof

Roof system is performing as expected. Replace in 10 years. Includes roof Areas 1-3.

Replace the adhered EPDM roof in this area.

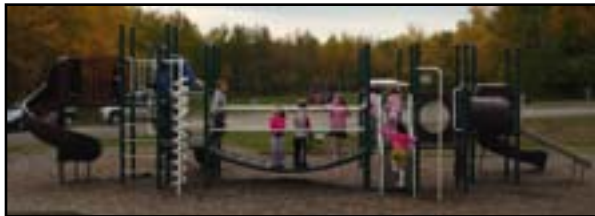
Site Furnishings: Playground Upgrade / Replacement

Playground equipment was built in 1991 and 1998. Swings are non-conforming to safety standards (not enough room). Has "pea rock" which does not meet ADA. The playground equipment does not meet current safety and ADA requirements. Site is close to adequate for population size.

Replace existing playground with new equipment to meet needs of enrollment. Replace surface material with district standard and replace edging as needed.

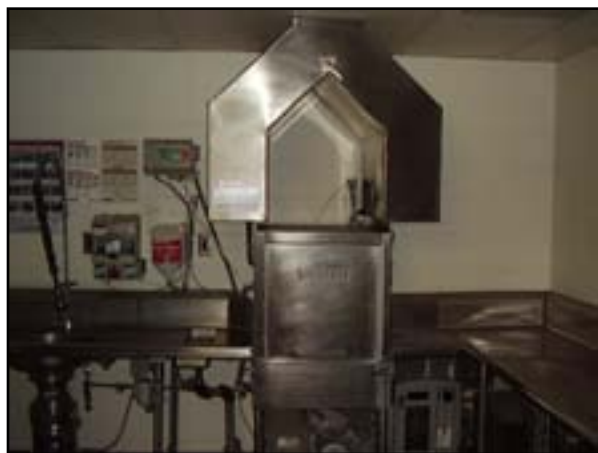
HVAC: Replace Dishwasher Exhaust Hood

The existing dishwasher has an existing exhaust hood but is not tagged as a type II Hood. It does not have an exhaust hood as required by the 2000 International Mechanical Code. Exhausting the dishwasher steam is critical in maintaining proper indoor air quality in the kitchen.

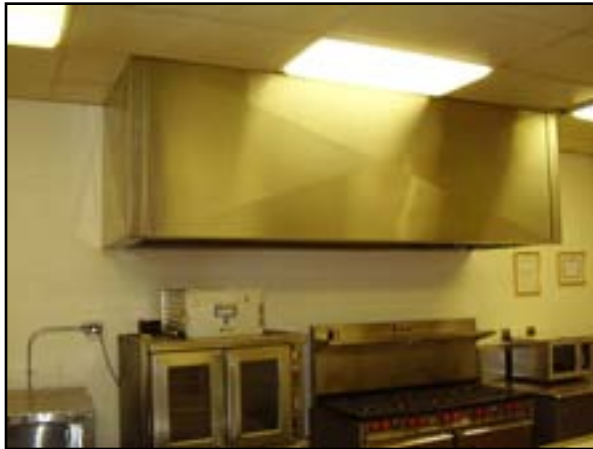
HVAC: Replace Kitchen Grease Exhaust Hood / Add Kitchen Make Up Air

The existing grease exhaust hood does not appear to be drawing the exhaust airflow as required by the 2000 Uniform Mechanical Code. This hood needs to be replaced with a code compliant grease exhaust hood and fan.

In addition, the kitchen does not have a dedicated make up air unit. Make up air for the kitchen hood is required by the 2000 International Mechanical Code.

Replace the existing grease exhaust hood and fan and grease duct with 2000 International Mechanical Code compliant kitchen grease hood exhaust system.

Add a dedicated make up air unit with dehumidification.

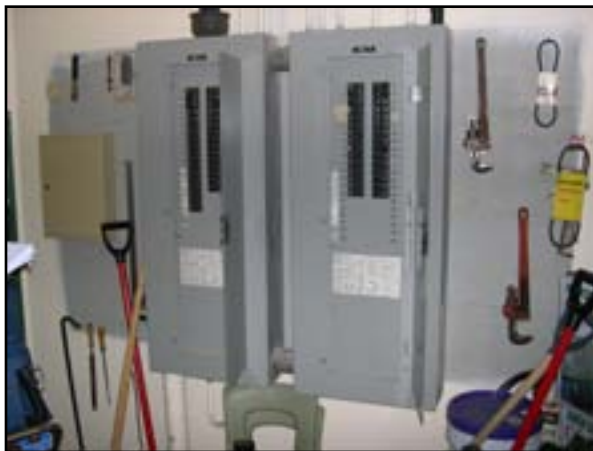
Electrical Distribution: Insufficient Capacity

Existing Branch Panels are lacking capacity for additional circuits. A panel must be added to accommodate circuits needed for additional receptacles.

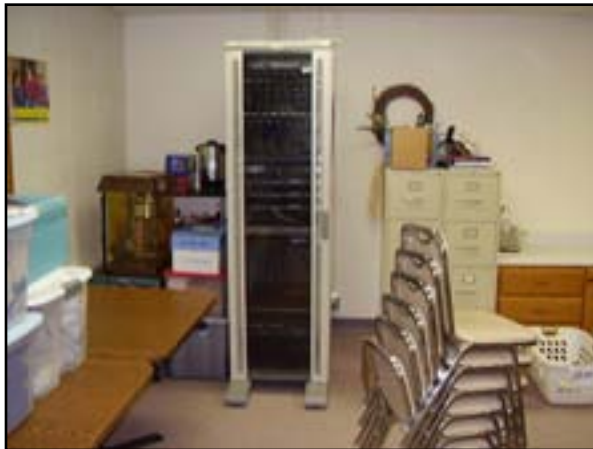
HVAC: Add Cooling Capability to IT Data Room

The Computer Lab and IT Data rooms get hot, which could cause technology equipment failure.

Provide a fan coil with a DX cooling coil with full economizer capability to utilize free cooling when outdoor conditions allow.

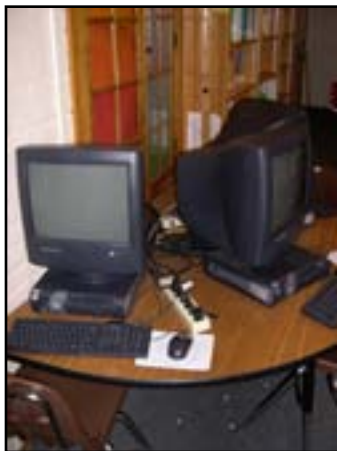
Wiring Devices: Insufficient Receptacles

With rapid advances in technology, additional receptacles may be required in 6 to 10 years. The Addition of receptacles will require additional branch panels.

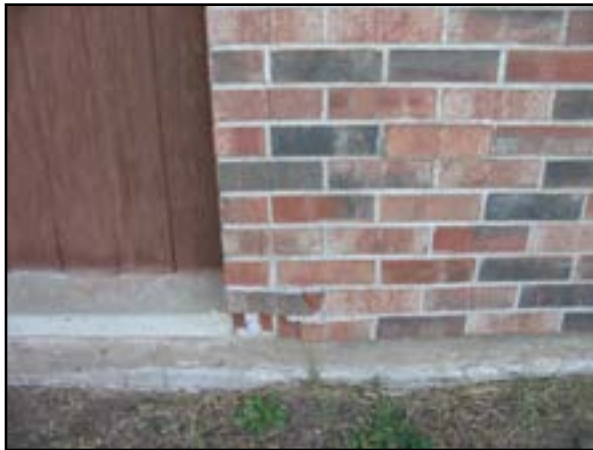
Exterior Walls: Wall Restoration

Deteriorated walls around the entire perimeter of building.

Tuck pointing, spot brick replacement, joint sealant replacement, painting, and other misc. items.

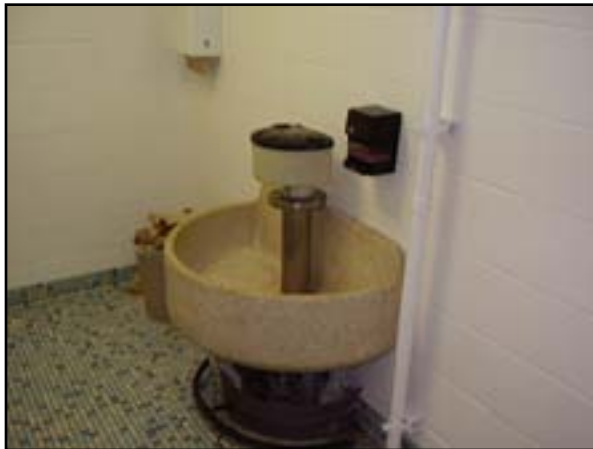
Plumbing: Replace Lavatory Wash Fountains

There are two(2) old style lavatory wash fountains are in need of constant maintenance and most leak water. They are also located inside the toilet rooms. These wash fountains have exceeded the recommended useful life.

Replace two wash fountains with new wash fountains with infrared mixing stations.

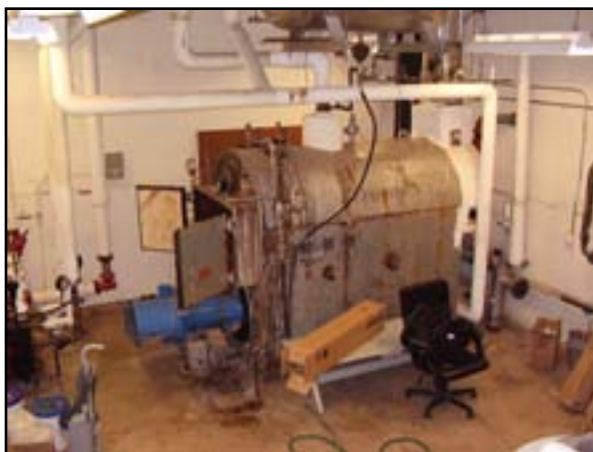
HVAC: Boiler Room Upgrades

The existing boiler has exceeded the recommended useful life expectancy. The boiler shell is in poor condition and rust has formed. The building has only one boiler, thus backup heating capacity is not present. This could lead to building freeze up if the boiler fails. The existing boiler should be replaced with two high efficiency hot water boilers to increase the efficiency of the boiler plant.

This would also provide heating backup for the building.

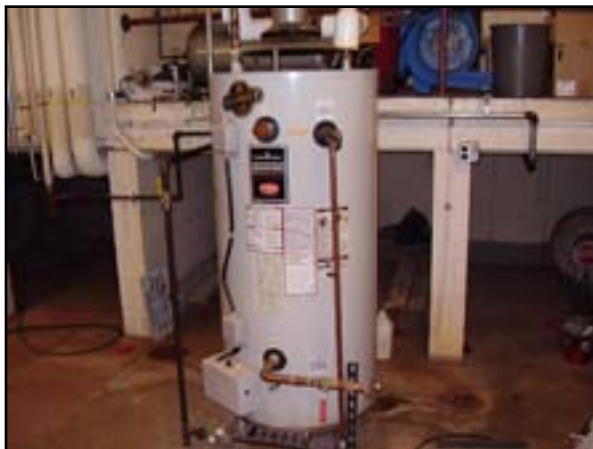
Plumbing: Add Water to Water Heat Exchanger for Domestic Hot Water

Provide a domestic hot water heat exchanger. This will allow for an interruptible natural gas rate.

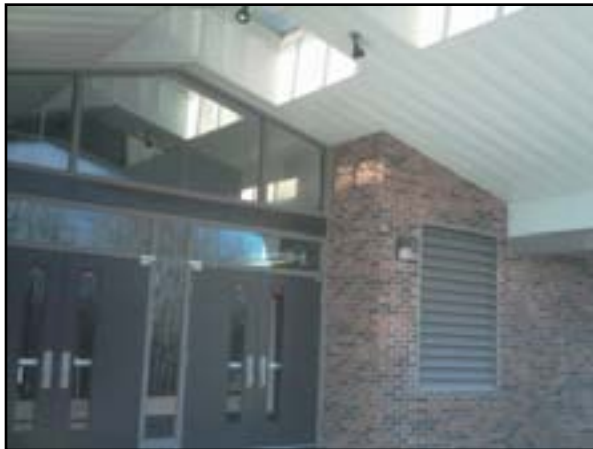
Communication and Security: Access Control
-

Doors need ability to be locked down with access allowed only to authorized people. Also doors without card readers should be monitored for unauthorized access.

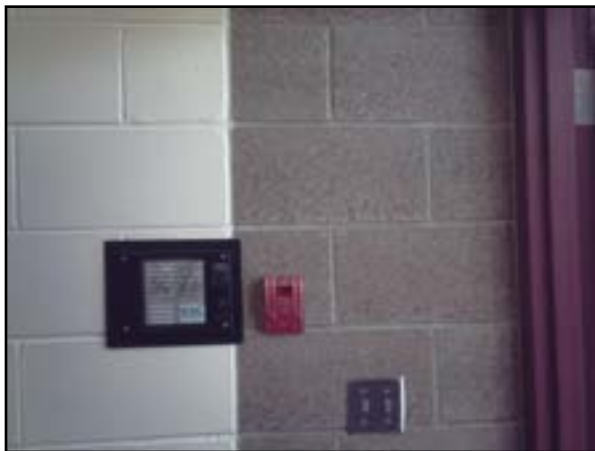
Fire Alarm Systems: Outdated System

Fire alarm systems are old analog system. System is prone to malfunctions and is very hard to identify exact area of alarm. It is also difficult to troubleshoot and find malfunctions.

Replace fire system with a fully addressable fire system.
 This will allow for quick response to exact alarm device
 And allow for better maintenance and safety

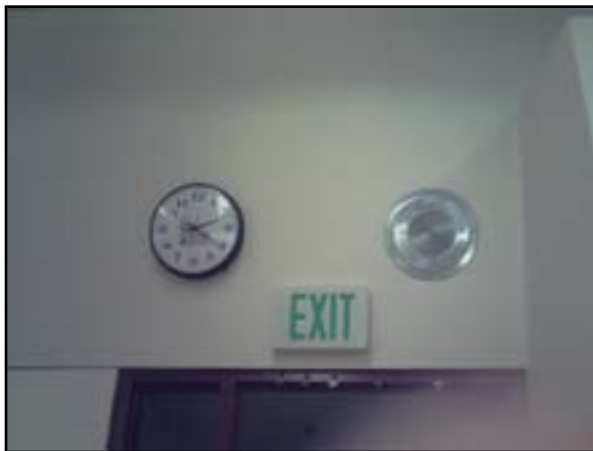
Communication and Security: Clock System

Master clock systems no longer keep clocks in time. Most are only used for running the bells. Atomic clocks may not receive a signal through the brick buildings. Many clocks do not work at all.

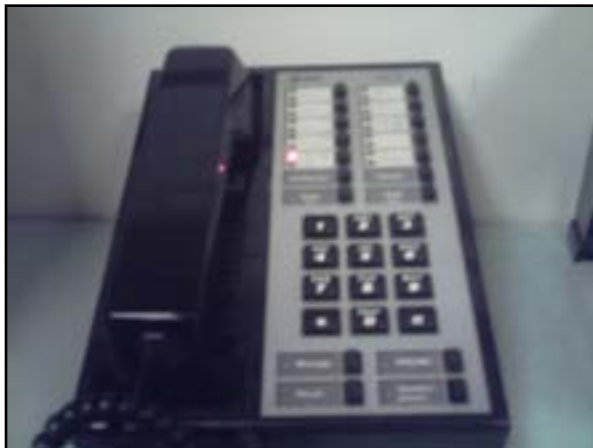
Communication and Security: Public Address and Sound System
 -

PA system is 25+ years old but is still functional.
 There are no speakers located in hallways or commons areas.

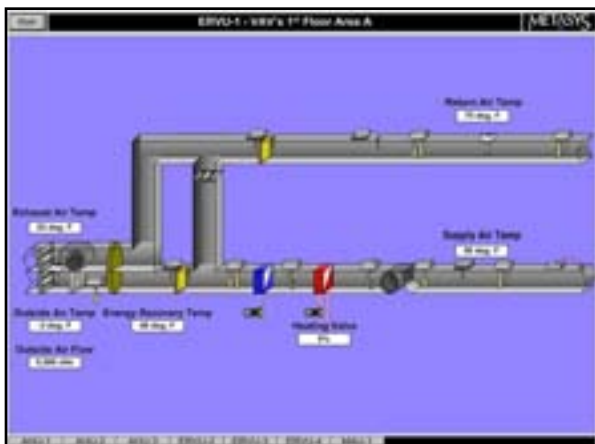
BAS Graphic

Upgrade/replace existing temperature control valves, dampers, and actuators. The majority are beyond rated life and many are disconnected and not functioning, thus not operating as energy efficiently as possible.

Replace existing temperature control air compressor and air dryer with new and repair control air line leaks. This will improve the energy efficiency of the existing control system.

The existing controls shall be recommissioned to verify proper sequence of operation and optimize energy efficiency. Additional control and monitoring points shall also be added to the BAS system to optimize HVAC system performance.

Replace existing BAS headend to Web-based headend to tie District wide BAS. Replace existing DDC and pneumatic controls with new JCI DDC controls to allow integration to District wide BAS.

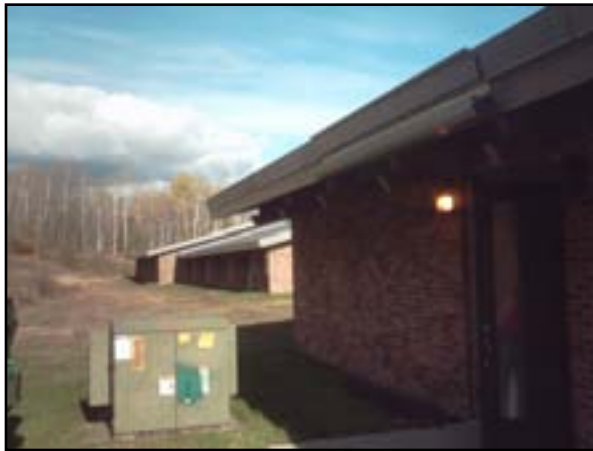
Emergency Power Distribution: Generator Backup

School currently has no backup power system to be used during a power failure. To keep students in school during power outage sufficient lighting must be maintained along with necessary life safety systems.

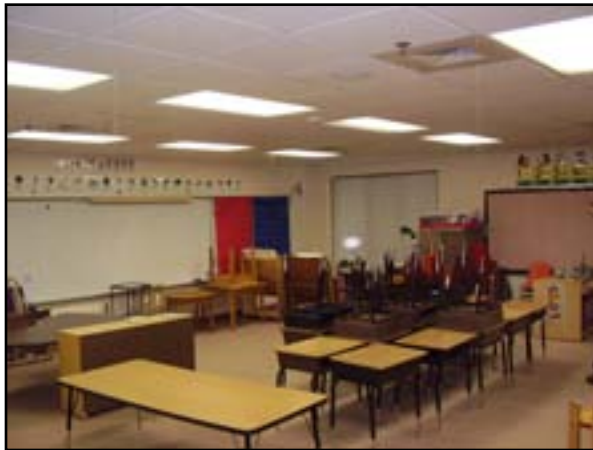
Fittings: Chalkboard

Existing Chalkboard does not meet district standardization/ modernization plan to replace with markerboard.

Replace existing chalkboard with markerboard approximately 112 S. F.
