Requirement Detail

**TRANSPORTATION
CENTER**

District: Duluth Public Schools
Facility: Transportation Center
Category: Upgrades

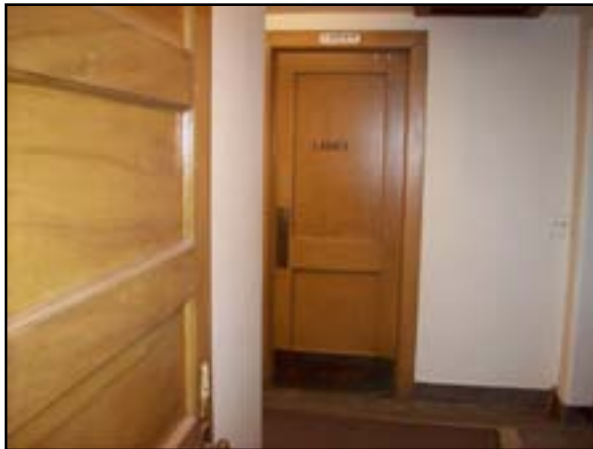
Interior Doors: Replace Knob Hardware with Lever Hardware

Interior door hardware is cylindrical design and does not meet current ADA Accessibility Standards.

Replace cylindrical design door hardware with lever type. All doors without panic hardware.

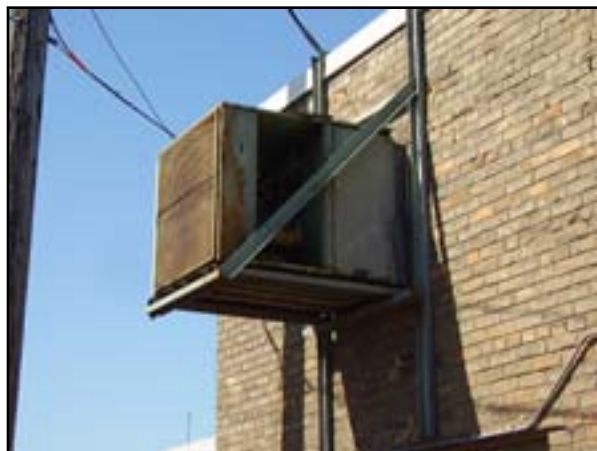
HVAC: Upgrade Office Ventilation and Add Dehumidification

The air handling system serving the Office has exceeded it's recommended service life and has no means of dehumidification due to failed components. Without dehumidification capabilities, these spaces cannot meet ASHRAE 55-1992 space design conditions.

In addition the storage room does not have means of ventilation nor heating.

Installation of new air handling unit with dehumidification capabilities (DX Coil and Condensing Unit). Installation of supply duct with external insulation. Upgrade Controls System. Test and Balance and Commissioning of air handling units.

Installation of unit heaters in storage area and ventilation via the office unit.

This unit would serve the locker rooms as well.

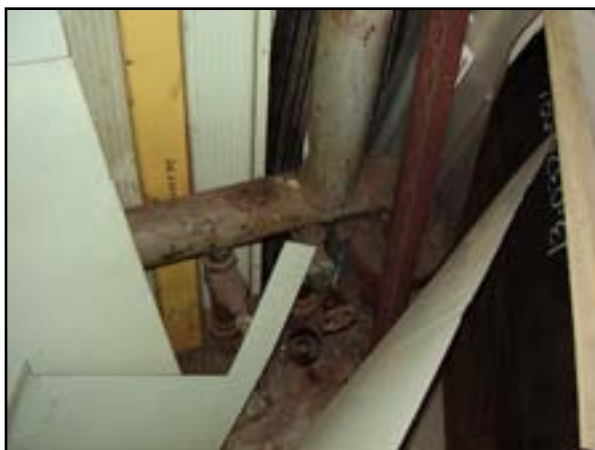
Plumbing: Replace Galvanized Domestic Water Piping

The domestic water distribution piping consists of galvanized piping which is connected together via lead based solder. Current flushing procedures have maintained lead levels at an acceptable level. As the piping continues to age, this may not be possible.

Remove all the remaining galvanized domestic water distribution piping as well as faucets and fixtures containing lead solder. Install insulated copper piping and fixtures/faucets where required. Wall cutting and patching would be required.

This would include directly connecting the drinking fountain sumps.

This includes the bradley shower stations in the locker rooms.

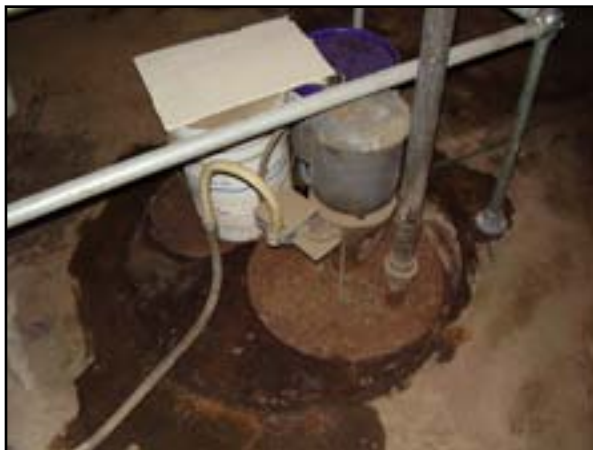
Plumbing - Sump Pump Replacement

The sump pump in the pump room is 8beyond it's recommended service life.

Replace the existing submersible sump pump with a new vertical duplex set of sump pumps with new duplex control panel.

Sump pit may require replacement at this site.

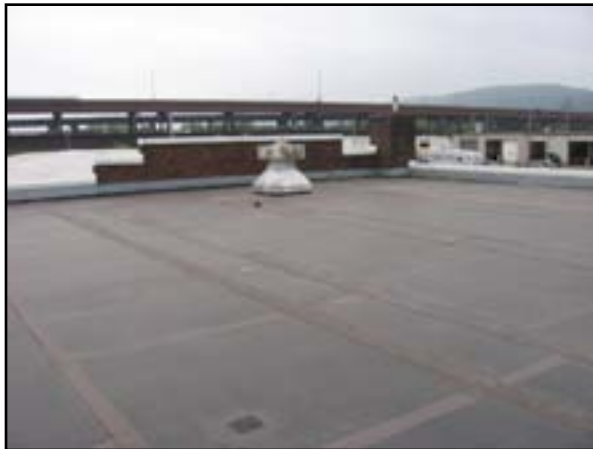
Roof System: Replace Roof

Roof system beyond rated service life. Leakage persists. Includes roof Area 1.

Replace the adhered EPDM roof in this area. Sequence work with roof-level wall restoration.

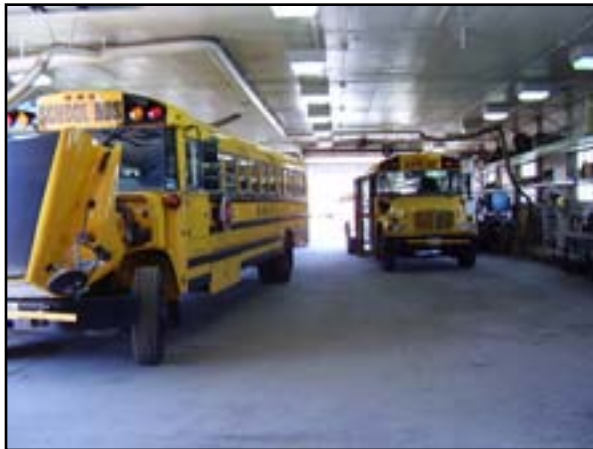
HVAC: Ventilation Improvements - Shop

The shop does not have adequate exhaust, nor does it have a CO, CO2, NO2 detection and make up air system as required by 2000 Mechanical Code.

Install new vehicle exhaust system, gas fume detection system, and make up air system.

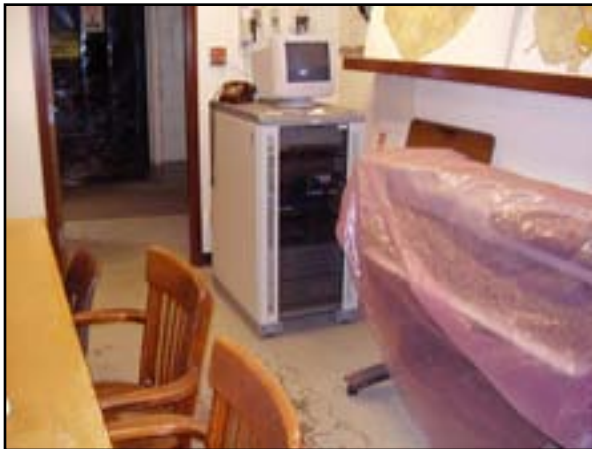
HVAC: Add Cooling Capability to IT Data Rooms

The IT Data room gets hot, which could cause technology equipment failure.

Provide a fan coil with a DX cooling coil and full economizer capability to utilize free cooling when outdoor conditions allow.

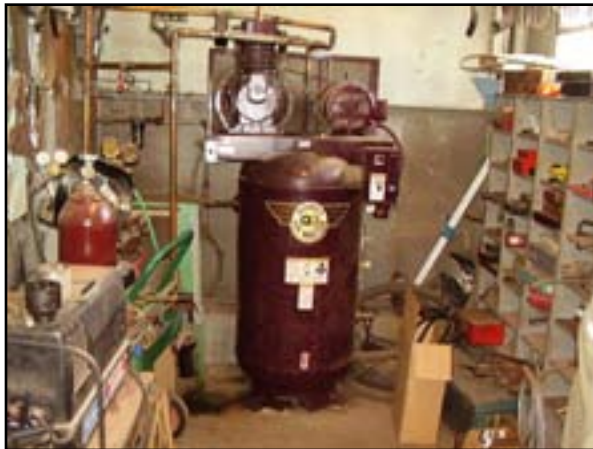
Plumbing: Upsize Service Air Lines

The existing shop air lines do not allow for multiple tool operation. This is especially true for when the sand blaster is in use.

Upsize the air lines on both sides of the shop to allow for multiple tool operation.

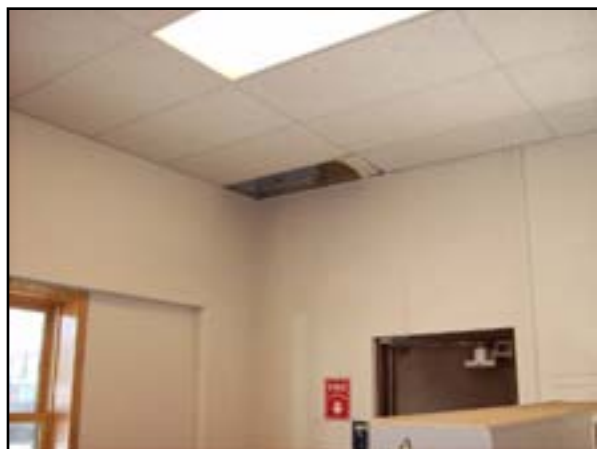
Ceiling Finishes: Suspend Acoustical Tile

Portions of existing 2x4 suspended acoustical tile ceiling are missing and insulation is falling down.

Repair damaged and missing acoustical tile and glass fiber blanket insulation.

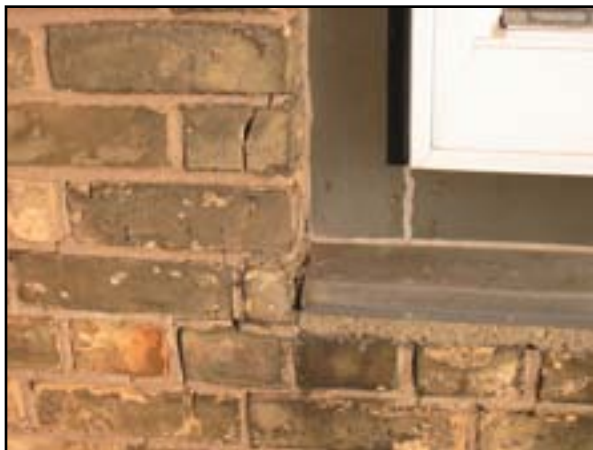
Exterior Walls: Wall Restoration

Deteriorated roof-level and grade-level walls around entire building perimeter for all three buildings on site.

Tuck pointing, spot brick replacement, joint sealant replacement, painting, replace and flash lintels, and replace sheet metal panels. Sequence work with reroofing Area 1.

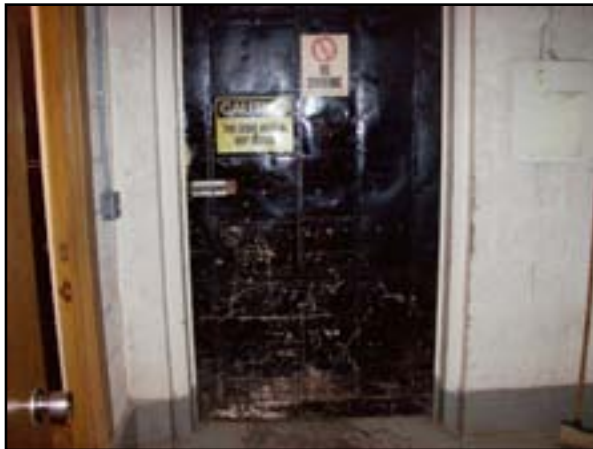
trans wood door

Wood panel doors (some with untempered glass panels & sidelights) & steel doors are old, unsightly & without lever hardware.

Replace wood panel and steel doors with new. 8 doors.

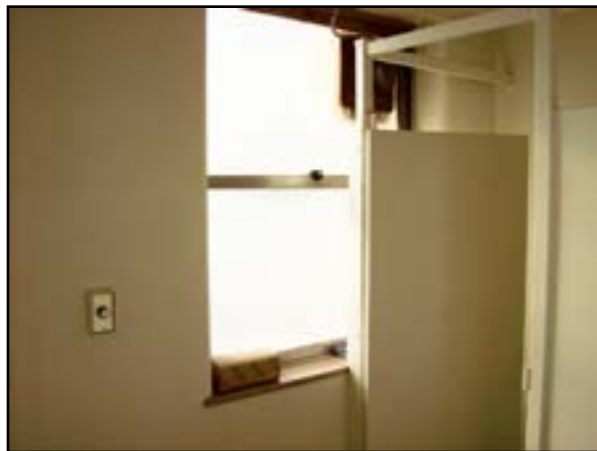
Exterior Windows: Steel Windows

Steel windows are single pane glass & old. Energy Inefficient

Replace existing steel single pane windows with new vinyl or aluminum windows with insulating glass. (11) 4' X 3' windows.

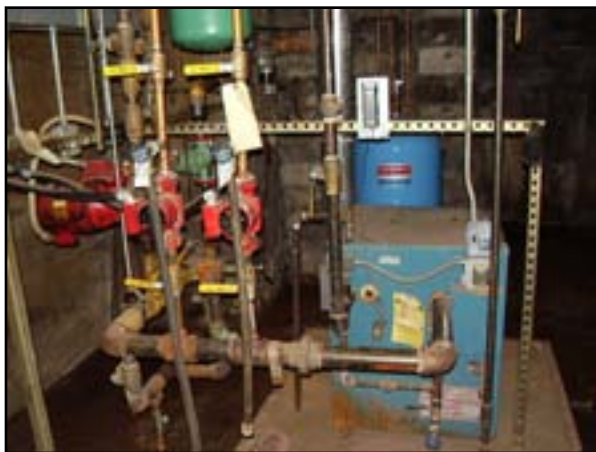
HVAC: Boiler Room Upgrades

The existing boiler does not have backup capabilities.

In addition, the heating piping is not insulated which consumes more energy than an insulated piping system.

Install one new high efficiency backup boiler and insulate heating piping.

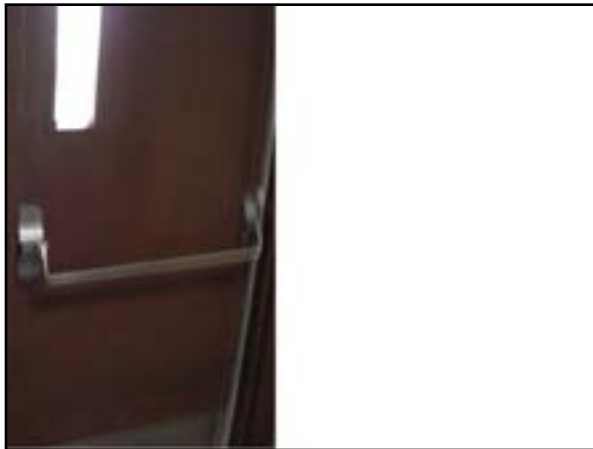
Communication and Security: Access Control

Doors need ability to be locked down with access allowed only to authorized people. Also doors without card readers should be monitored for unauthorized access.

INSTALL CARD READERS AT 2-3 DOORS AS NEEDED, INSTALL MAGNETIC CONTACTS ON ALL OTHER DOORS INCLUDING GARAGE DOOR

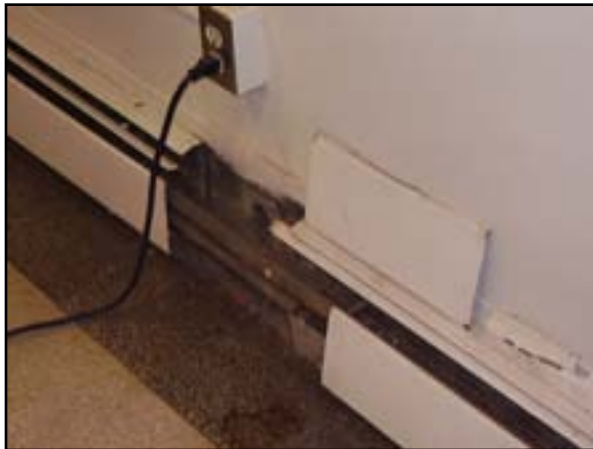
HVAC: Add Propylene Glycol to Heating System

The heating system currently serving the building does not contain glycol, which creates the opportunity for heating coil freeze up.

Add Propylene Glycol into the entire heating system to prevent coil freeze up.

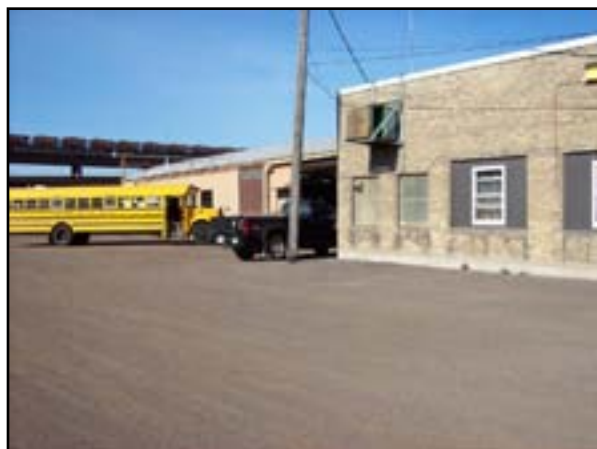
Superstructure: Replace Garage

Existing repair garage is in poor condition and does not function well and in hard to heat; replace building.

Demo existing building and replace with new steel building.
