Requirement Detail

DENFELD HS

District: Duluth Public Schools
Facility: Denfeld High School
Category: Deferred Maintenance

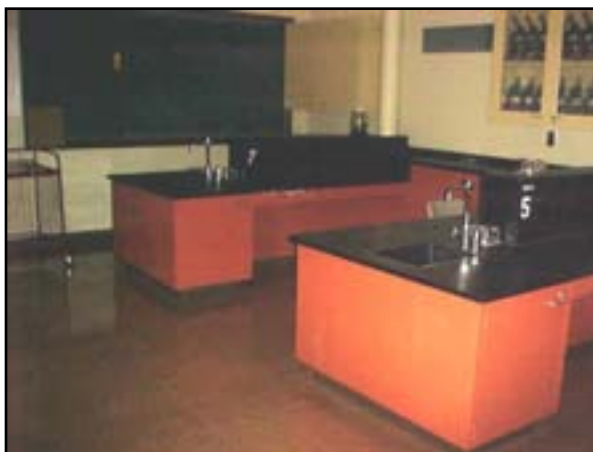
Equipment and Furnishings: Accessibility

It also includes accessibility issues found in Specialty Areas (science labs, cooking labs, industrial arts areas, as well as the media center/library). Items include: providing accessible work stations in kitchens, providing accessible labs and lowering eyewashes.

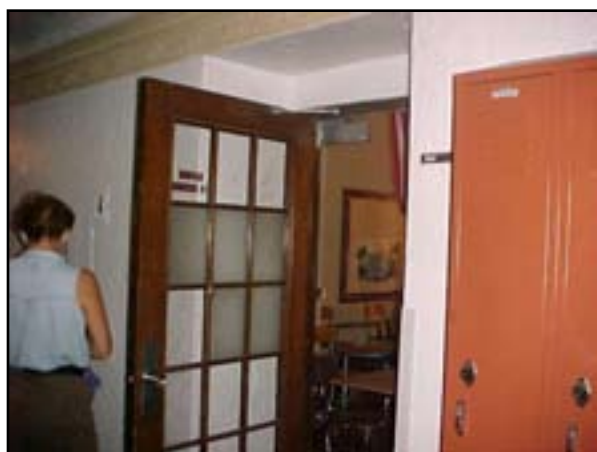
Interior Construction: Accessibility

This requirement includes accessibility issues encountered while you move through the school. Items include: providing elevator or ramp, adding/modifying handrails (only if the level is not served by an elevator or other accessible route), widening doors, replacing door hardware, eliminating protruding hazards and all permanent room identification signage as well as directional signage (adding signs, replacing signs and relocating signs).

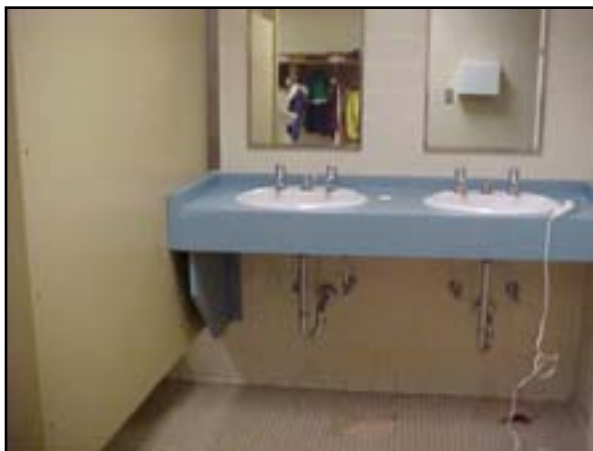
Plumbing: Accessibility

Note: the actual cost to complete work in toilet rooms may be increased by a decision to do work beyond what is required for accessibility, such as re-tiling, replacing all fixtures, replacing all stall partitions, etc.

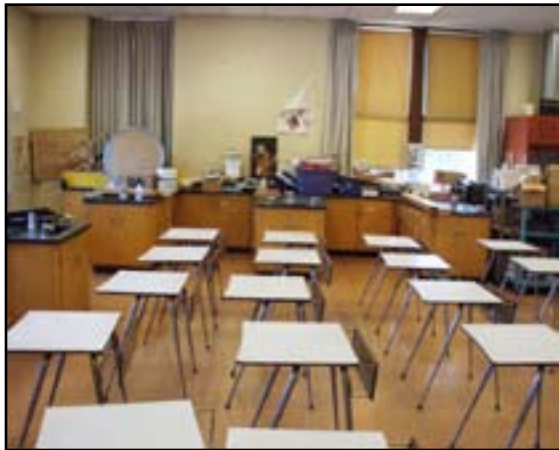
Wall Finishes: Repaint Classrooms

Walls will require repainting due to soiling.

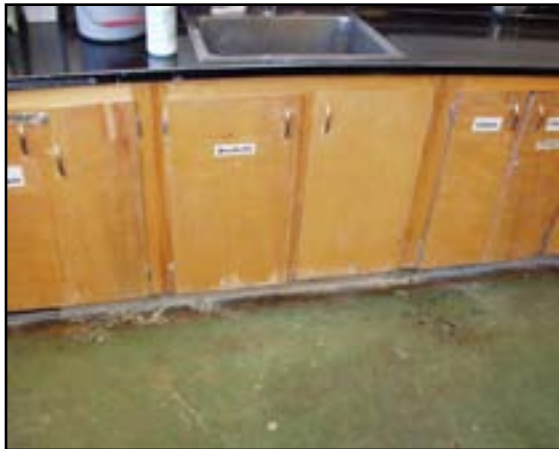
Equipment and Furnishings: Refinish Wood Cabinets

Existing wood cabinets require refinishing.

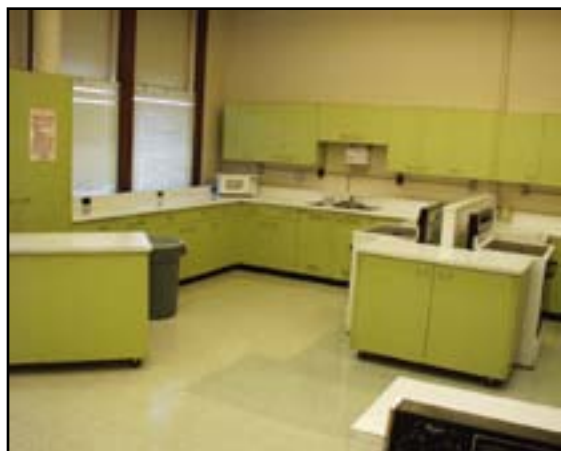
Equipment and Furnishings: Refurbish Cabinets and Countertops

Existing metal cabites are in good shape, lime green paint is very dated as well as plastic laminate countertops.

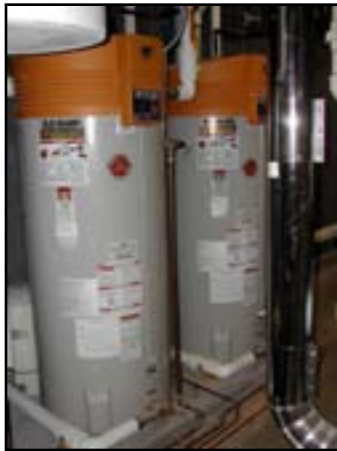
Plumbing - Addition of Natural Gas Water Heater

The domestic hot water is currently generated by a steam to hot water heat exchanger. A natural gas water heater is desired for summer operation.

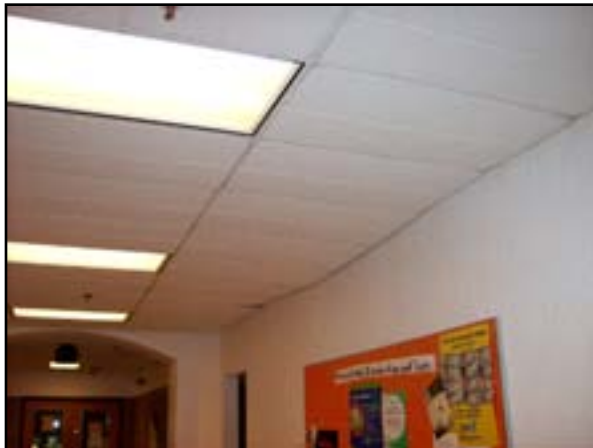
Ceiling Finishes: Replace 2x4 Acoustical Tile

District future standardization goal is to convert to 2x2 suspended acoustical tile ceilings.

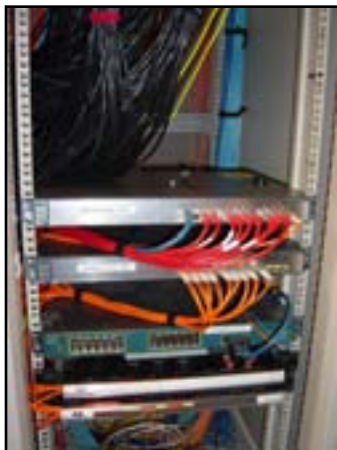
Communication and Security: Cabling Upgrade

Existing building cabling has been installed in several stages over the years and contains different categories of cabling.

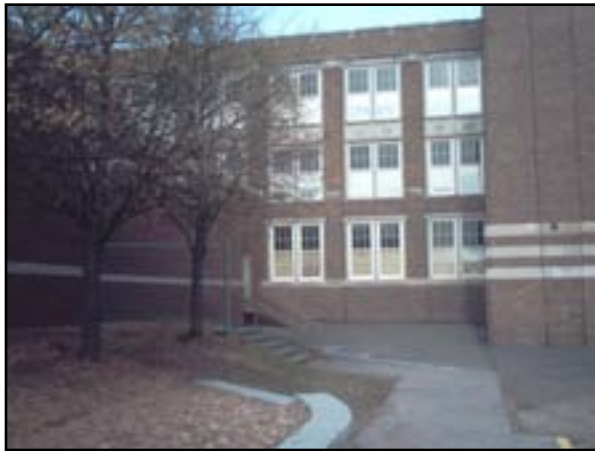
Emergency Power Distribution: Generator Backup

School currently has no backup power system to be used during a power failure. To keep students in school during power outage, sufficient lighting must be maintained along with necessary life safety systems.

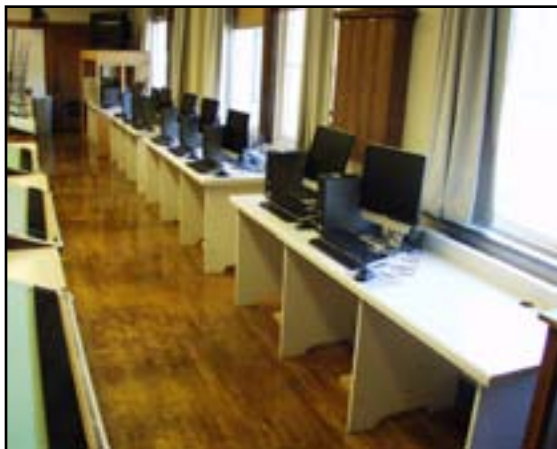
E-Equipment and Furnishings: Construct New Computer Stations

Existing computer stations do not meet districts guture goal to standardize computer stations.

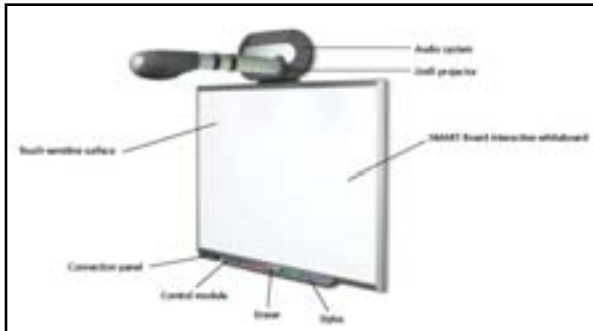
Equipment and Furnishings: Visual Systems (Smart Boards)

Site has two projectors and three Smart Boards installed. Three Smart Boards are on order.

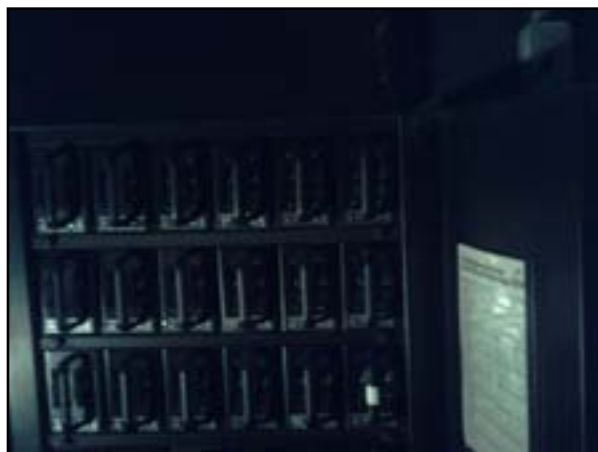
Lighting Equipment: Dimming System

Dimming system could be improved with newer system and better technology.

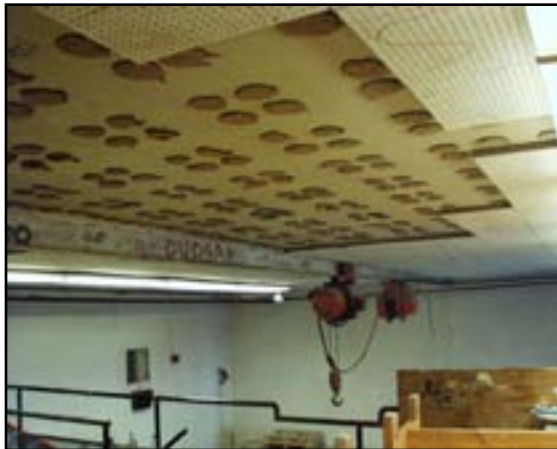
Superstructure: Renovate Ceramics Classroom

Existing classroom is in poor condition, cabinets require replacement, ceiling has been pulled off, mezzanine railing is non-code compliant.

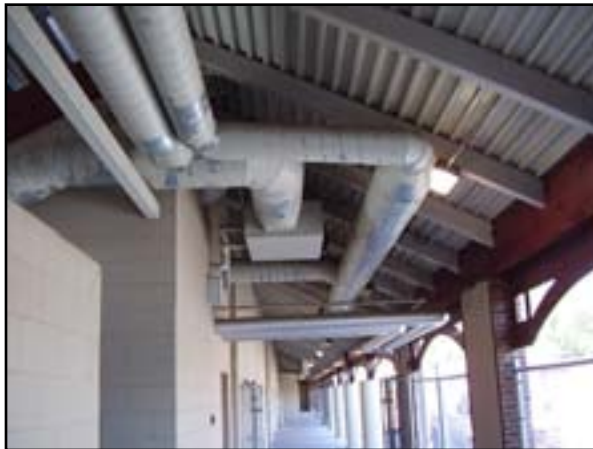
Ceiling Finishes: Paint Surfaces

General interior painting will be required within or around 10 years of ceiling surfaces and ductwork as routine maintenance.

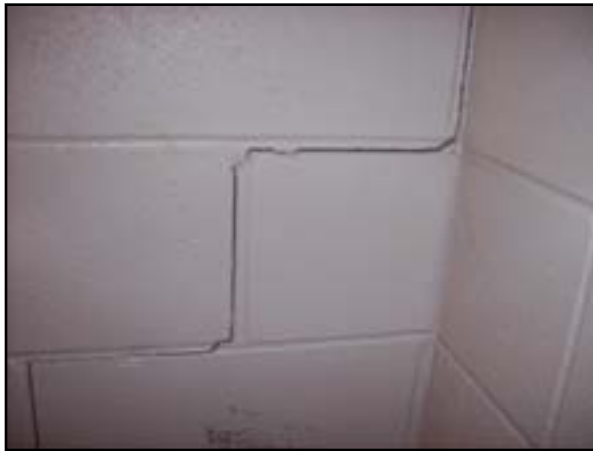
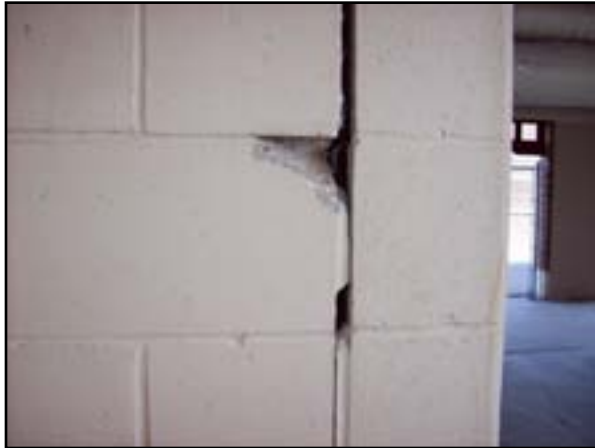
Exterior Walls: Repair Cracks in Masonry Walls

Exterior masonry walls have settlement cracks and need to be caulked and tuckpointed.

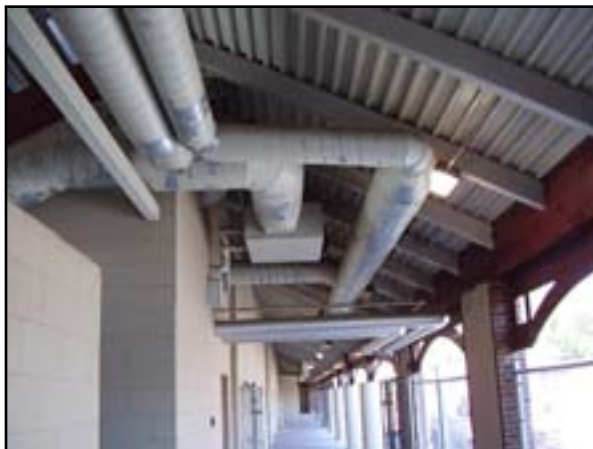
Fan coils

The exhaust for the boiler generates ice, causing a walking hazard.
