Requirement Detail

LESTER PARK

District: Duluth Public Schools
Facility: Lester Park Elementary School
Category: Upgrades

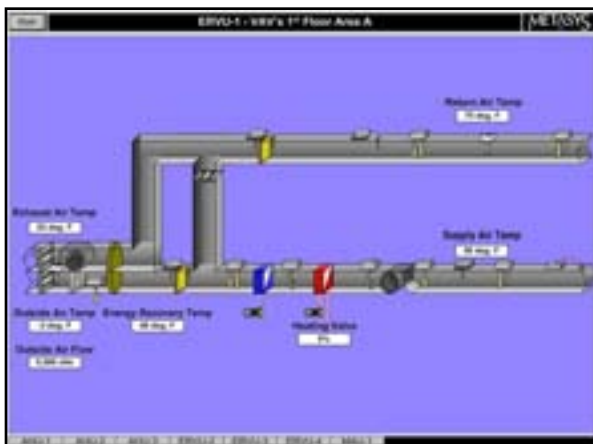
BAS Graphic

Requirement Name	Controls and Instrumentation: BAS and Controls Upgrade		
Linked System	Controls and Instrumentation	Inspection Date	08/08/2006
Prime System	Building Automation Systems	Finish Date	-
Priority	2- Potentially Critical (1-2 Yrs)	Status	Open
Inspector Name	Schmidt, Brian	Actual Cost	0
Action Date	08/08/2007	Total Estimated Cost:	100,300
Funding Year	-	Funding Type	-
Requirement Location	Entire Building	Annual Energy/Ops Savings \$	1,271
Savings Description	Energy saving through optimization and repairs of existing control system.

Upgrade/replace existing temperature control valves, dampers, and actuators. The majority are beyond rated life and many are disconnected and not functioning, thus not operating as energy efficiently as possible.

Replace existing temperature control air compressor and air dryer with new and repair control air line leaks. This will improve the energy efficiency of the existing control system.

The existing controls shall be recommissioned to verify proper sequence of operation and optimize energy efficiency. Additional control and monitoring points shall also be added to the BAS system to optimize HVAC system performance.

Replace existing BAS headend to Web-based headend to tie back to Facilities Management Office. Replace existing DDC and pneumatic controls with new JCI DDC controls to allow integration to District wide BAS.
